Your Inspection Report

139 Verobeach Boulevard
Toronto, ON M9M 1R2

INSPECTION DATE:
Thursday, May 25, 2023

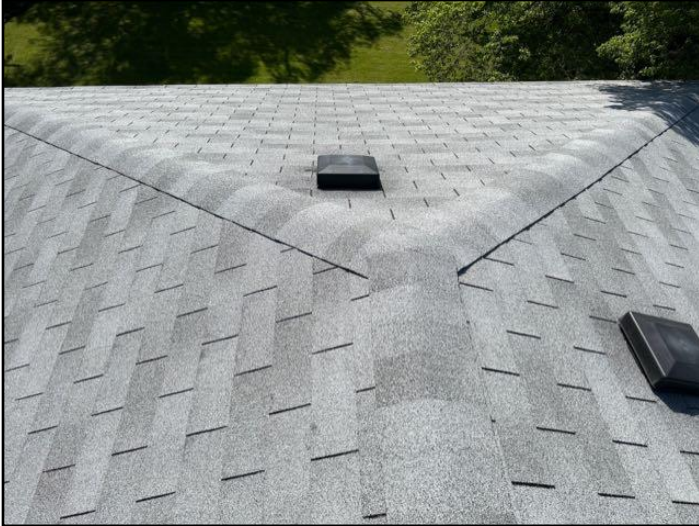
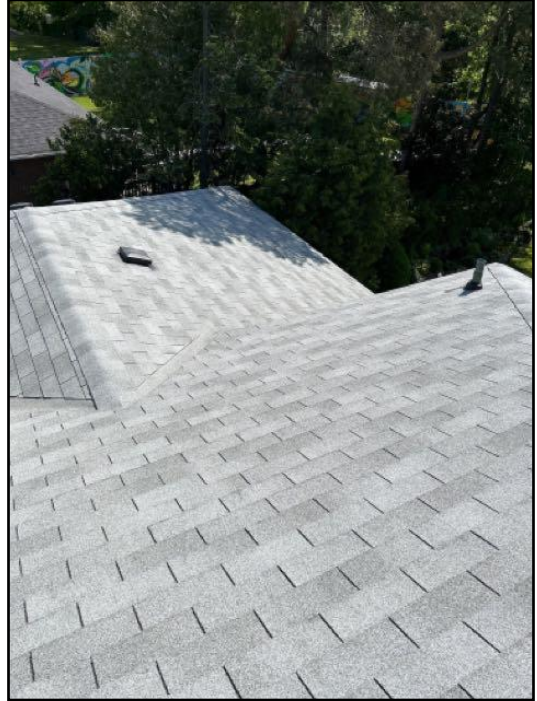
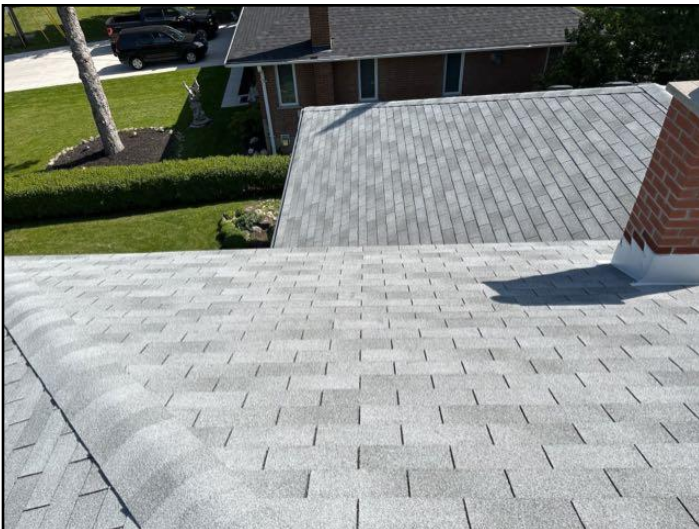
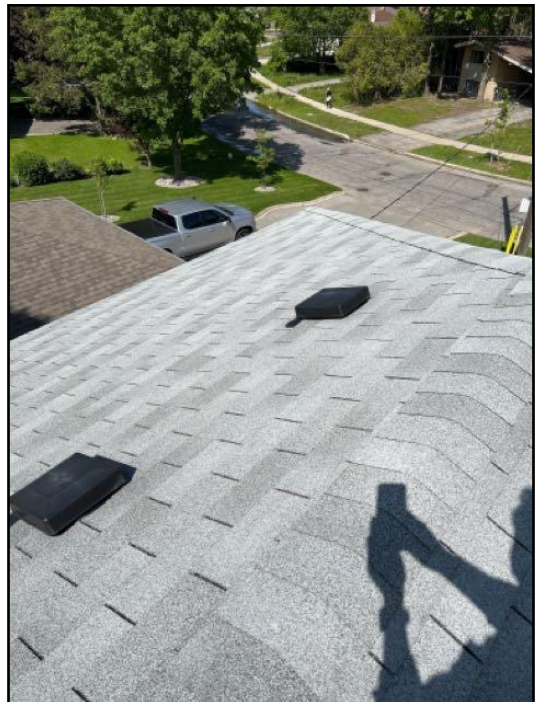
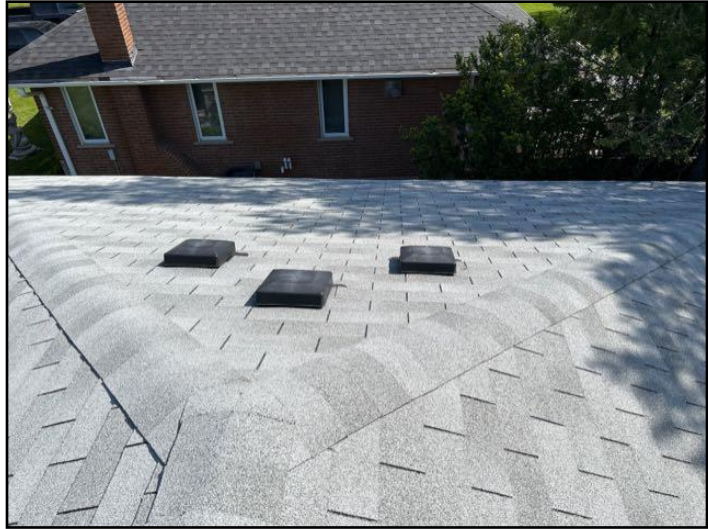
Asphalt shingles

Condition: • No roofing recommendations are offered as a result of this inspection. Roofing material appears to be in good condition.

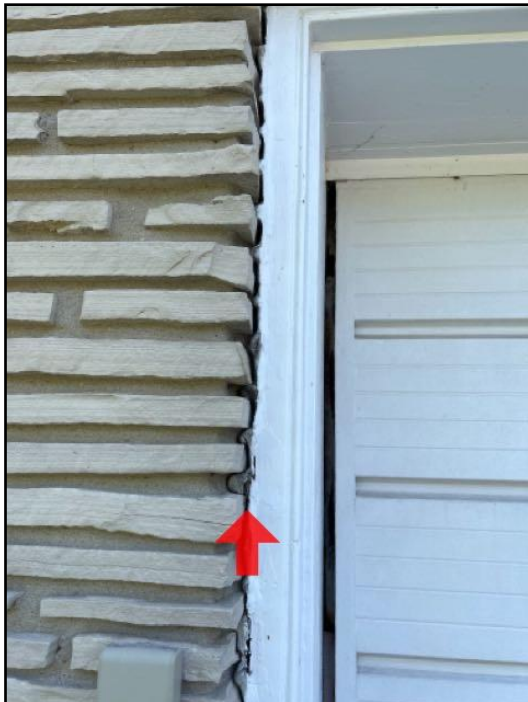
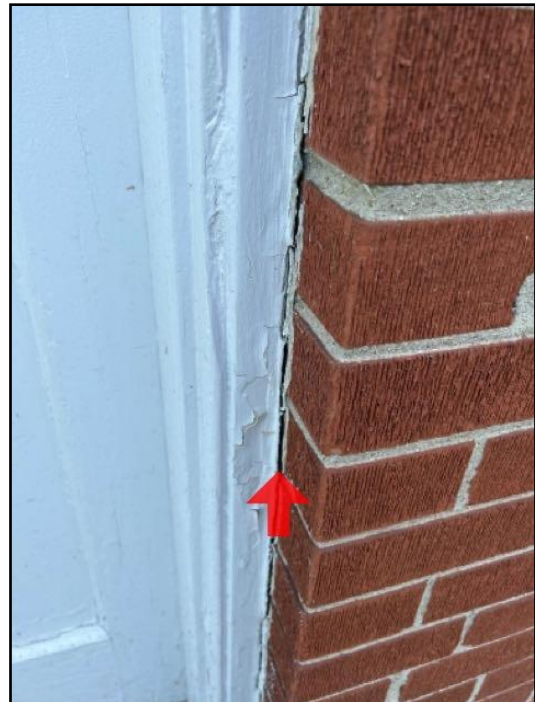
Condition: • [Caulking - deteriorated, loose or missing](#)

Implication(s): Chance of damage to finishes and structure

Location: Garage Door (Vehicle and access doors)

Caulking - deteriorated, loose or missing

Task: Repair

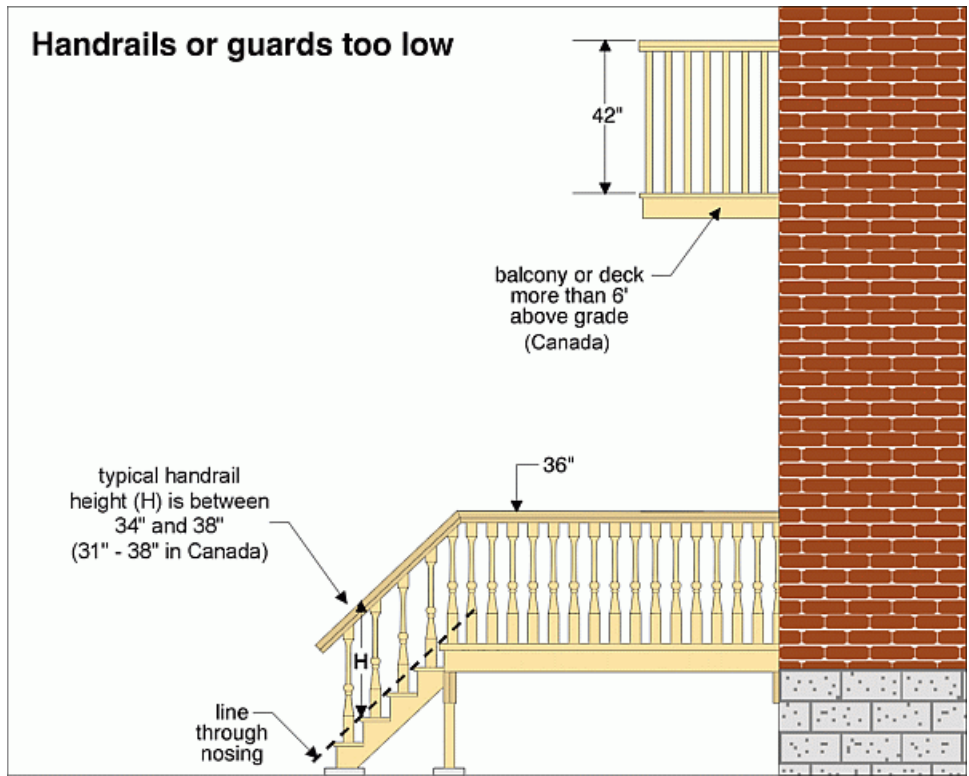
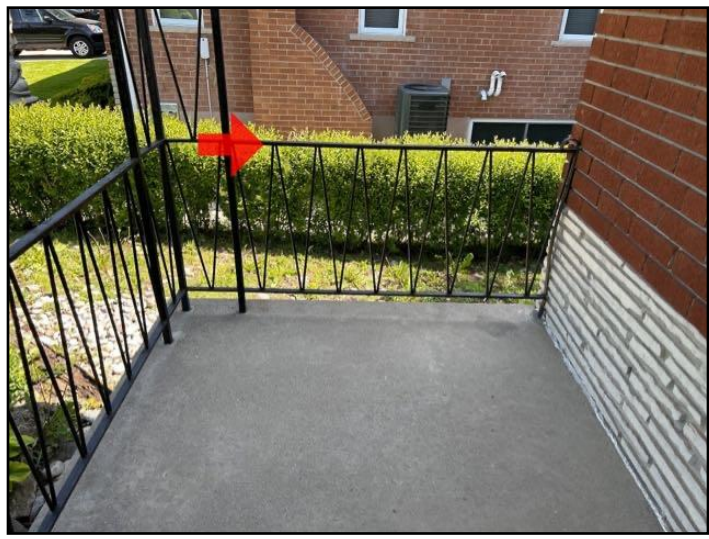
Condition: • [Too low](#)

Implication(s): Fall hazard

Location: Front

Too low

Task: Correct

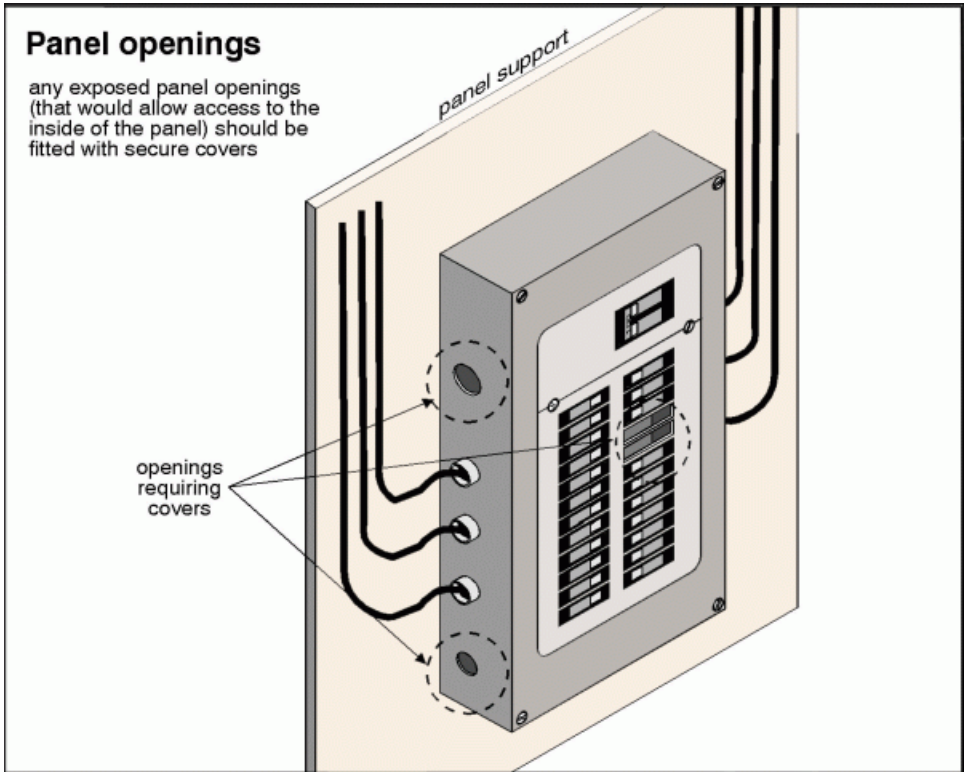
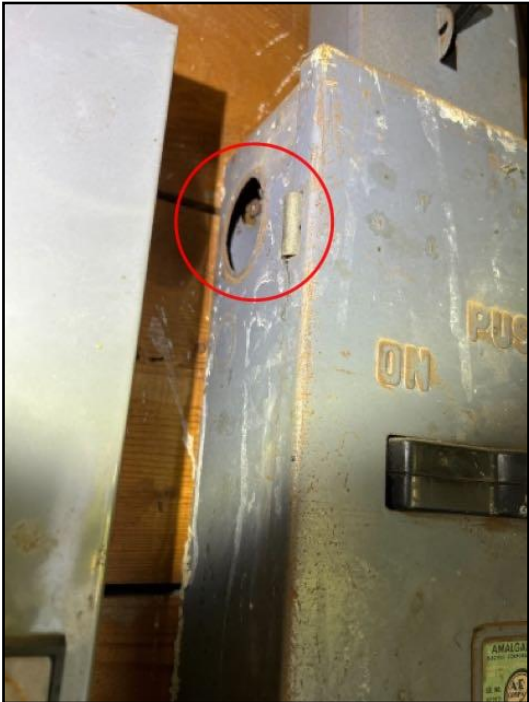
Condition: • [Unprotected openings](#)

Implication(s): Electric shock

Location: Garage

Unprotected openings

Task: Repair

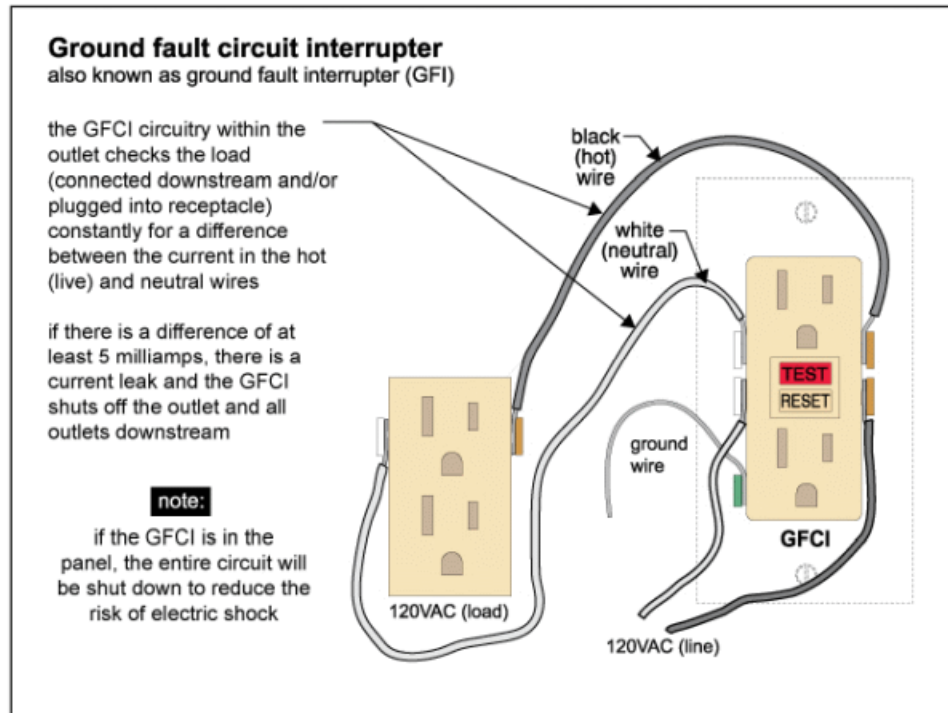
Condition: • [No GFCI/GFI \(Ground Fault Circuit Interrupter\)](#)

Implication(s): Electric shock

Location: Exterior, Kitchen, Bathrooms

Task: Provide

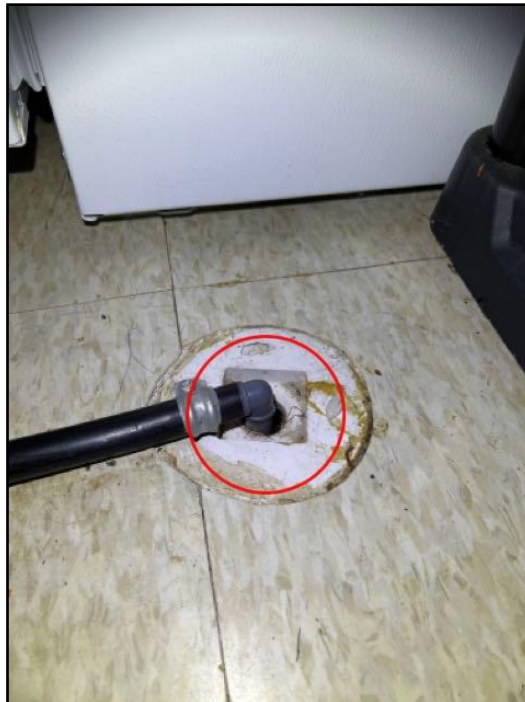
Condition: • [Condensate problems](#)

Condensate drain line from furnace discharges into the clean-out in the cold room. This can lead to sewer odours in the cold room and through the heating system.

Condensate drains into clean-out

Task: Correct

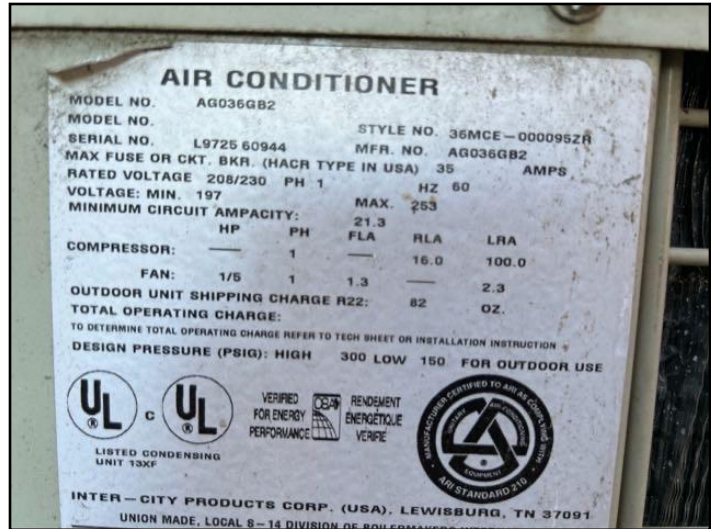
Air conditioner data plate

Compressor approximate age: • 26 years

Condition: • [Old](#)

Task: Replace

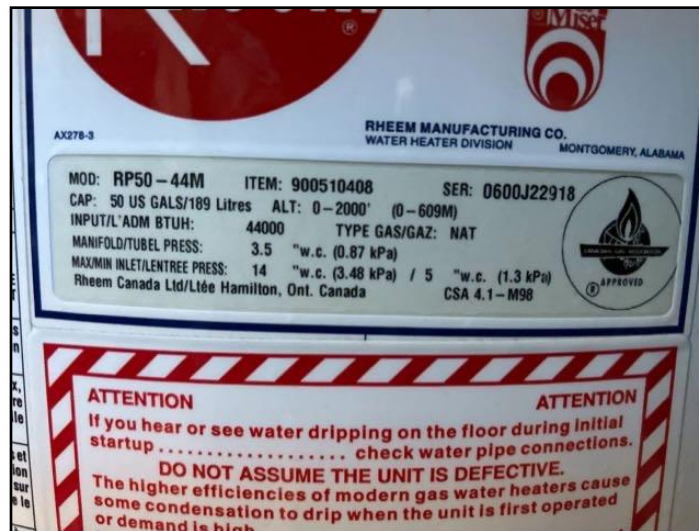
Water heater data plate

Water heater approximate age: • 23 years

Condition: • [Old](#)

Task: Replace

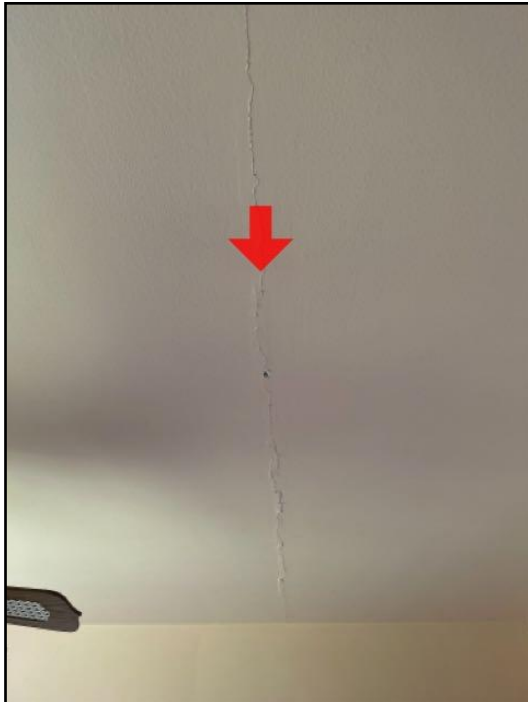
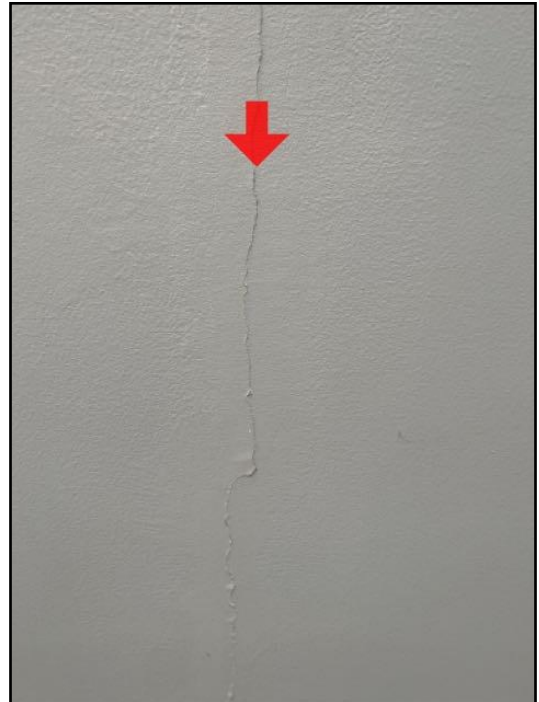
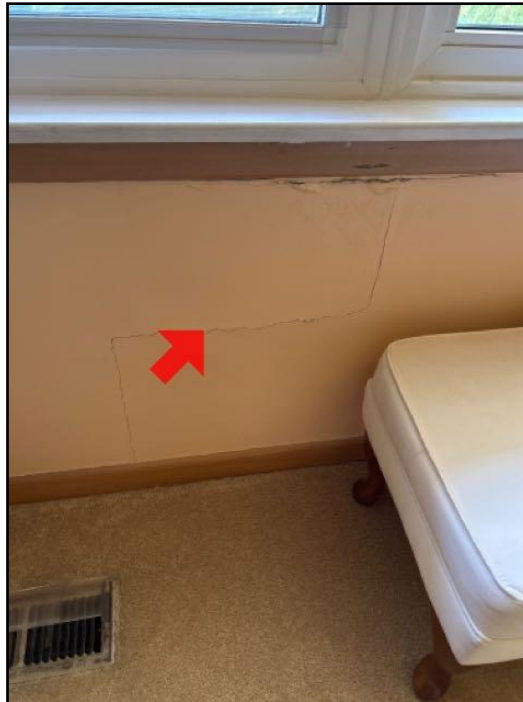
Condition: • Minor cracks noted on upper floor ceilings and on wall under rear window are not a structural concern.

Minor cracks

Task: Repair

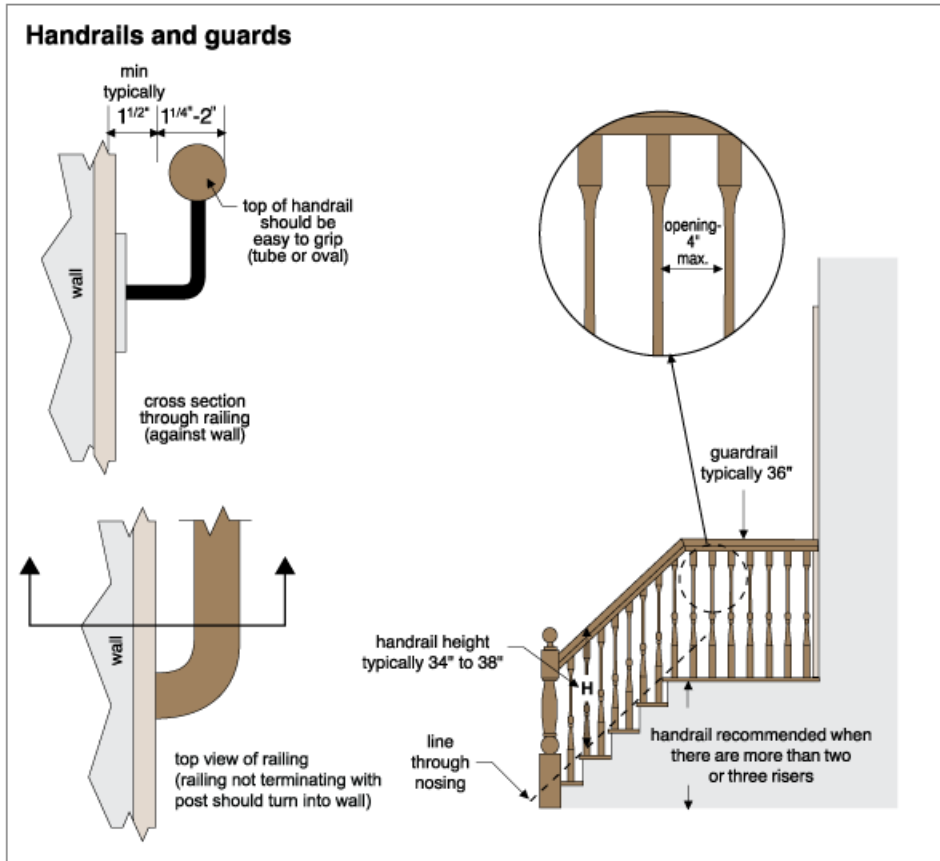
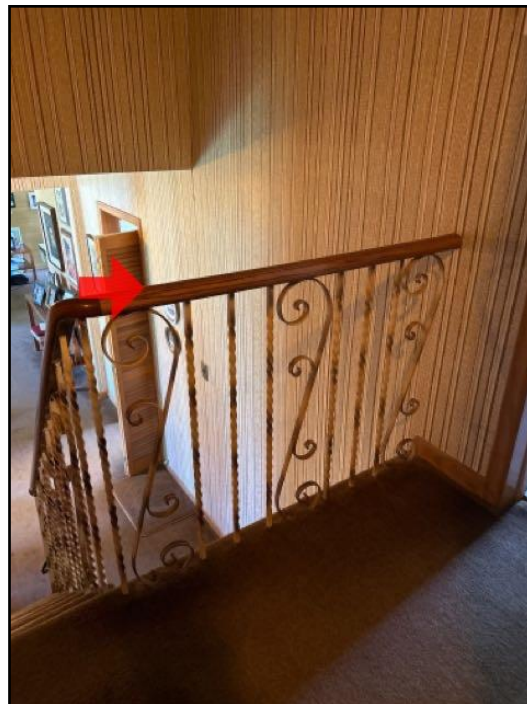
Condition: • [Too low](#)

Implication(s): Fall hazard

Location: Second Floor

Too low

Task: Correct

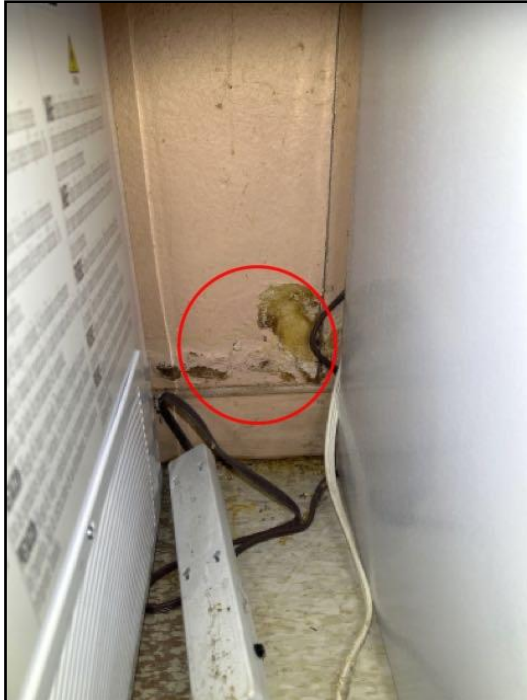
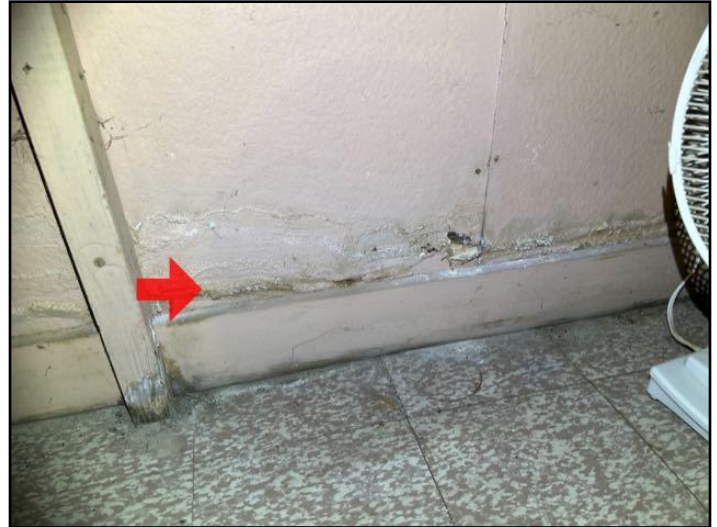
Condition: • Stains/damage - The areas pictured measured as mildly damp with a moisture meter.

Location: Cold Room

Stains/damage

Task: Further evaluation/repair

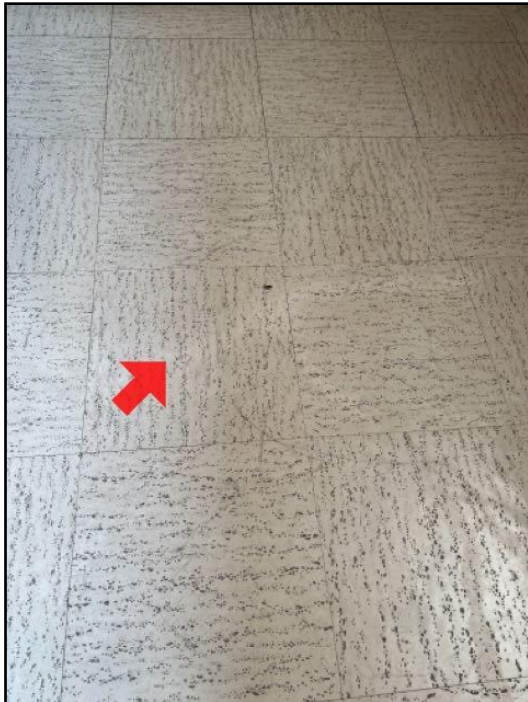
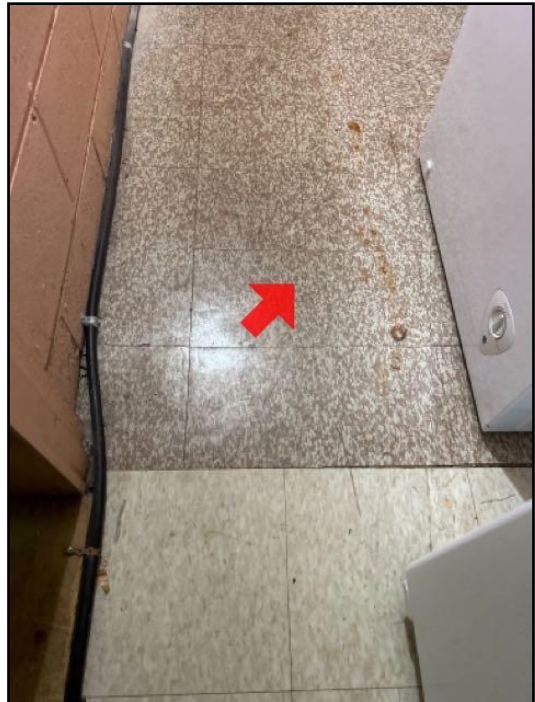
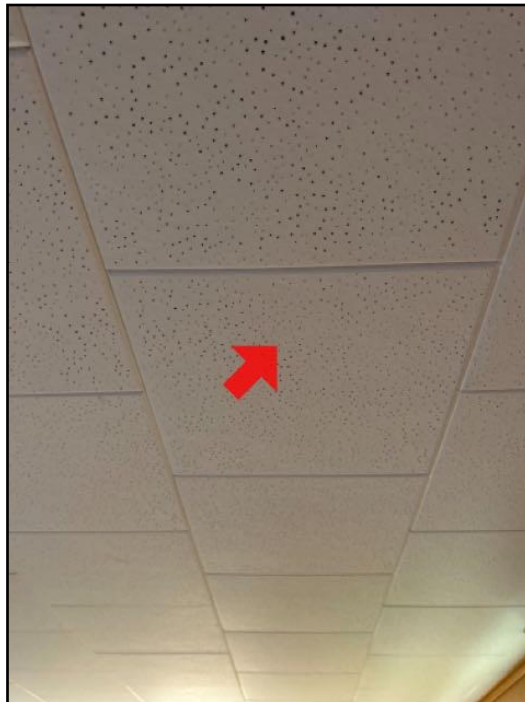
Condition: • Possible asbestos containing materials

Old linoleum floor tile and acoustic ceiling tile may contain asbestos. Left undisturbed the pose little risk.

Possible asbestos containing materials

Task: Further evaluation
