Your Inspection Report

52 Dixfield Drive
Toronto, ON M9C 4J3

INSPECTION DATE:
Thursday, September 7, 2023

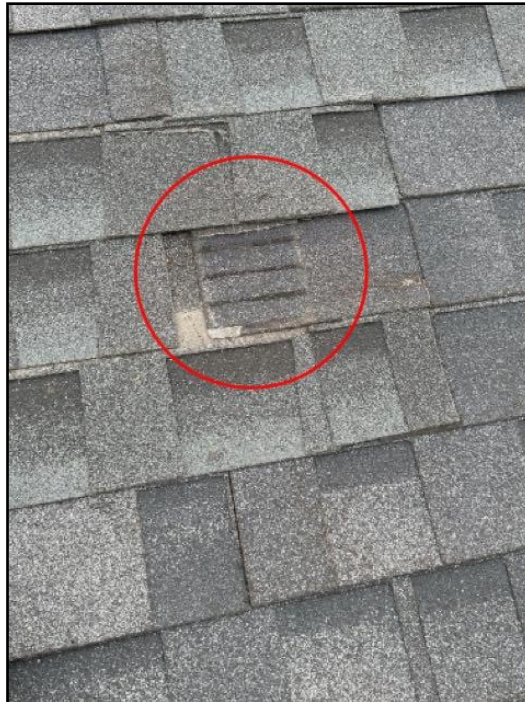
Condition: • [Missing, loose or torn](#)

Implication(s): Chance of water damage to structure, finishes and contents

Location: West

Missing, torn

Task: Repair

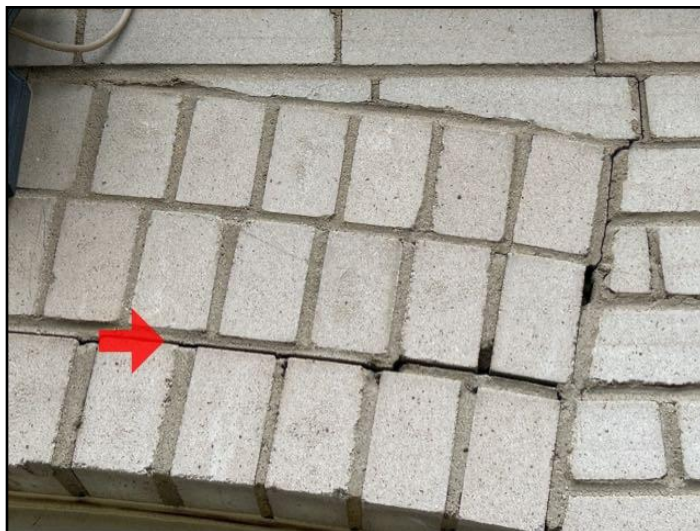
Condition: • Typical minor cracks

Location: South

Typical minor cracks

Task: Repair

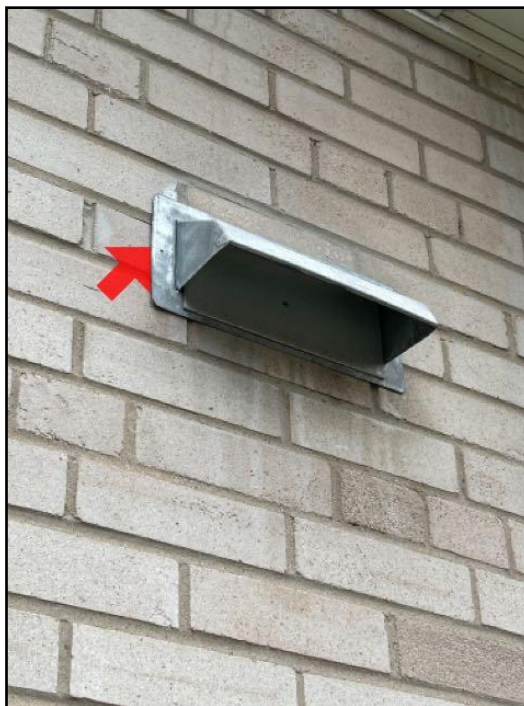
Condition: • Caulking deteriorated/missing

Location: South

Caulking deteriorated/missing

Task: Provide

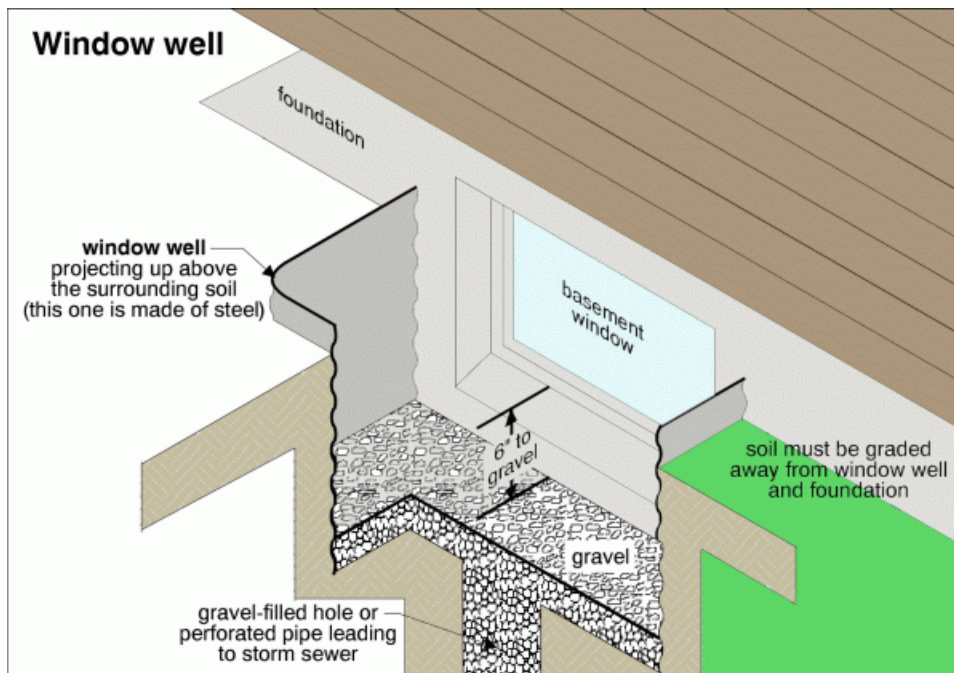
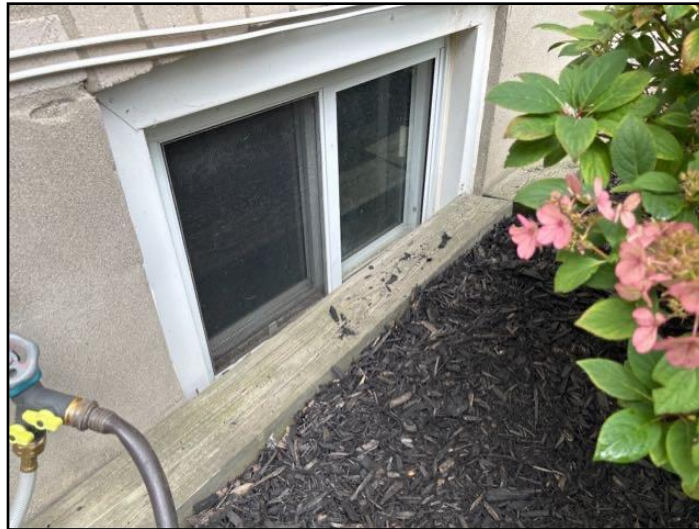
Condition: • [Missing](#)

Implication(s): Chance of water damage to structure, finishes and contents | Material deterioration

Location: Southeast

Window well needed

Task: Provide

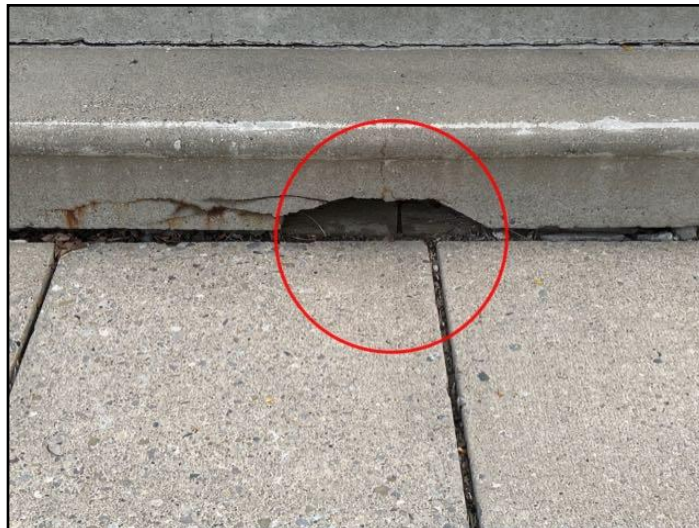
Condition: • Damage

Location: West

Task: Repair or replace

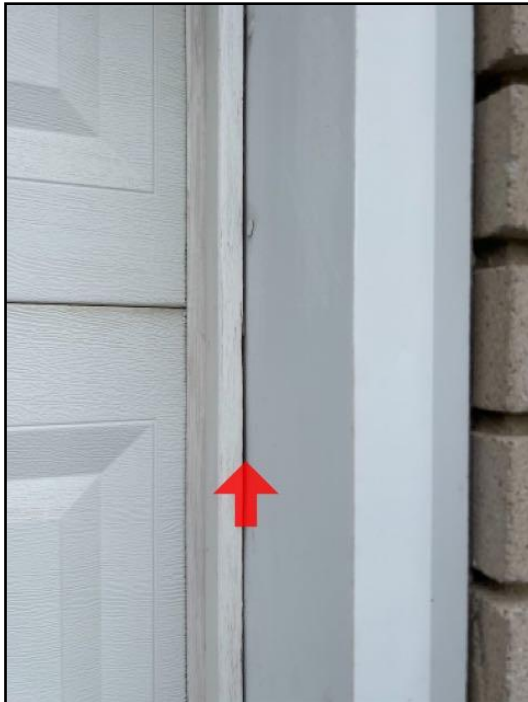
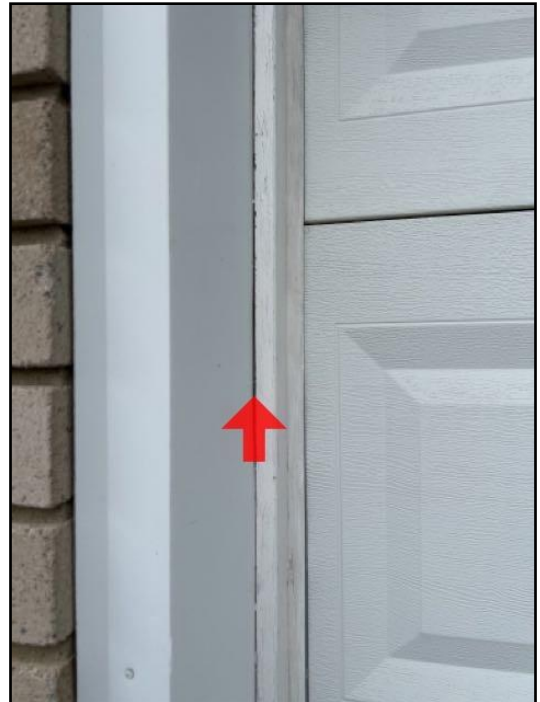
Condition: • Caulking missing

Task: Provide

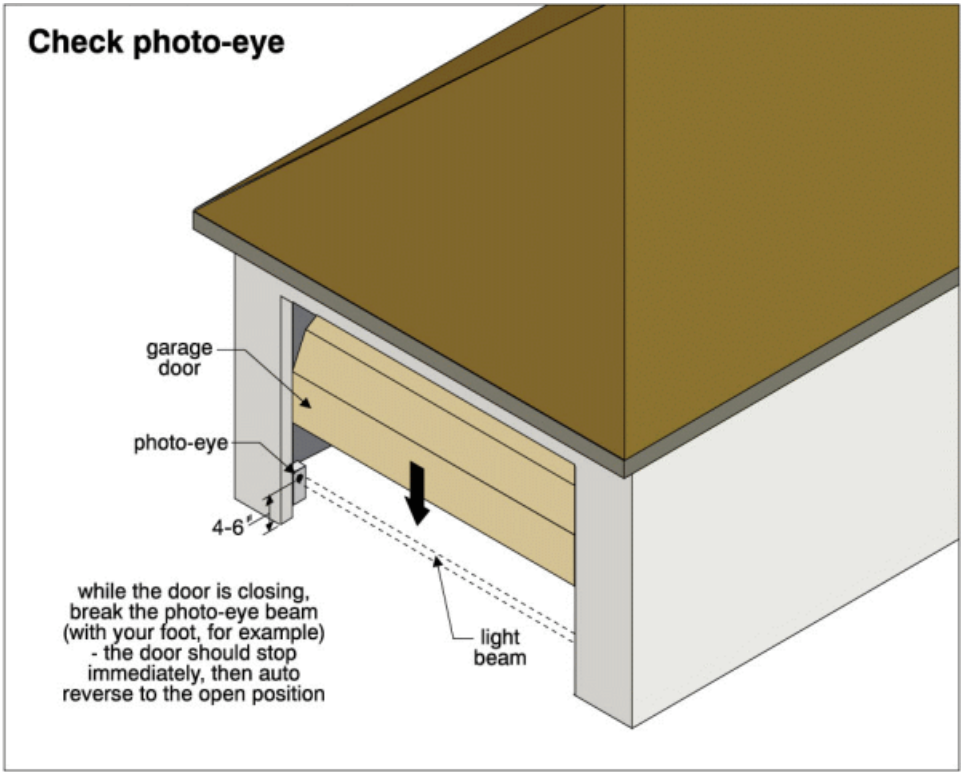
Condition: • Safety photo electric sensors missing

Implication(s): Risk of injury

Location: Garage

Task: Correct

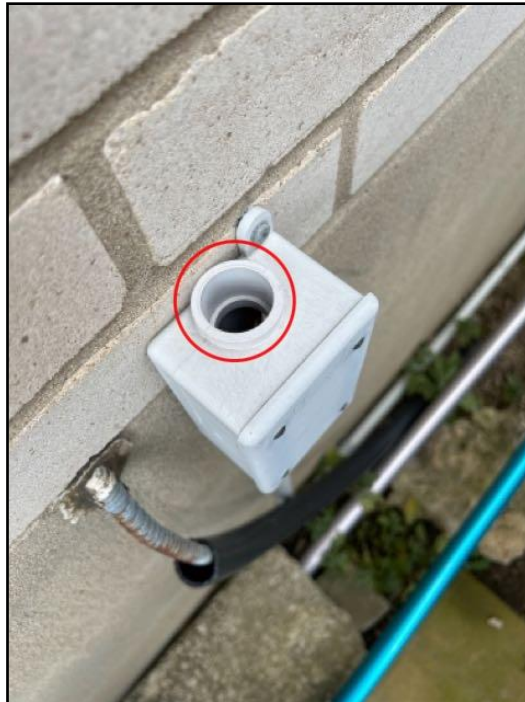
Condition: • Not weathertight

Location: Northeast Exterior

Task: Repair

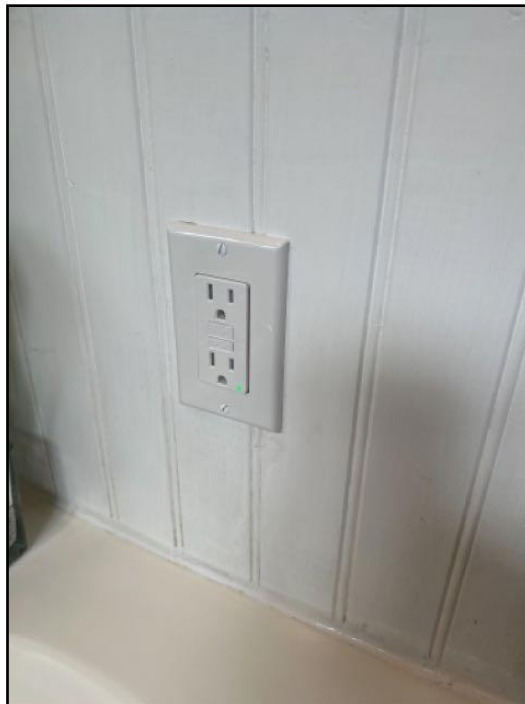
Condition: • [Inoperative](#)

Implication(s): Equipment inoperative

Location: Basement Bathroom

Inoperative

Task: Replace

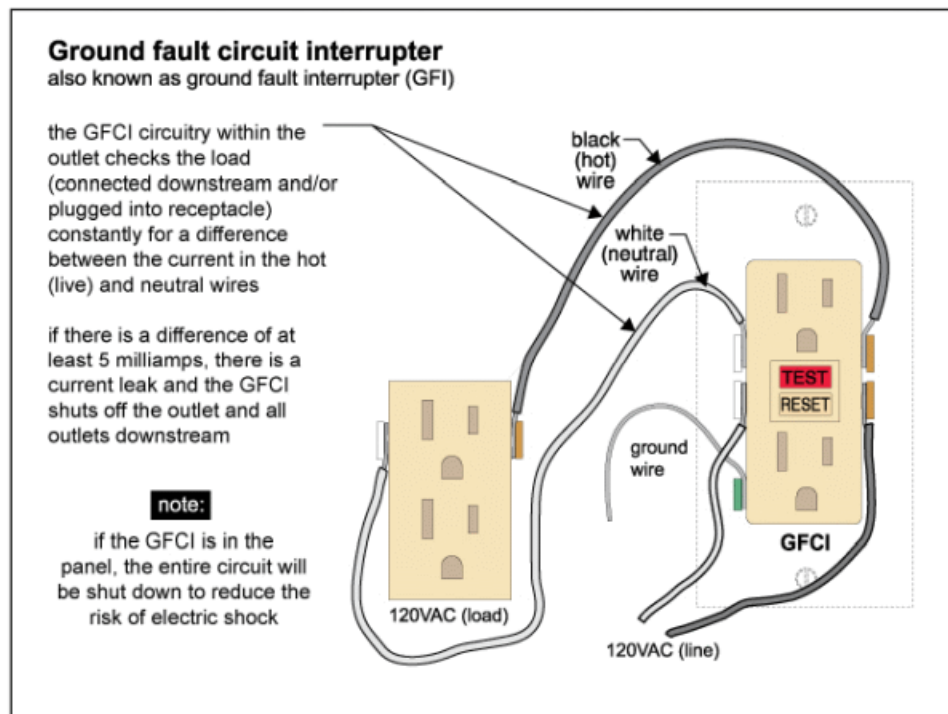
Condition: • [No GFCI/GFI \(Ground Fault Circuit Interrupter\)](#)

Implication(s): Electric shock

Location: First Floor Bathroom, Kitchen

Task: Provide
