# Your Inspection Report

549 Legresley Lane  
Newmarket, ON L3Y 8R6

**INSPECTION DATE:**  
Friday, February 24, 2023

Report No. 3785

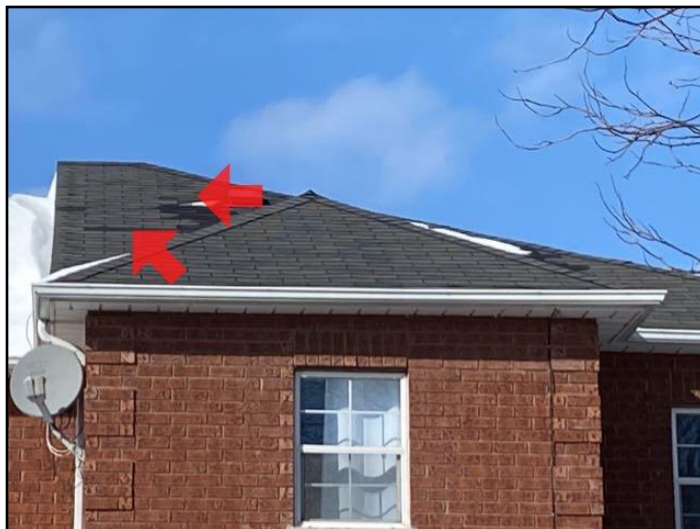
**Condition:** • [Patched](#)

**Location:** South

*Patched*

**Task:** Monitor

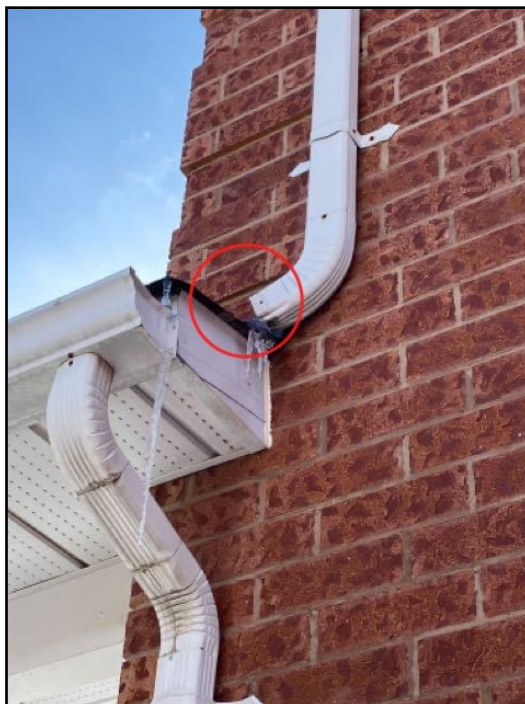
Condition: • [Discharge onto roofs](#)

Implication(s): Chance of water damage to structure, finishes and contents

Location: Southeast

*Discharge onto roofs*

Task: Improve

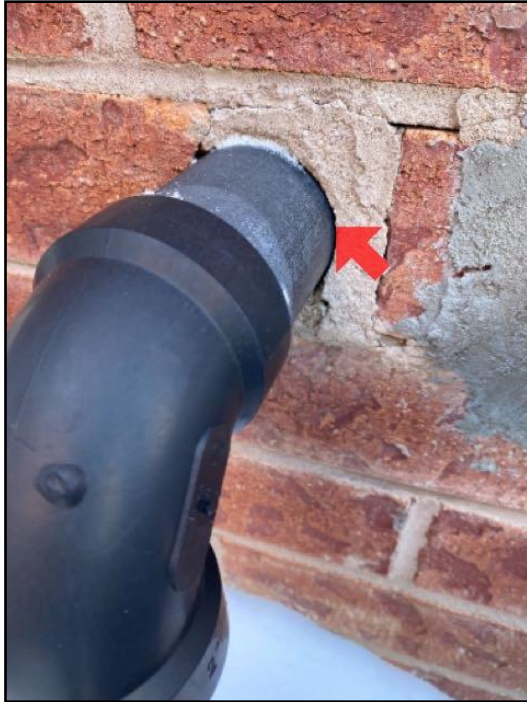
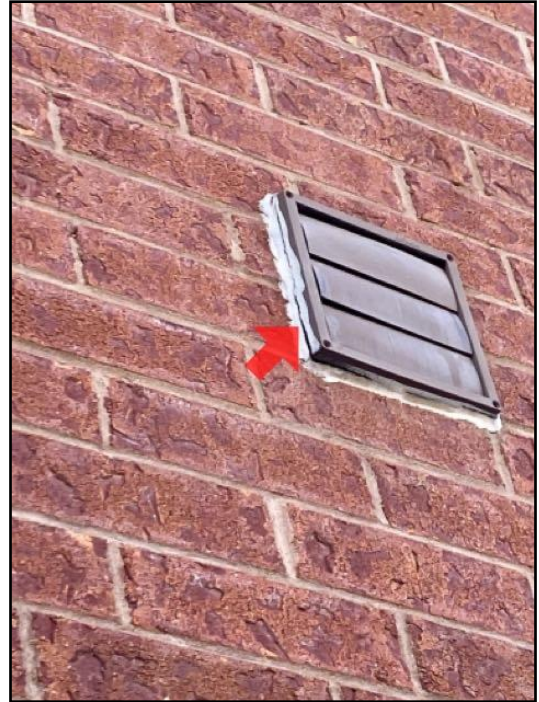
**Condition:** • Caulking deteriorated/missing

**Location:** Northeast

*Caulking deteriorated/missing*

**Task:** Provide

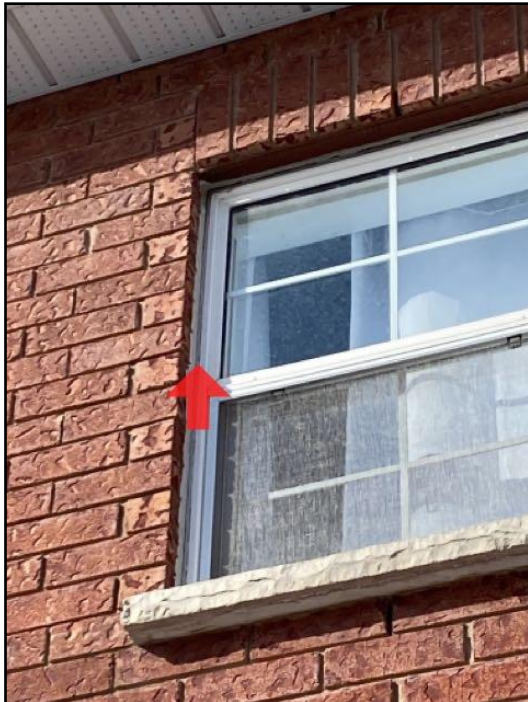
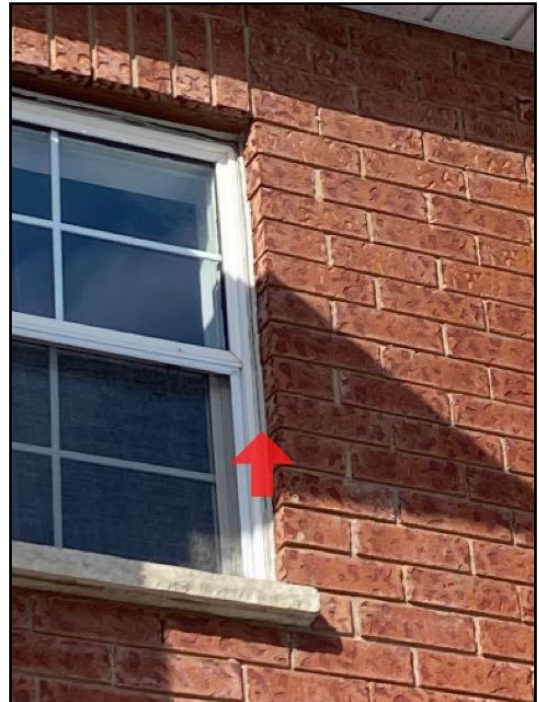
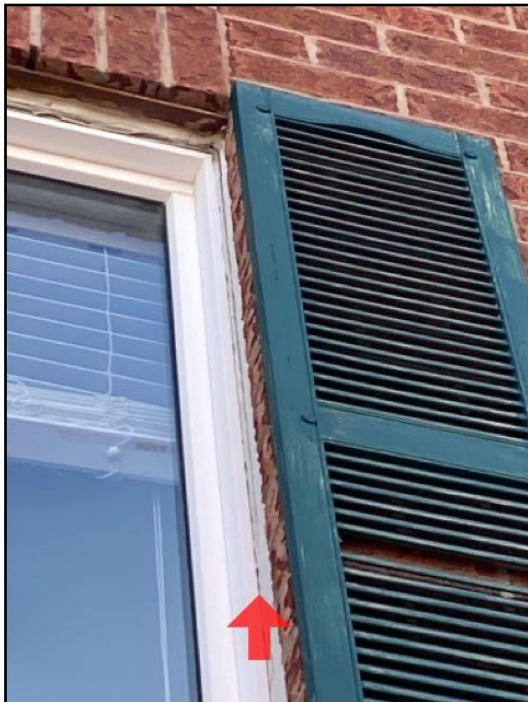
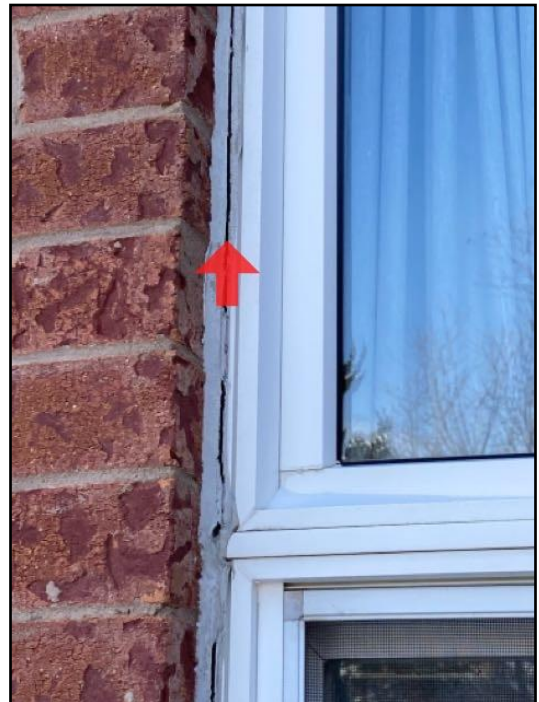
**Condition:** • [Caulking missing, loose or deteriorated](#)

**Implication(s):** Chance of water damage to structure, finishes and contents

**Location:** Various

*Caulking missing, loose or deteriorated*

**Task:** Repair

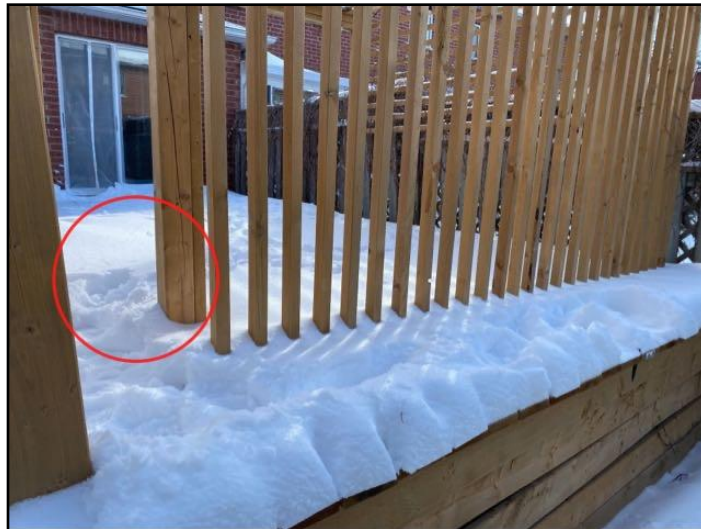
**Condition:** • [Missing](#)

**Implication(s):** Fall hazard

**Location:** North end of rear deck

*Missing*

**Task:** Provide

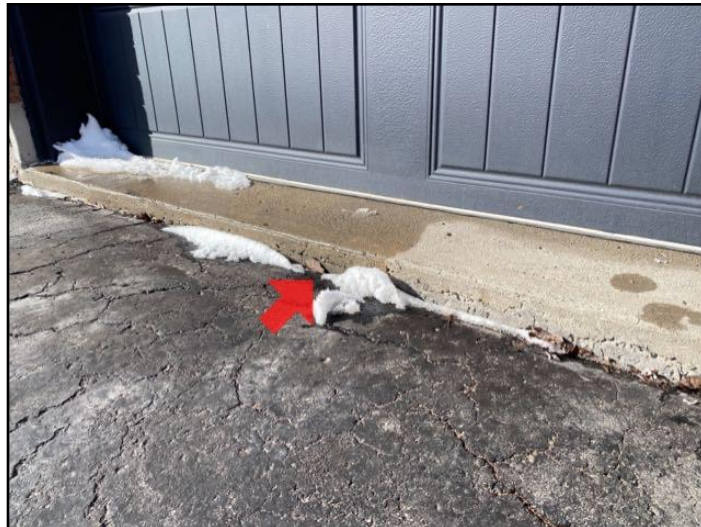
**Condition:** • Poor transition: Driveway not flush with garage floor slab

**Implication(s):** Trip hazard

*Poor transition*

**Task:** Improve

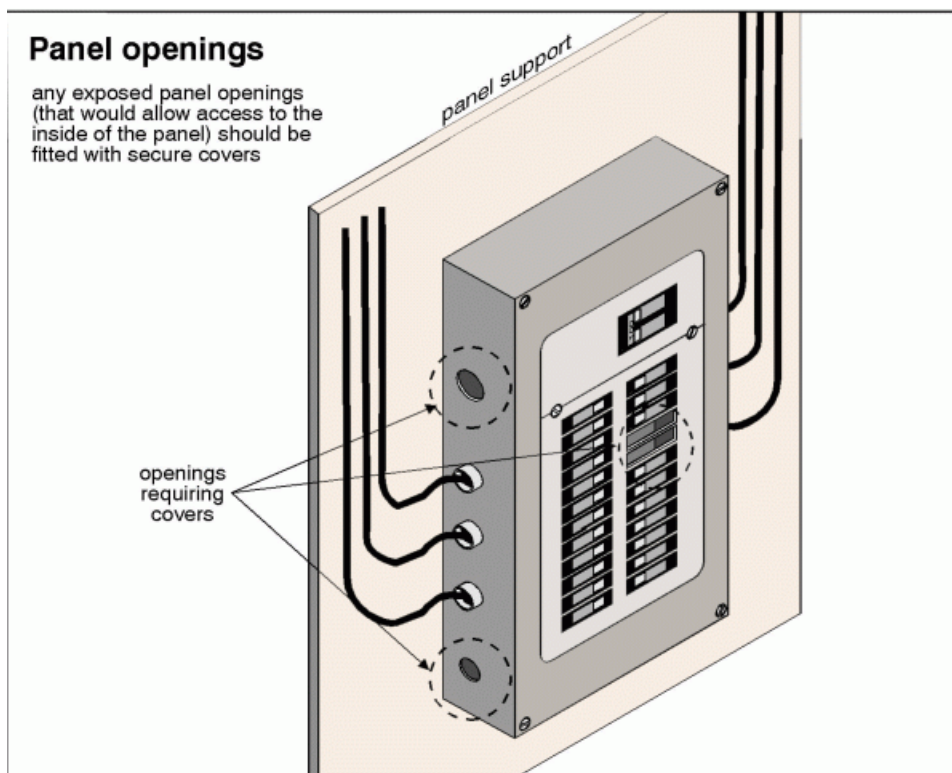
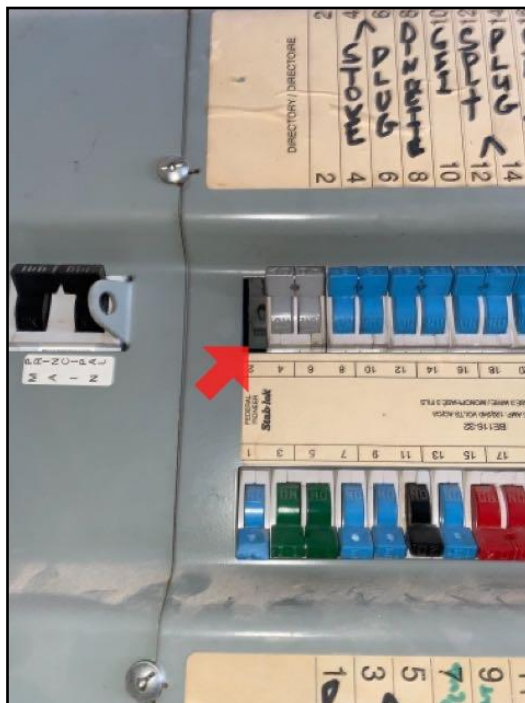
**Condition:** • [Openings in panel](#)

**Implication(s):** Electric shock | Fire hazard

*Openings in panel*

**Task:** Correct

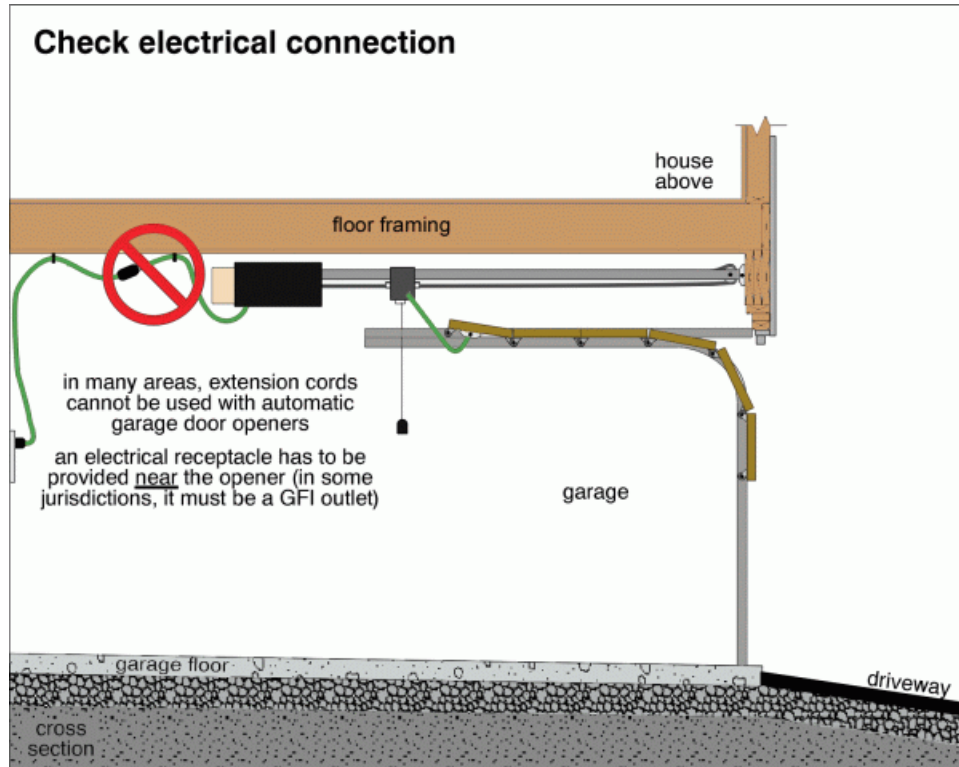
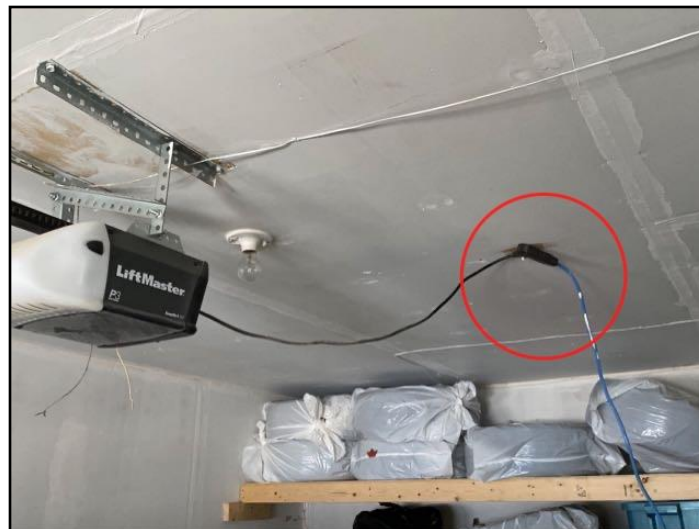
**Condition:** • Extension cord for garage door operator (opener)

**Implication(s):** Electric shock

*Extension cord for garage door operator...*

**Task:** Correct

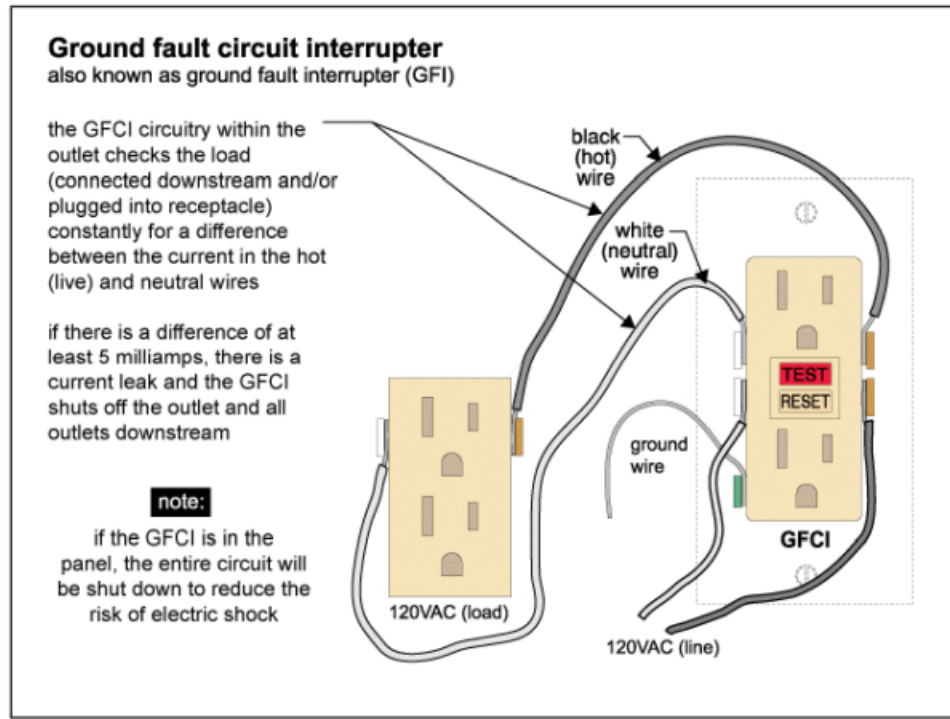
**Condition:** • [No GFCI/GFI \(Ground Fault Circuit Interrupter\)](#)

**Implication(s):** Electric shock

**Location:** Kitchen

**Task:** Provide**Time:** Less than 1 year**Cost:** Minor

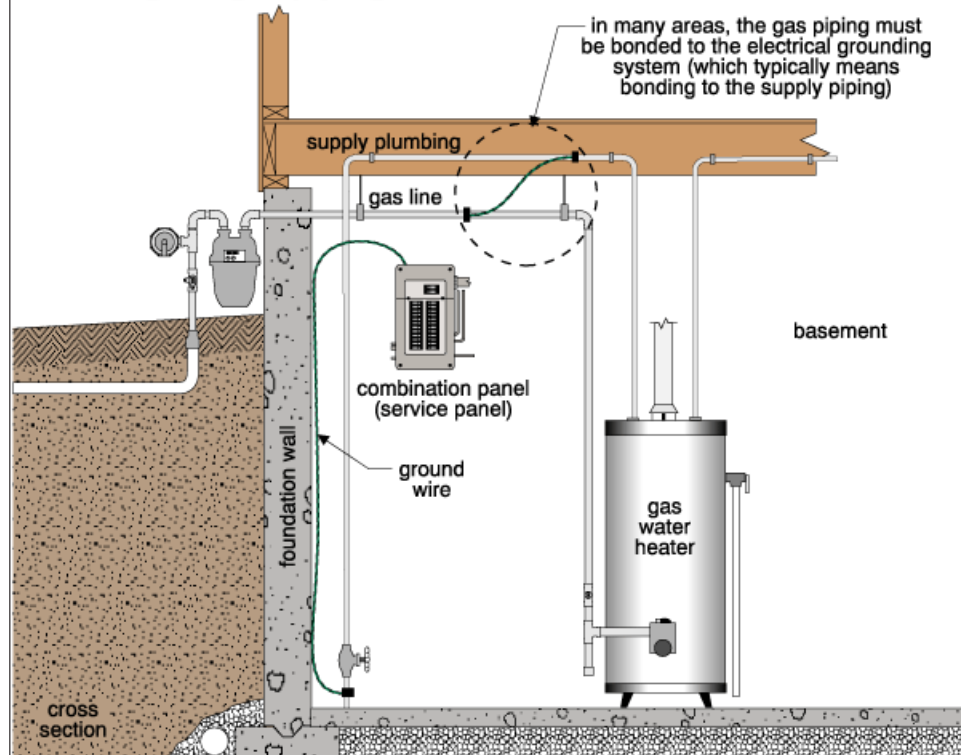
## Bonding the gas piping

- Condition: • Piping not properly bonded
- Task: Correct
- Time: Immediate
- Cost: Minor

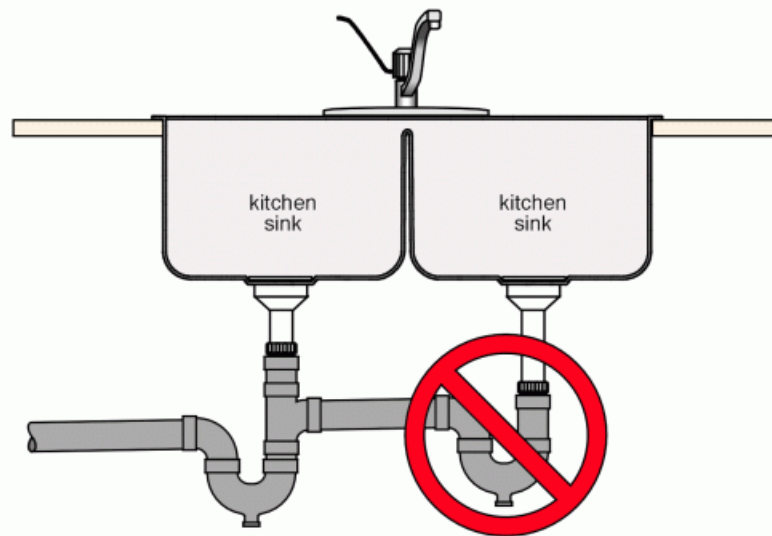
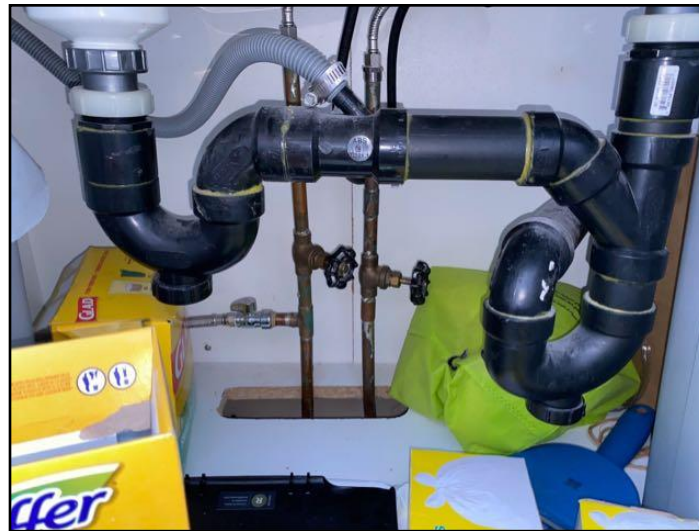
**Condition:** • [Double trapping](#)

No issues with water drainage at present. Double trapping can result in slow drains and/or odours.

**Location:** Kitchen

Double trapping

**Task:** Repair

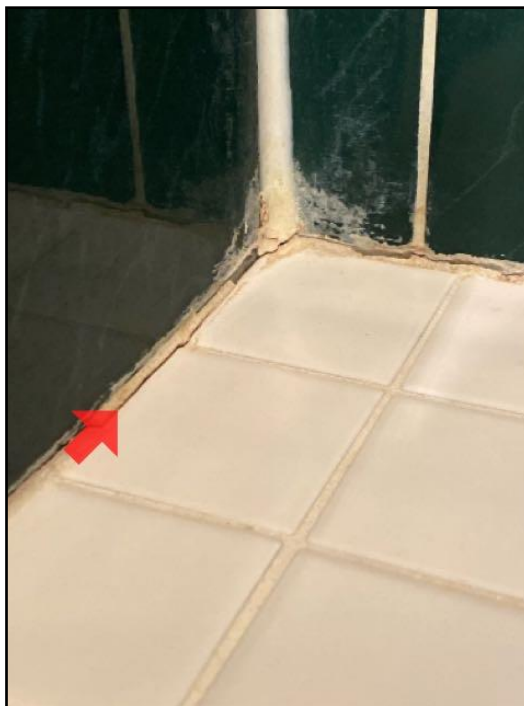
**Condition:** • [Caulking loose, missing or deteriorated](#)

**Implication(s):** Chance of water damage to structure, finishes and contents

**Location:** Principal Ensuite Bathroom

*Caulking loose, missing or deteriorated*

**Task:** Provide

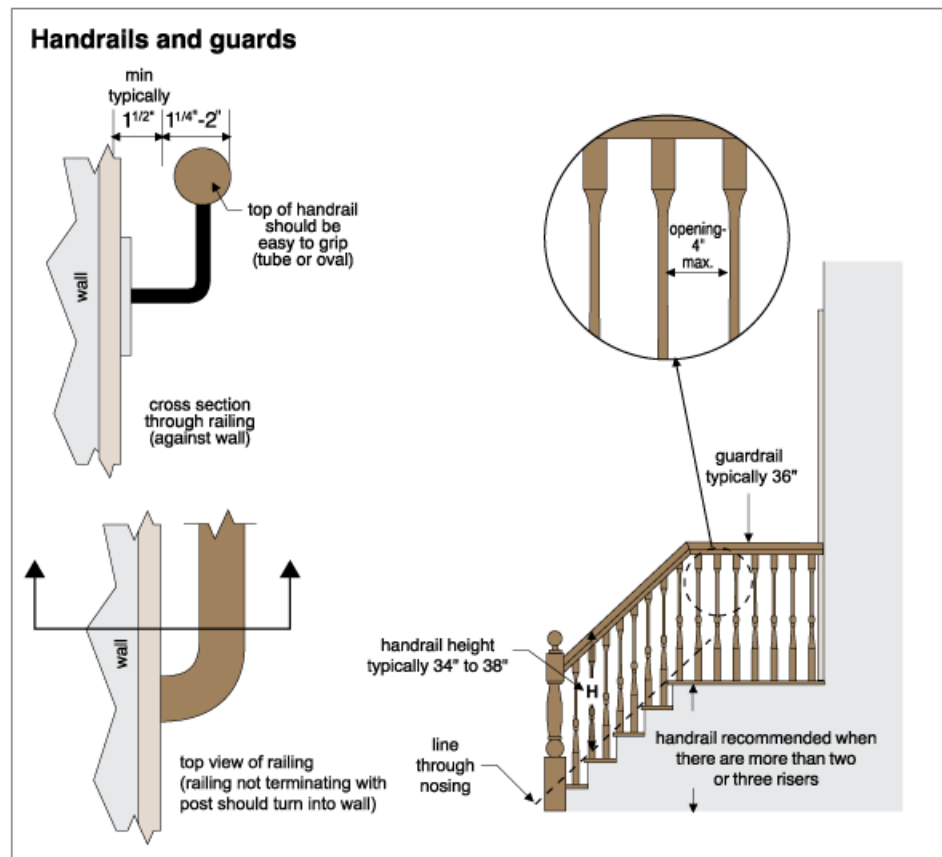
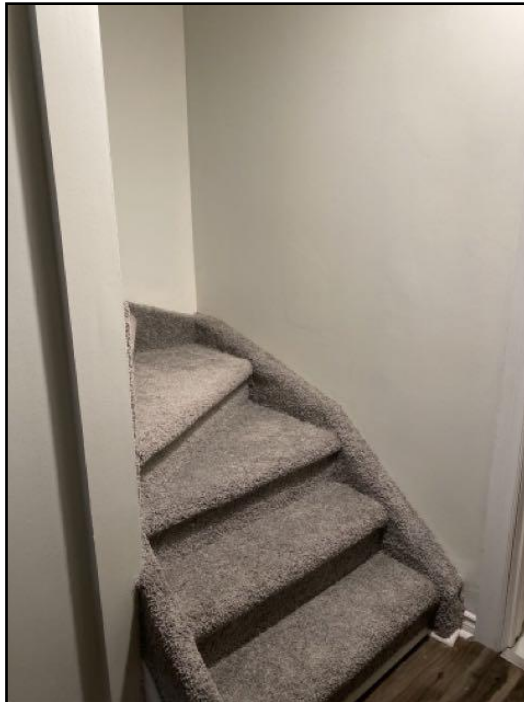
**Condition:** • [Missing](#)

**Implication(s):** Fall hazard

**Location:** Bottom section of basement staircase

*Missing handrail*

**Task:** Provide
