A Buyer's Choice Home Inspections

PROPERTY INSPECTION REPORT

64-5536 Montevideo Rd, Mississauga, ON, L5N 2P4

Date of Inspection: 5/23/2023 Time: 10:30 AM
Age of Home: 1977 Size: 1400
Order ID: 88

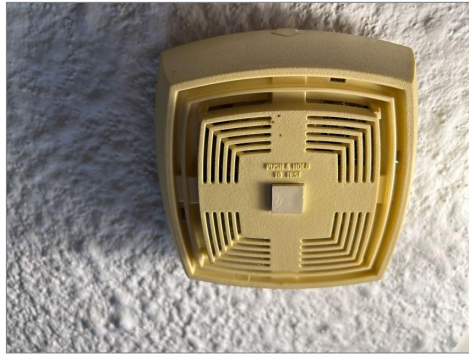
Main Level

Page 6 Item: 1	Smoke Detectors	<ul style="list-style-type: none"> • Improve/Safety - Old detectors. Smoke detectors last 6-10 years. Recommend replacing.
----------------	-----------------	---

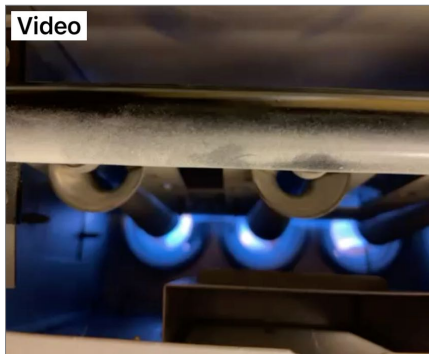
Page 15 Item: 12	Heat Exchanger	<ul style="list-style-type: none"> • Repair - The flame pattern at the burners is inconsistent and pops of orange flames are noted. This may be an indication of an improperly adjusted burner, debris in the gas valves or orifices, or a possibility of a cracked heat exchanger. Recommend evaluation and repairs by a qualified professional.
------------------	----------------	--

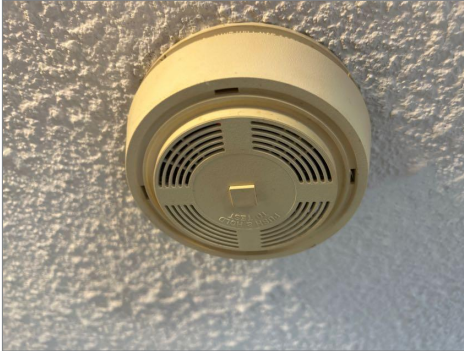
Upper Level

- **Improve/Safety - Old detectors. Smoke detectors last 6-10 years. Recommend replacing.**

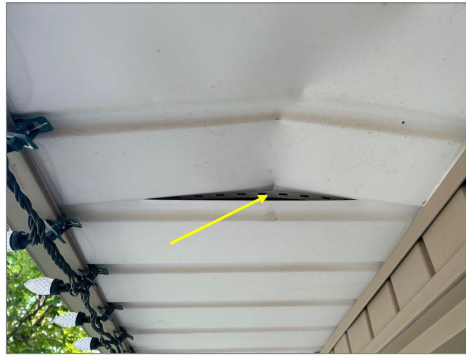
- **Repair - Minor damage noted on the soffit, above adjoining garage next door. This is a potential water infiltration point. Recommend repair.**

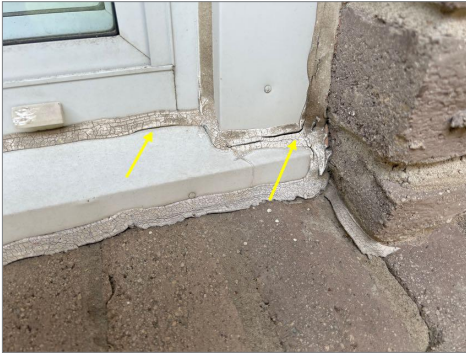
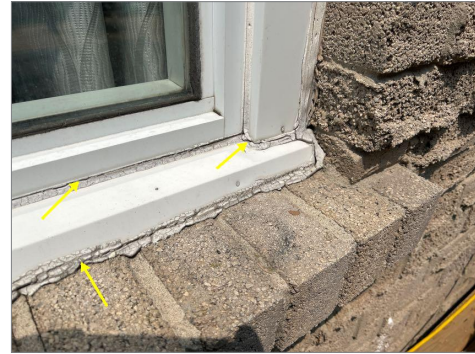
- **Maintenance - Caulking around windows is noted as deteriorated or missing. This is a potential water infiltration point. Recommend repair or replace.**

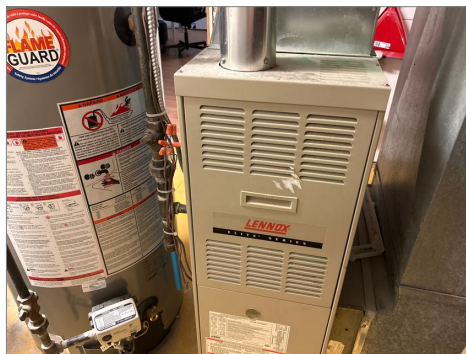
- Information - The unit is at or past the expected lifespan of this type of HVAC system. While these units can potentially last for quite a while longer than the expected lifespan, it is recommended that the client plans for replacement of these systems.

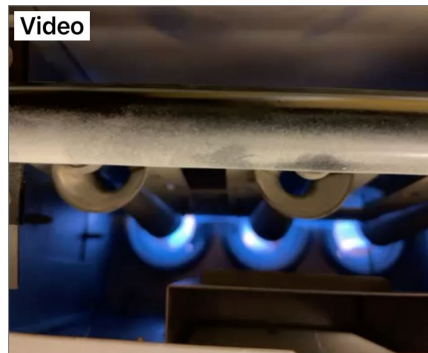
- Inspection limitation - Heat Exchangers inspection is beyond the scope of a home inspection and can only be inspected by a licensed HVAC technician.
- Repair - The flame pattern at the burners is inconsistent and pops of orange flames are noted. This may be an indication of an improperly adjusted burner, debris in the gas valves or orifices, or a possibility of a cracked heat exchanger. Recommend evaluation and repairs by a qualified professional.

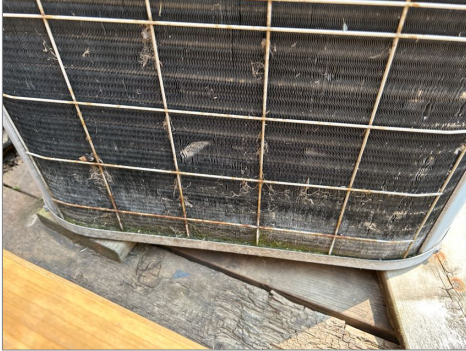
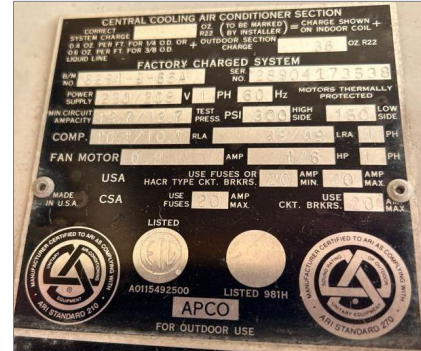
- Information - The unit is at or past the expected lifespan of this type of HVAC system. While these units can potentially last for quite a while longer than the expected lifespan, it is recommended that the client plans for replacement of these systems.
- Information - The unit was operated and tested and appears to be functional at the time of inspection.

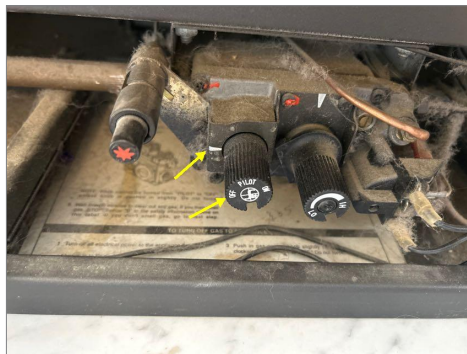
- Inspection limitation - The gas fireplace/insert was not tested at the time of inspection due to the fact that the gas was turned off. Recommend verifying operation prior to close of home sale.

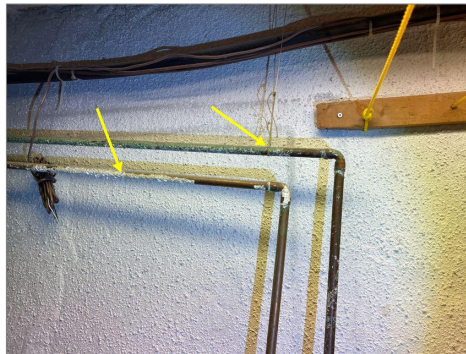
- Water pressure appears adequate when running multiple fixtures simultaneously.
- **Repair - Pipes above laundry tub appear to be loose. Proper hangers or support is recommended.**

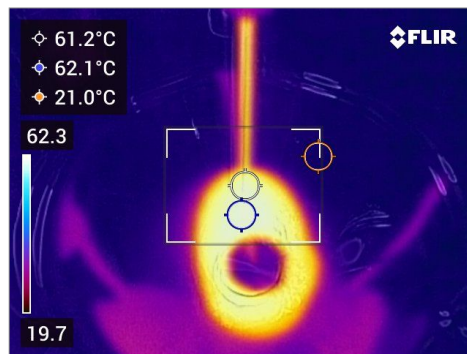
Typical Thermal Scan - Bathroom Sink

• Information/Safety - Water temperature noted at higher than recommended for safe operation. 49 C recommended as the maximum temperature for any outlet to avoid scalding hazard. Recommend adjustment of the thermostat or addition of a thermostatic mixing valve.

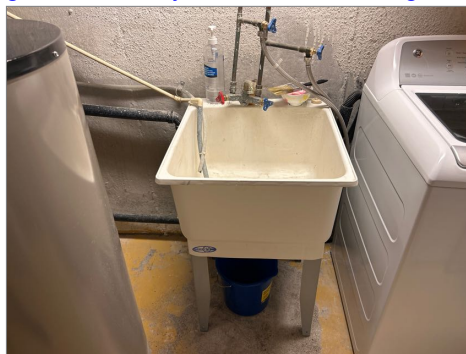
- Plastic sink
- Repair - Sink is loose, suggest securing as necessary, to ensure water tightness.

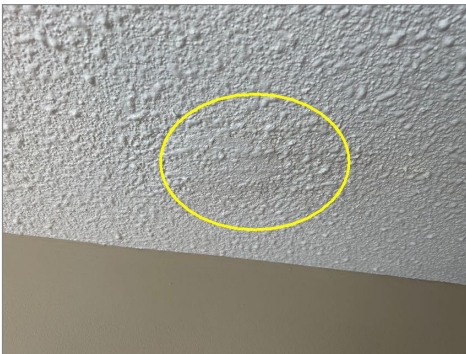
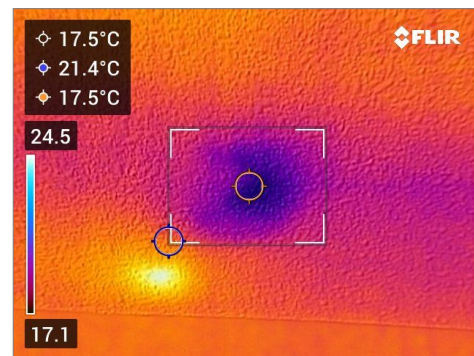
Living Room ceiling below bathroom

- **Monitor - There were signs of paint blistering on the ceiling. The areas tested dry at the time of the inspection. Recommend monitoring and repairs as necessary.**

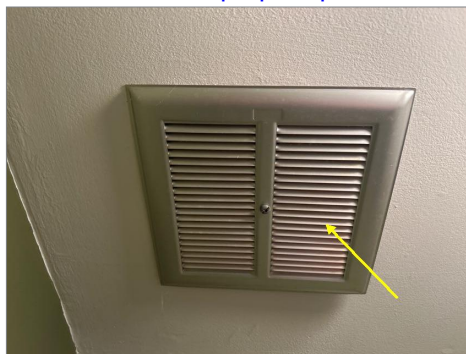
- **Repair - Exhaust fan does not move sufficient airflow for proper operation. Recommend replacement or repair.**

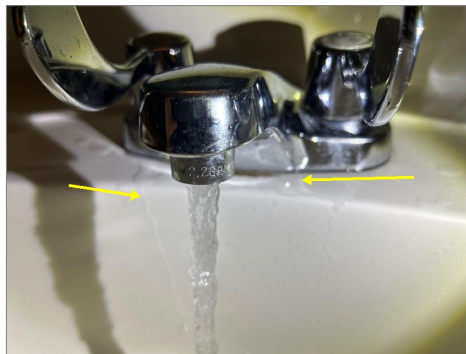
- **Repair - Faucet leaks at base, this will deteriorate the counter top. Recommend replacement or repair.**
