Your Inspection Report

56 Lynd Avenue
Toronto, ON M6R 1T9

INSPECTION DATE:
Monday, April 28, 2025

Report No. 4489

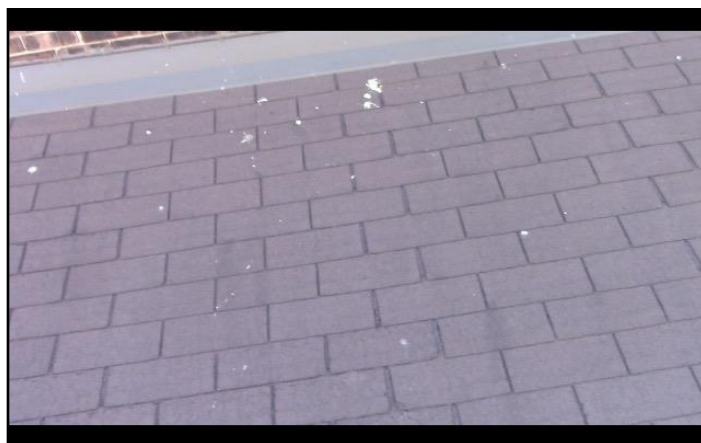
Condition: • Aging

Location: Rear Addition Roof

Aging (rear addition)

Task: Replace

Time: Less than 2 years

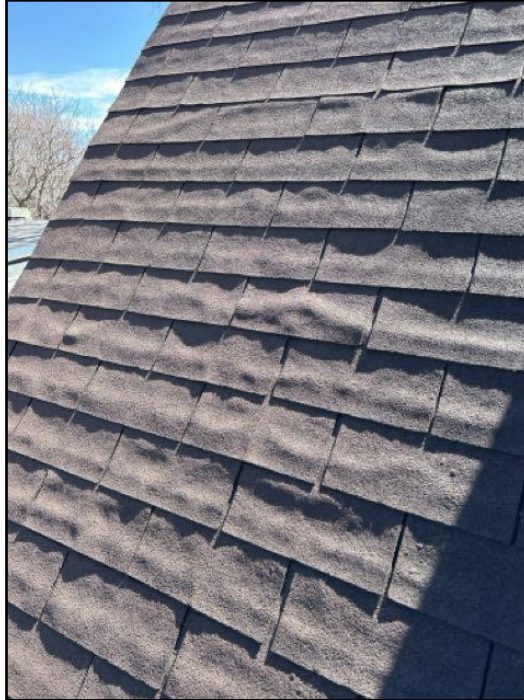
Condition: • Buckling/wavy

Location: Northwest

Buckling/wavy

Task: Further evaluation

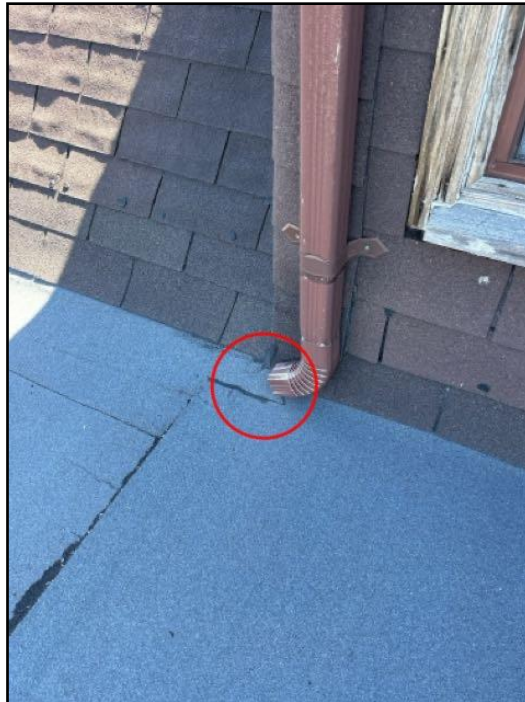
Condition: • Discharge onto roofs

Implication(s): Localized roof wear

Location: Northwest

Discharge onto roofs

Run downspout to the gutter at the edge of the flat roof.

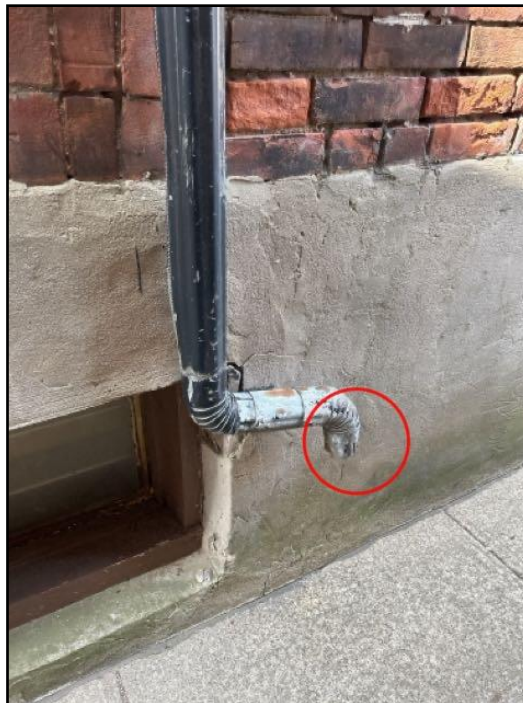
Condition: • [Discharge too close to building](#)

Implication(s): Chance of water damage to structure, finishes and contents

Location: North

Discharge too close to building

Task: Improve

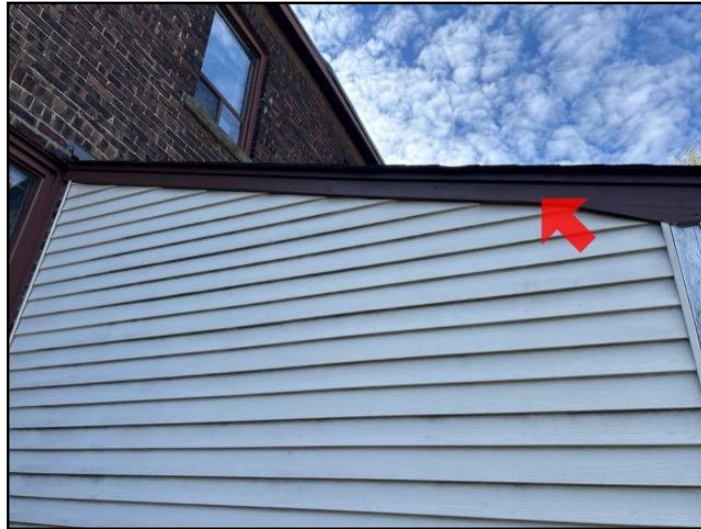
Condition: • [Flashings missing](#)

Implication(s): Chance of water damage to structure, finishes and contents

Location: West

Flashings missing

Due to the way the siding was installed, flashing should be installed to cover the top few inches of siding.

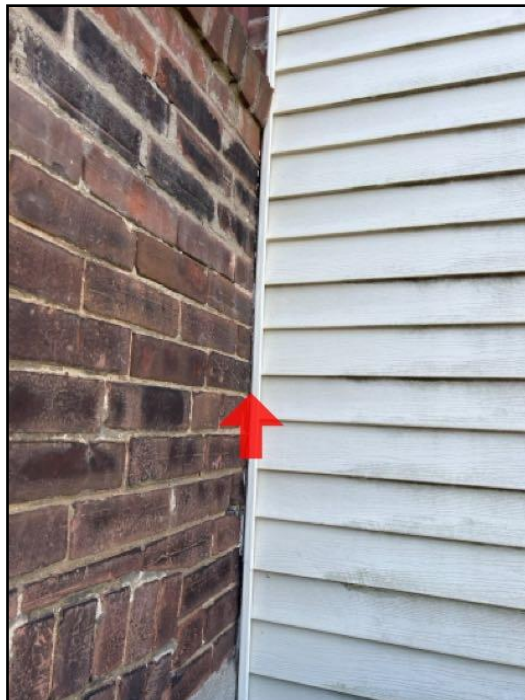
Condition: • [Caulking missing or ineffective](#)

Implication(s): Chance of water damage to structure, finishes and contents

Location: West

Caulking missing or ineffective

Task: Provide

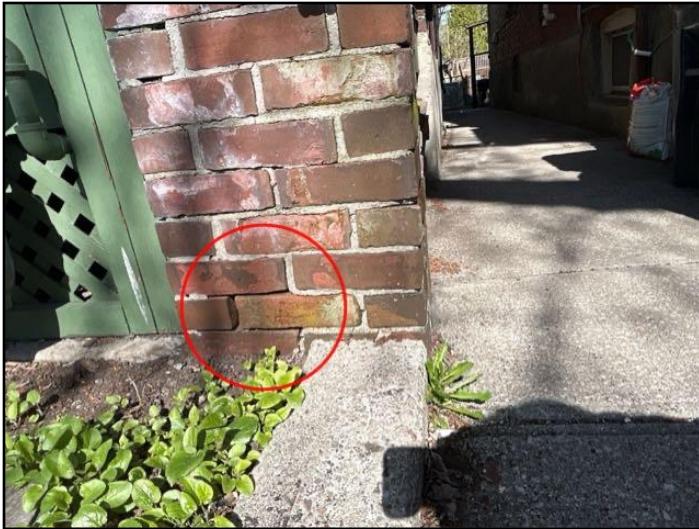
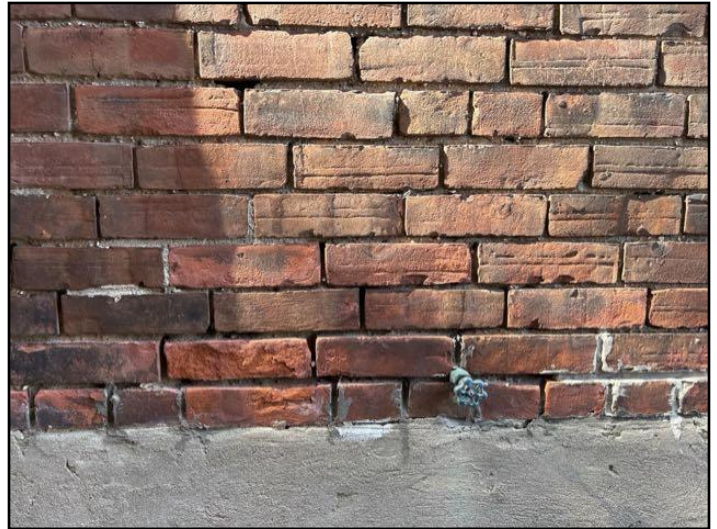
Condition: • [Mortar deterioration](#)

Implication(s): Chance of water entering building | Weakened structure | Chance of structural movement

Location: Northeast, North

Mortar deterioration

Task: Repair

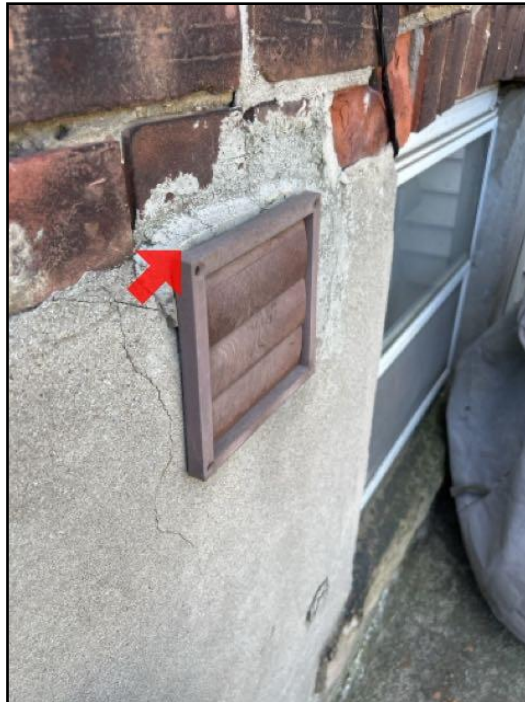
Condition: • Caulking deteriorated/missing

Location: West

Caulking deteriorated/missing

Task: Provide

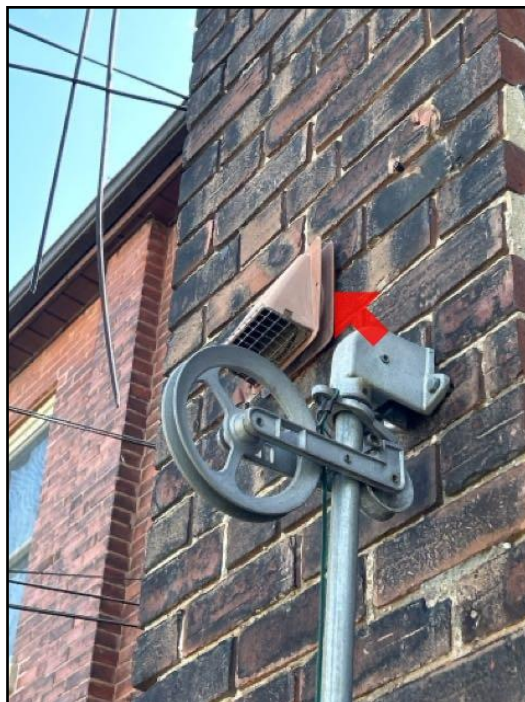
Condition: • Cover loose, not caulked

Location: West

Cover loose, not caulked

Task: Repair

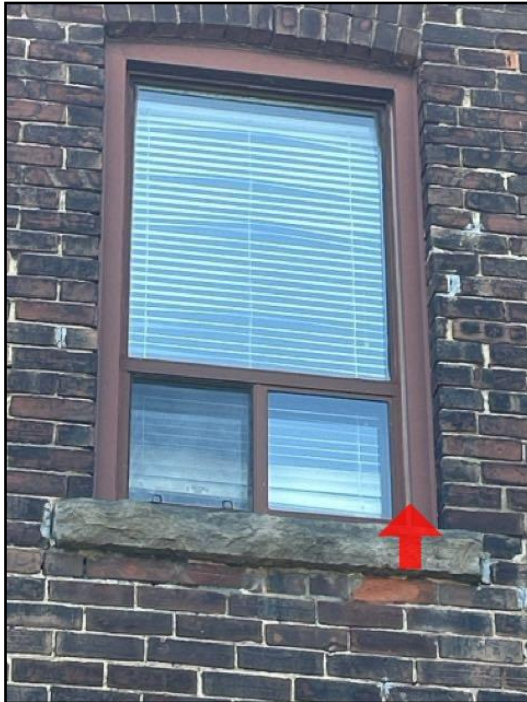
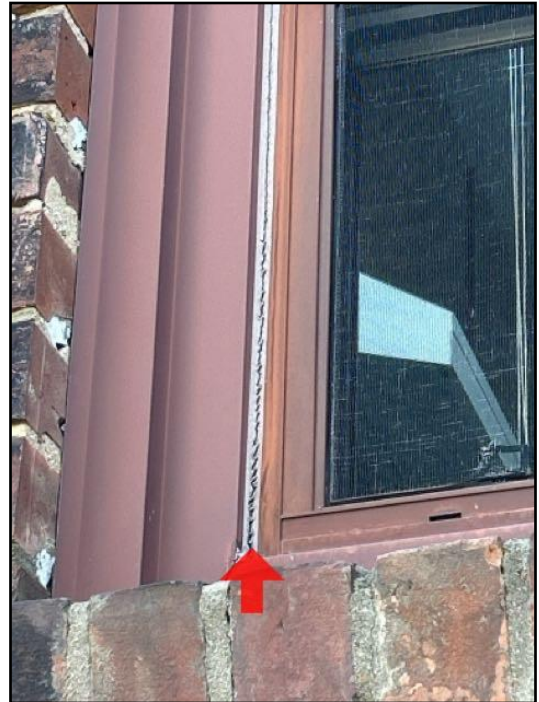
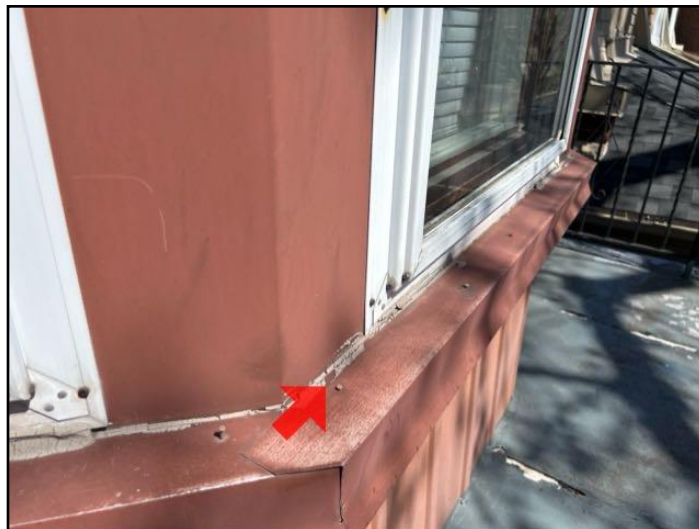
Condition: • [Caulking missing, loose or deteriorated](#)

Implication(s): Chance of water damage to structure, finishes and contents

Location: West, East

Caulking missing, loose or deteriorated

Task: Repair

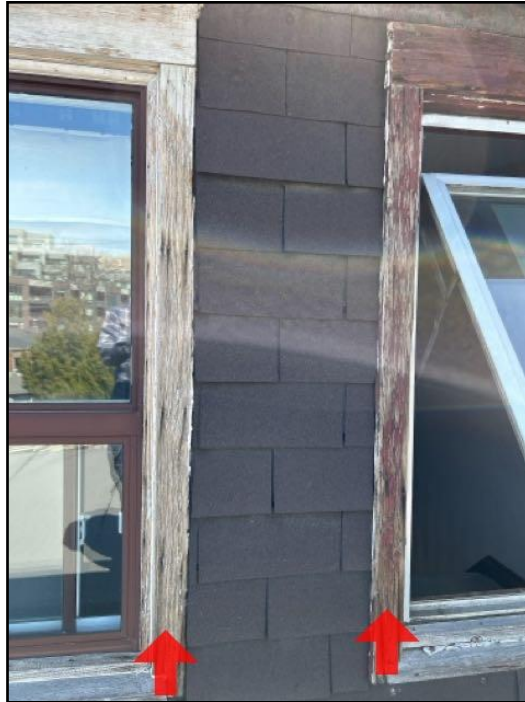
Condition: • [Rot](#)

Implication(s): Chance of water damage to structure, finishes and contents | Material deterioration

Location: West Third Floor

Rot

Task: Replace

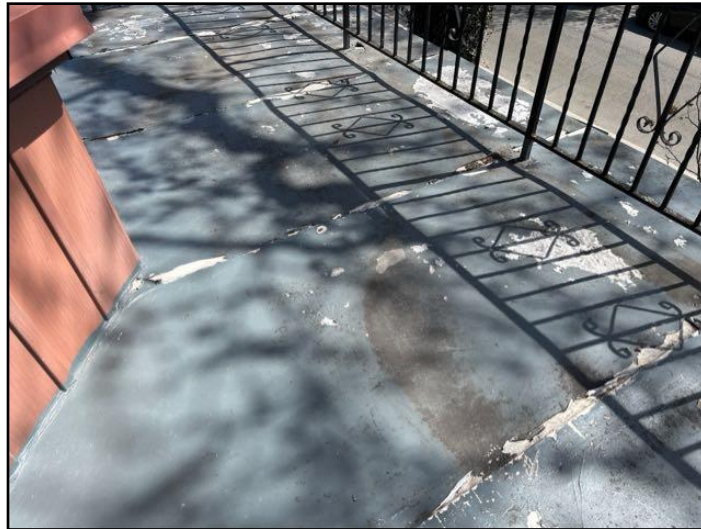
Condition: • Missing - the metal roof should be covered with decking to protect it.

Location: East Second Floor

Deck flooring needed

Task: Provide

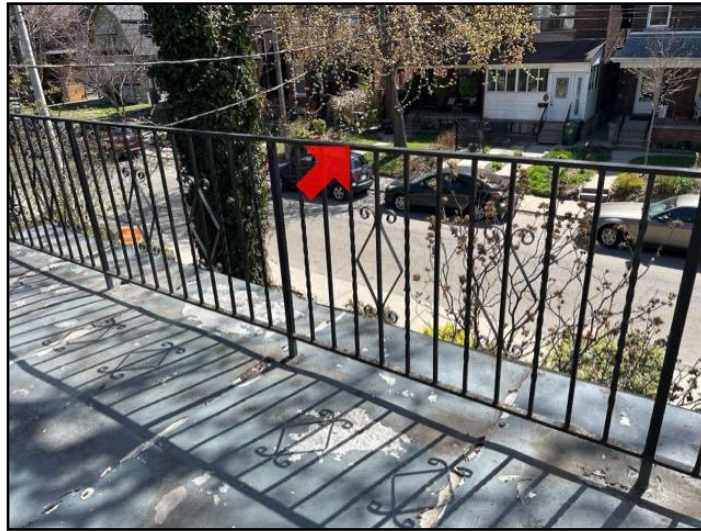
Condition: • [Too low](#)

Implication(s): Fall hazard

Location: East Second Floor

Too low

Task: Correct

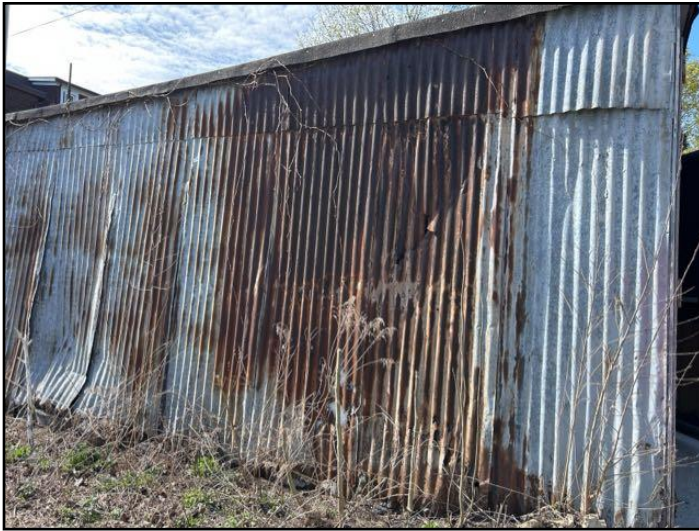
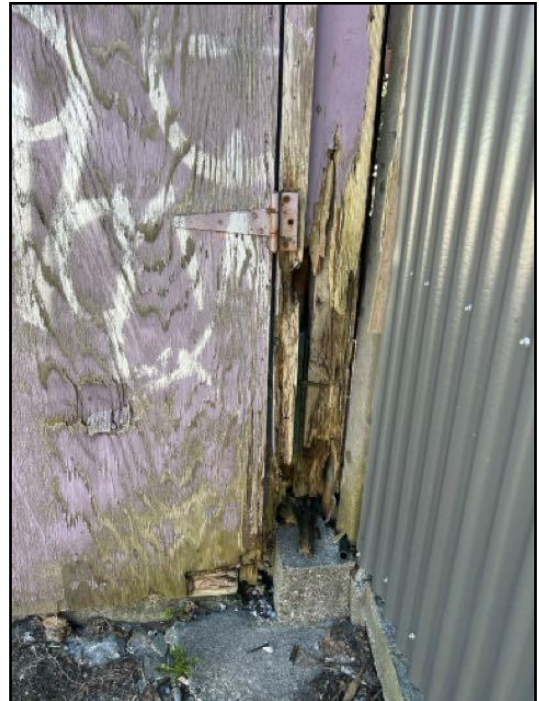
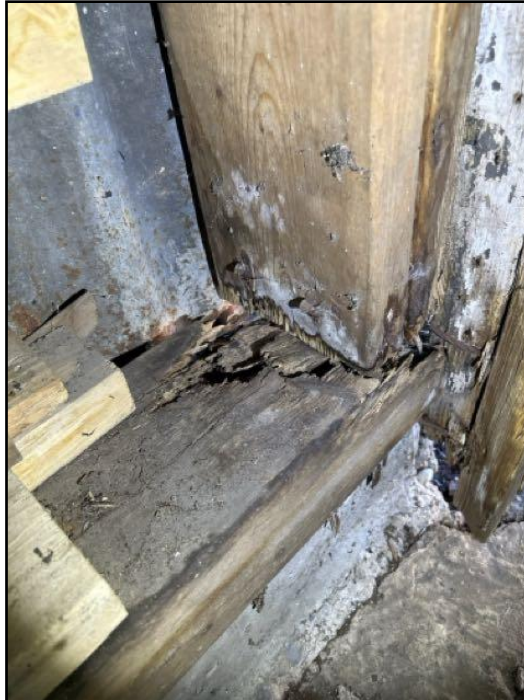
Condition: • Disrepair

Implication(s): Chance of water damage to structure, finishes and contents | Reduced operability

Disrepair

Task: Repair or replace

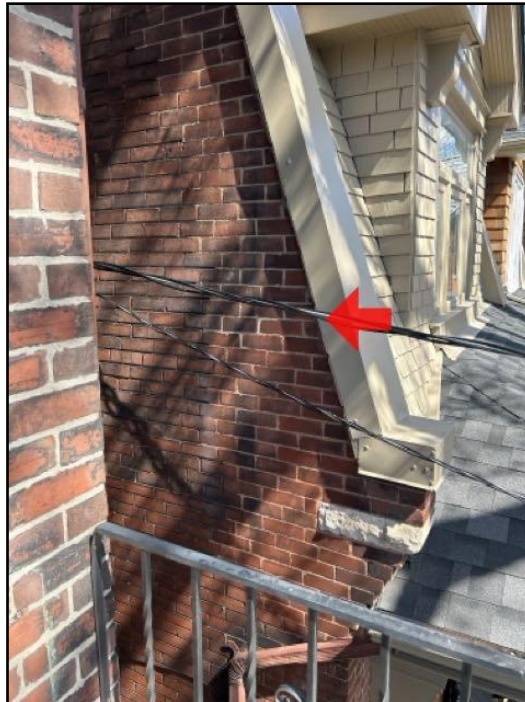
Condition: • [Height over balcony](#)

Implication(s): Electric shock

Location: Northeast Second Floor

Service wire too close

A barrier (such as lattice) should be installed on the side of the balcony to prevent access to the service wire.

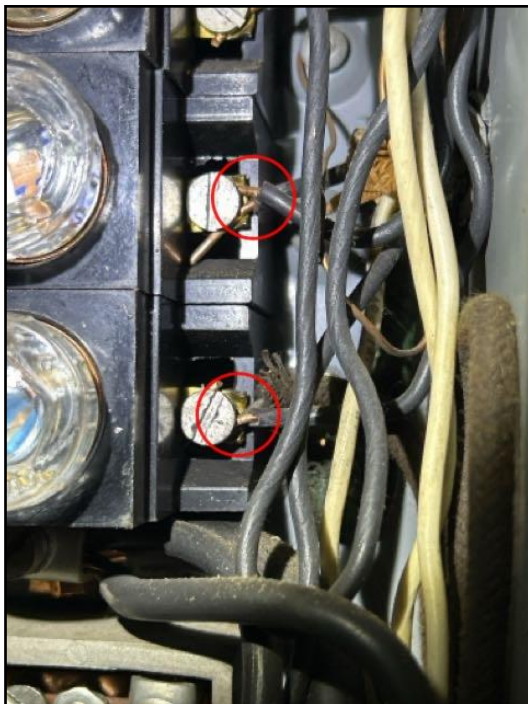
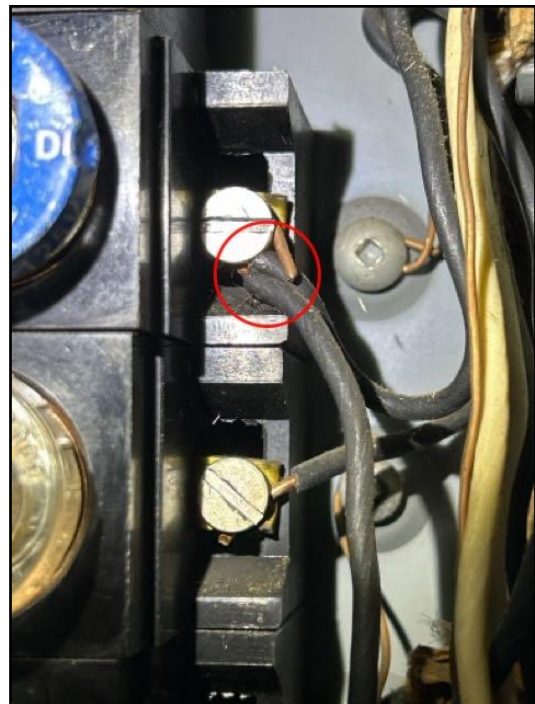
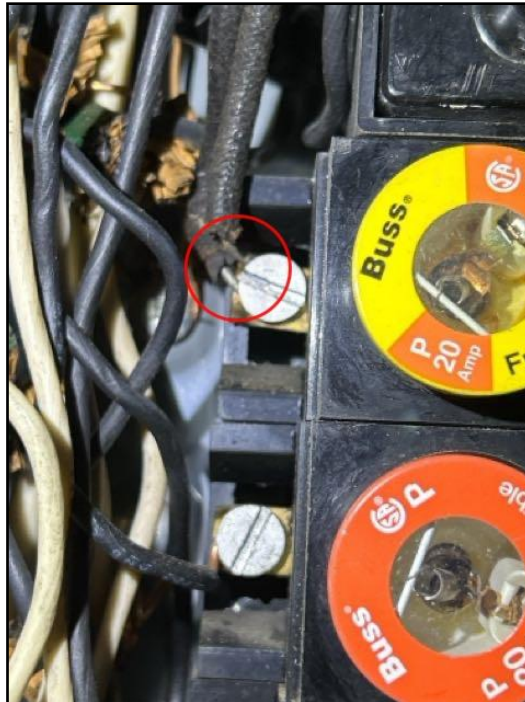
Condition: • [Double taps](#)

Implication(s): Fire hazard

*Double taps*

Double taps

Task: Correct

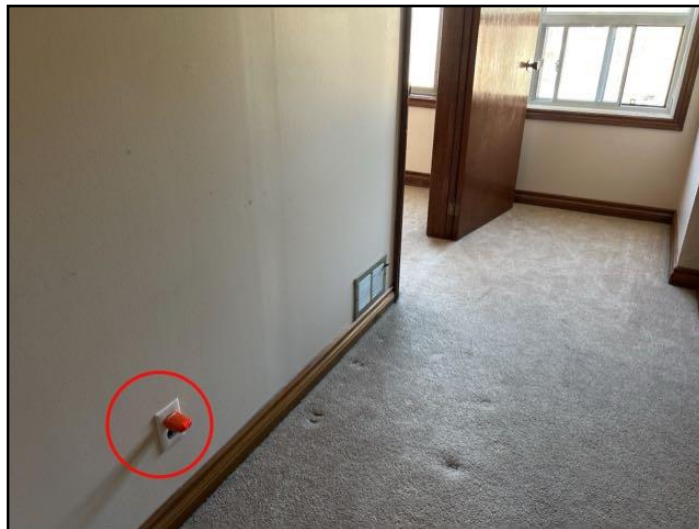
Condition: • [Reversed polarity](#)

Implication(s): Electric shock

Location: West Third Floor

Reversed polarity

Task: Repair

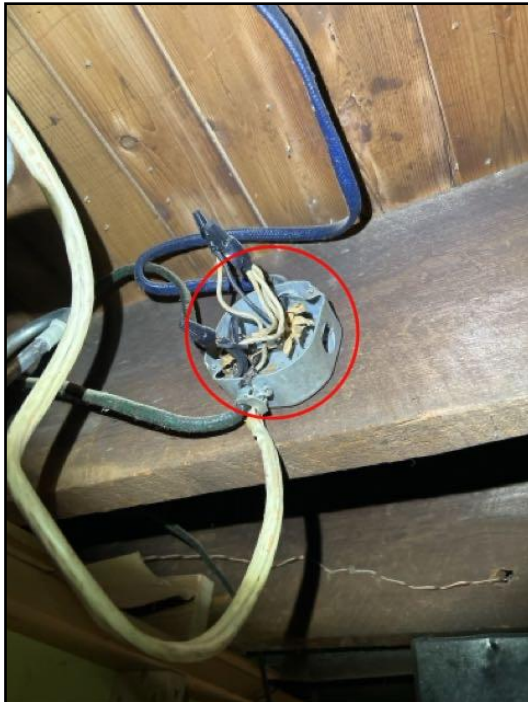
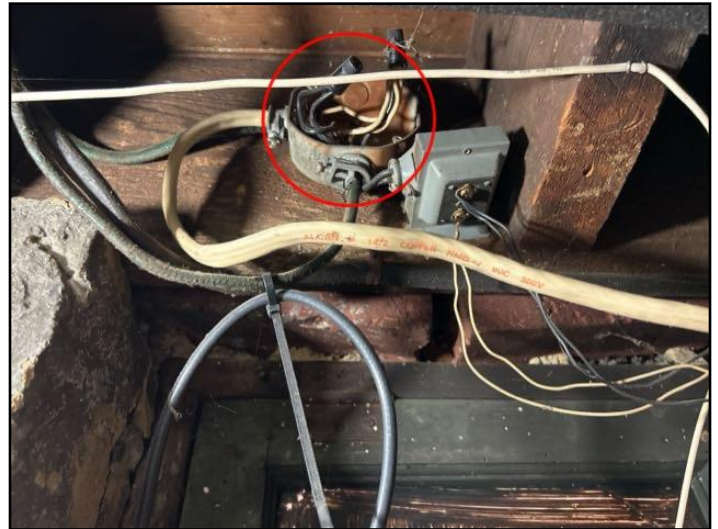
Condition: • [Missing](#)

Implication(s): Electric shock

Location: Utility Room

Missing cover plate

Task: Provide

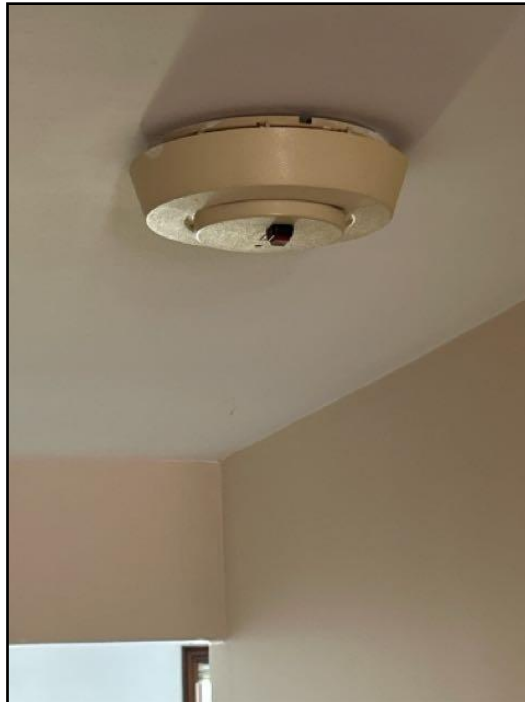
Condition: • Old

Implication(s): Life safety hazard

Location: First and Second Floor

Old smoke alarms

Task: Replace

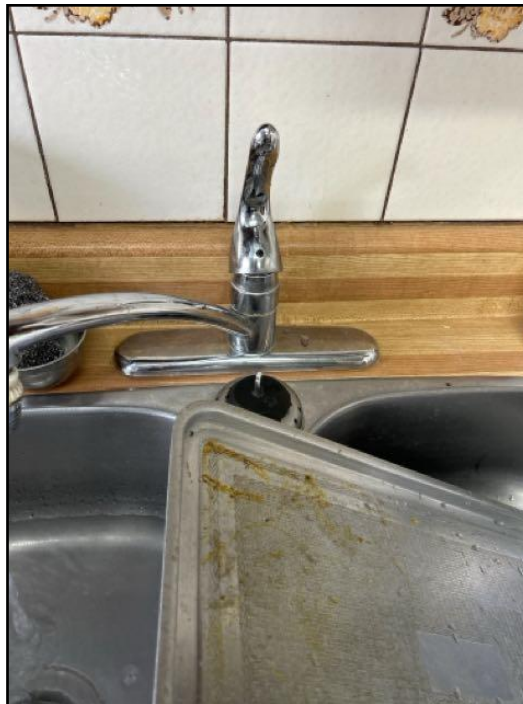
Condition: • [Hot and cold reversed](#)

Implication(s): Scalding

Location: Kitchen

Hot and cold reversed

Task: Repair

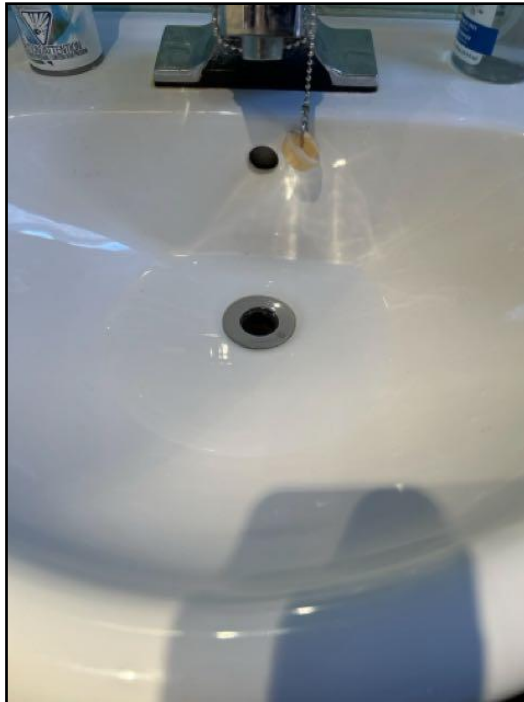
Condition: • [Slow drains](#)

Implication(s): Chance of water damage to structure, finishes and contents

Location: Second Floor Bathroom

Slow drains

Task: Clean

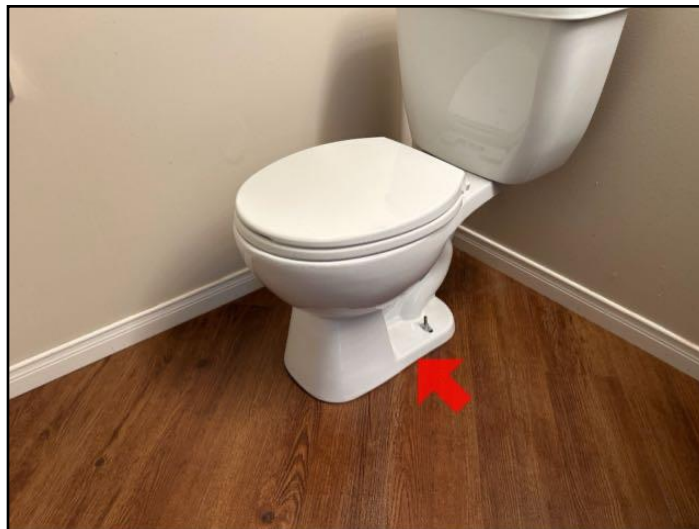
Condition: • [Loose](#)

Implication(s): Chance of water damage to structure, finishes and contents | Sewage entering the building | Possible hidden damage

Loose

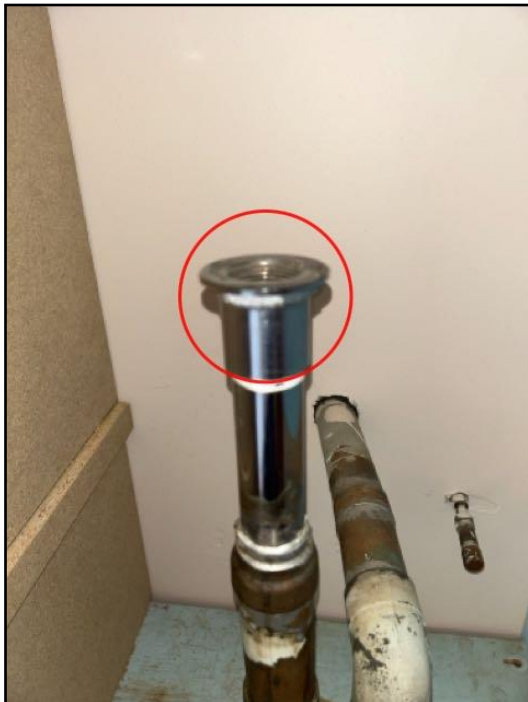
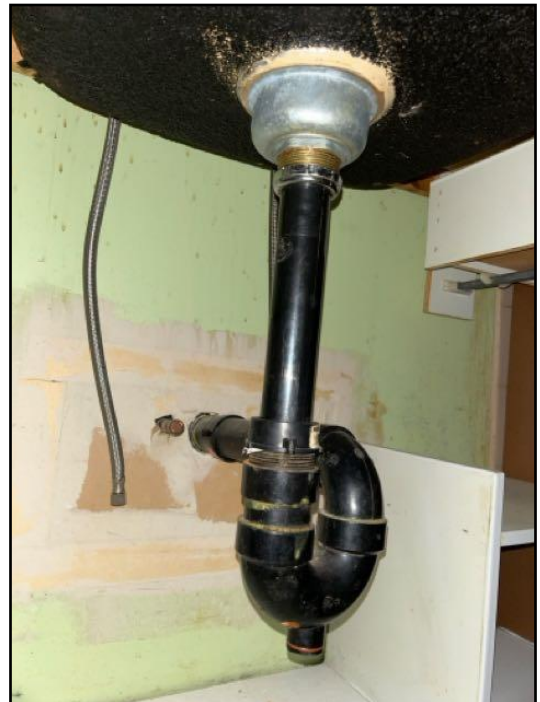
Condition: • In the past there were functional kitchens on the second and third floor. Supply plumbing has been capped. Waste plumbing (drains) should also be permanently capped.

Implication(s): Risk of odours

Uncapped drain

Task: Cap drains

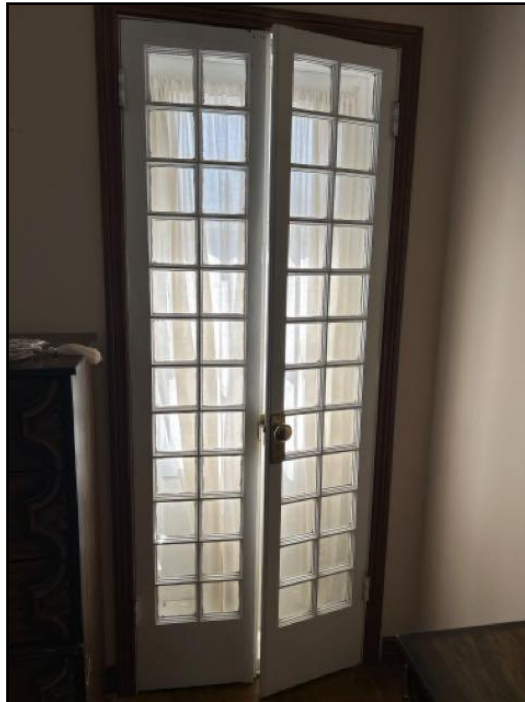
Condition: • Uninsulated exterior door - Upgrade to insulated exterior door

Implication(s): Increased heating costs, reduced comfort

Location: East Second Floor

Upgrade door

Task: Replace

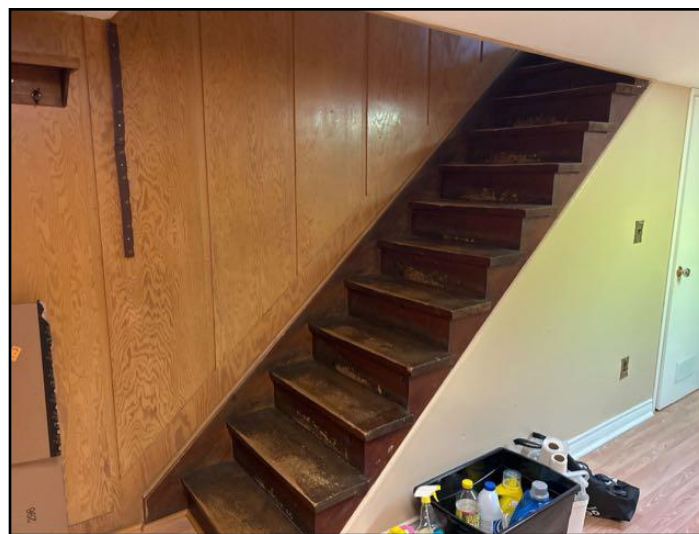
Condition: • [Missing](#)

Implication(s): Fall hazard

Location: Basement Staircase

Missing handrail, guard

Task: Provide

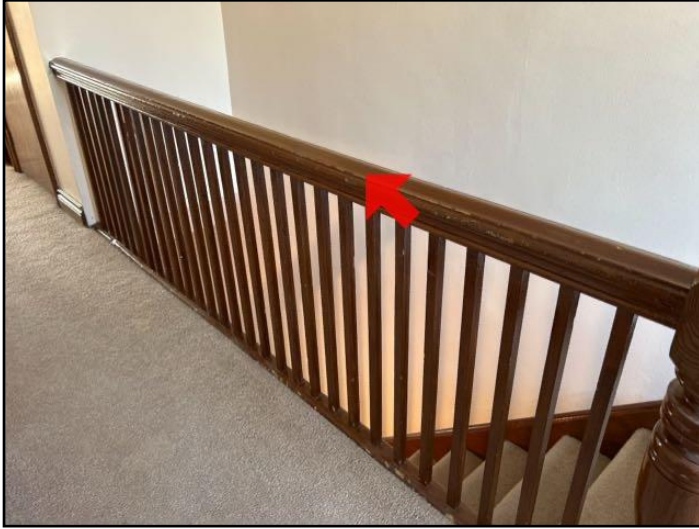
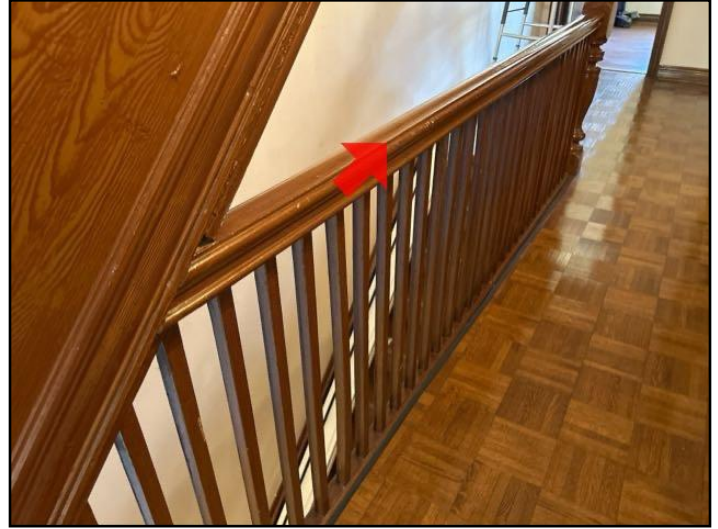
Condition: • [Too low](#)

Implication(s): Fall hazard

Location: Second and Third Floor

Too low

Task: Improve

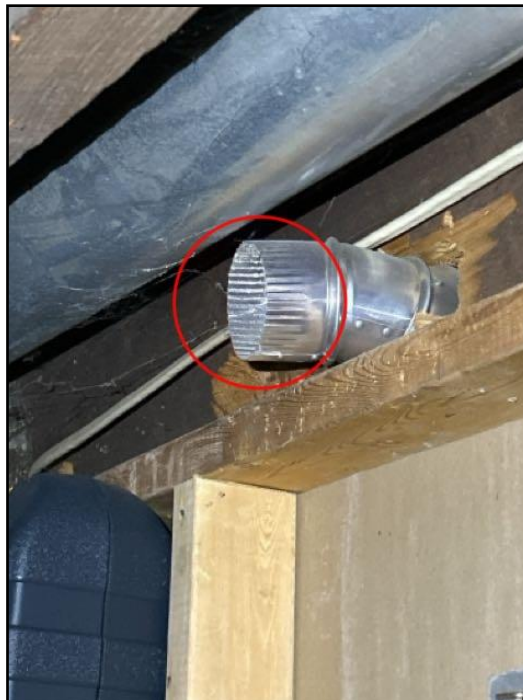
Condition: • [Not vented to exterior](#)

Implication(s): Chance of condensation damage to finishes and/or structure

Location: Utility Room

Not vented to exterior

Bathroom fan discharges into the utility room. It should vent on the house exterior.
