# Your Inspection Report

641 Bondi Avenue  
Newmarket, ON L3Y 8S8

**INSPECTION DATE:**  
Friday, March 7, 2025

Report No. 4405, v.2

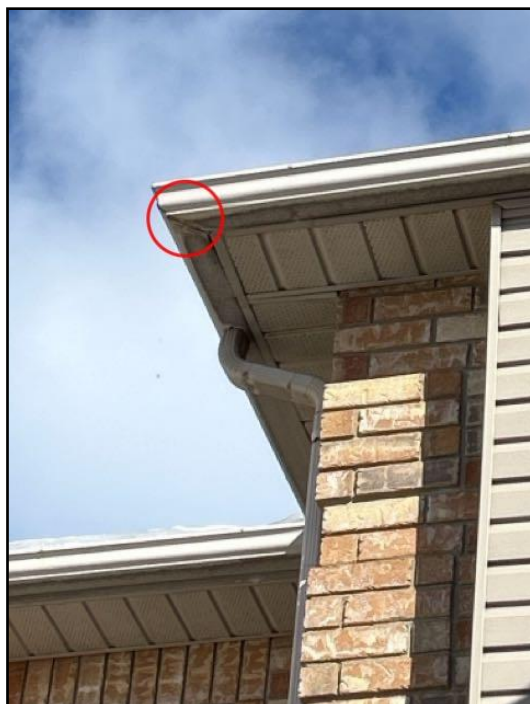
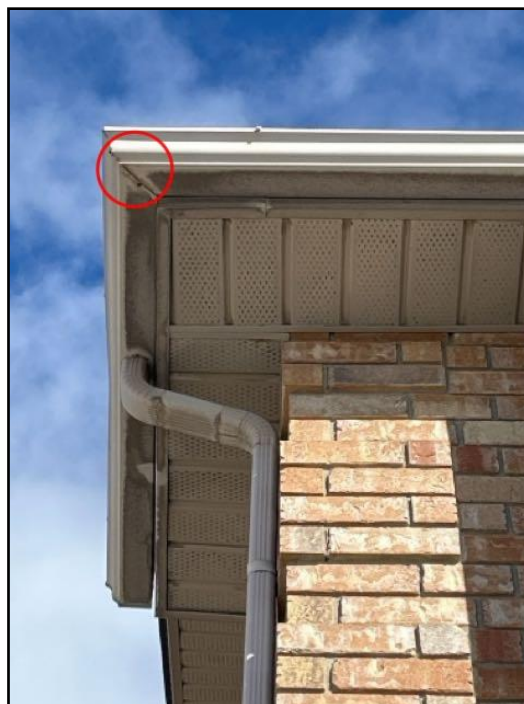
Condition: • [Leak](#)

Implication(s): Chance of water damage to structure, finishes and contents

Location: Front

Leak

Task: Repair

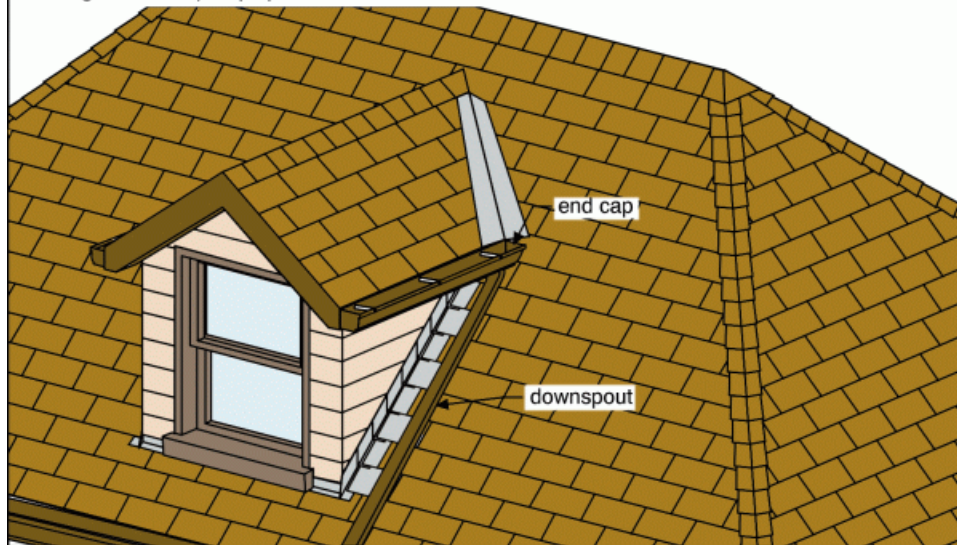
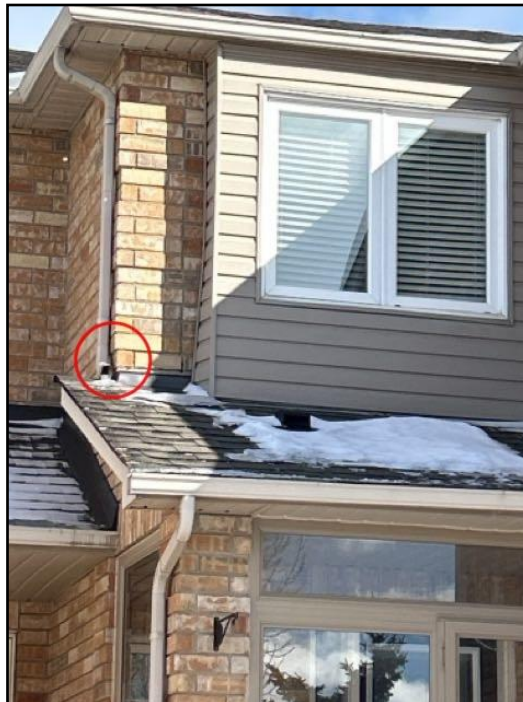
Condition: • Discharge onto roofs

**Implication(s):** Localized roof wear

**Location:** Front

Discharge onto roofs

**Task:** Improve

installing a downspout (from the secondary roof to the main gutter below) helps prevent localized roof wear

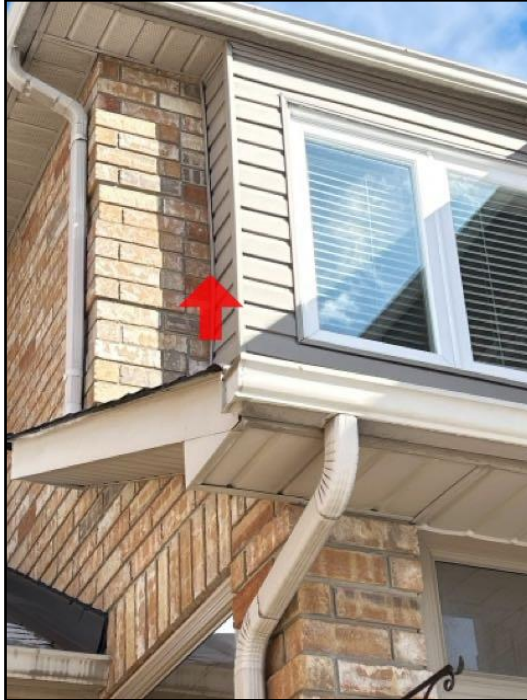
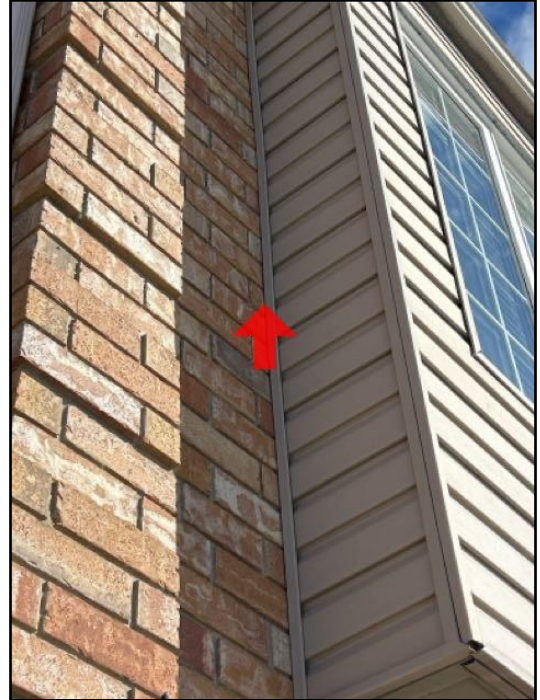
**Condition:** • [Caulking missing or ineffective](#)

**Implication(s):** Chance of water damage to structure, finishes and contents

**Location:** Front

*Caulking missing or ineffective*

**Task:** Provide

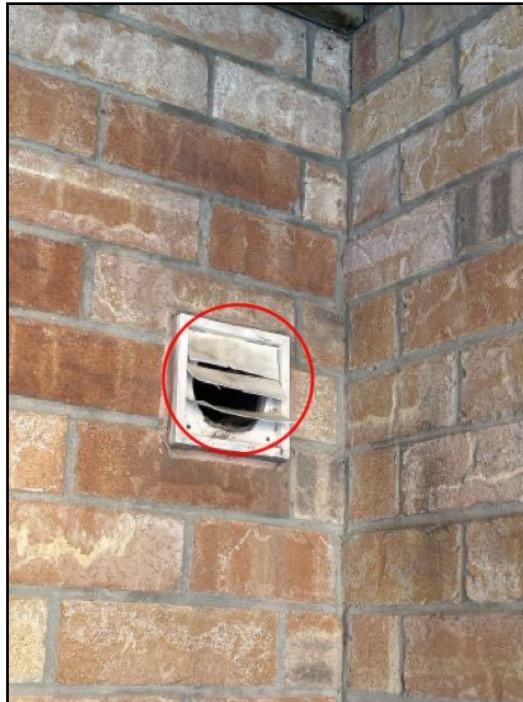
**Condition:** • Cover damaged

**Implication(s):** Increased operating costs

**Location:** Rear

*Cover damaged*

**Task:** Replace

Seller reports that this  
has been repaired.

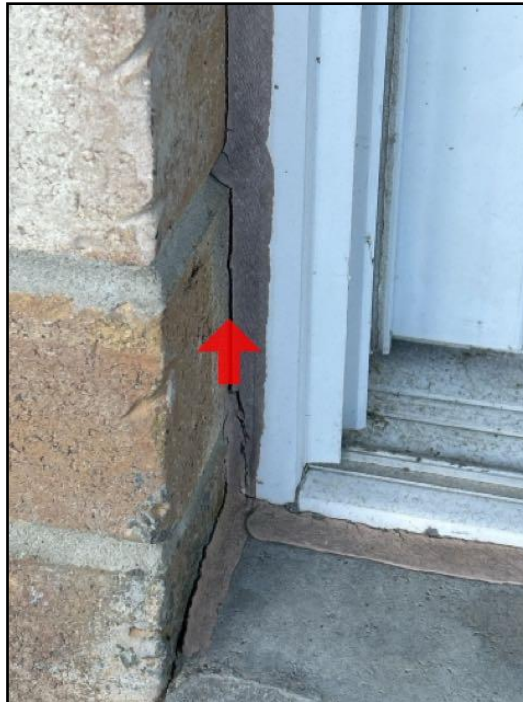
**Condition:** • [Caulking - deteriorated, loose or missing](#)

**Implication(s):** Chance of damage to finishes and structure

**Location:** Basement

*Caulking - deteriorated, loose or missing*

**Task:** Repair

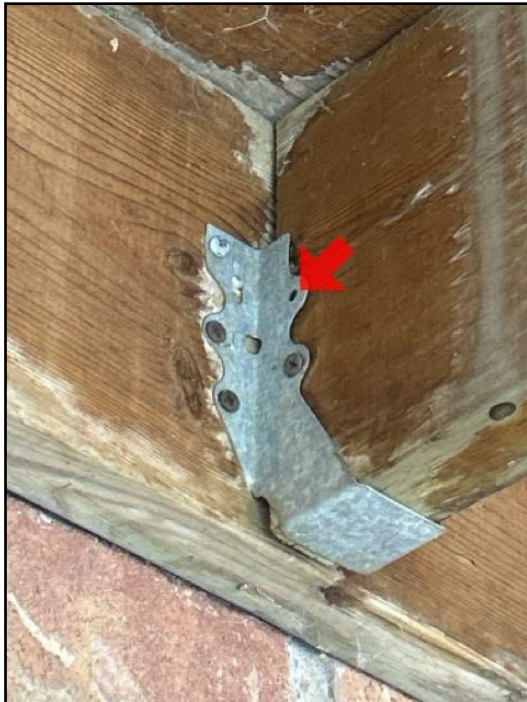
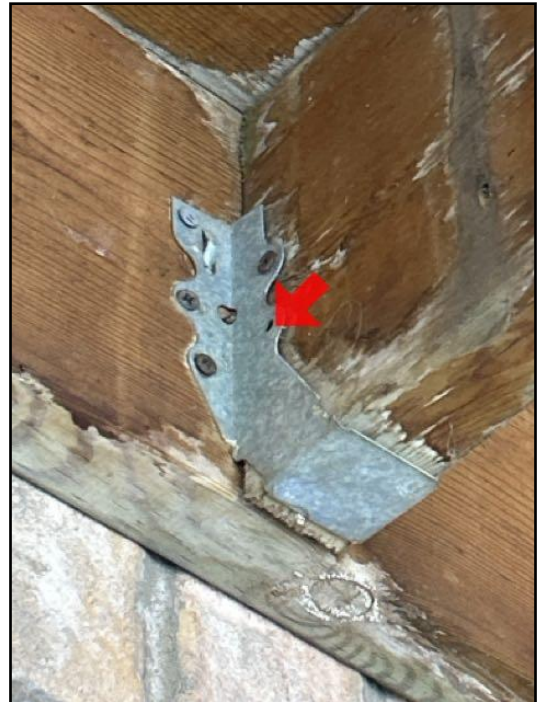
**Condition:** • Missing fasteners - joist hangers are engineered to have a nail or screw in every hole. Each hanger is missing one nail/screw on each side.

**Location:** Rear

Missing fasteners

**Task:** Repair

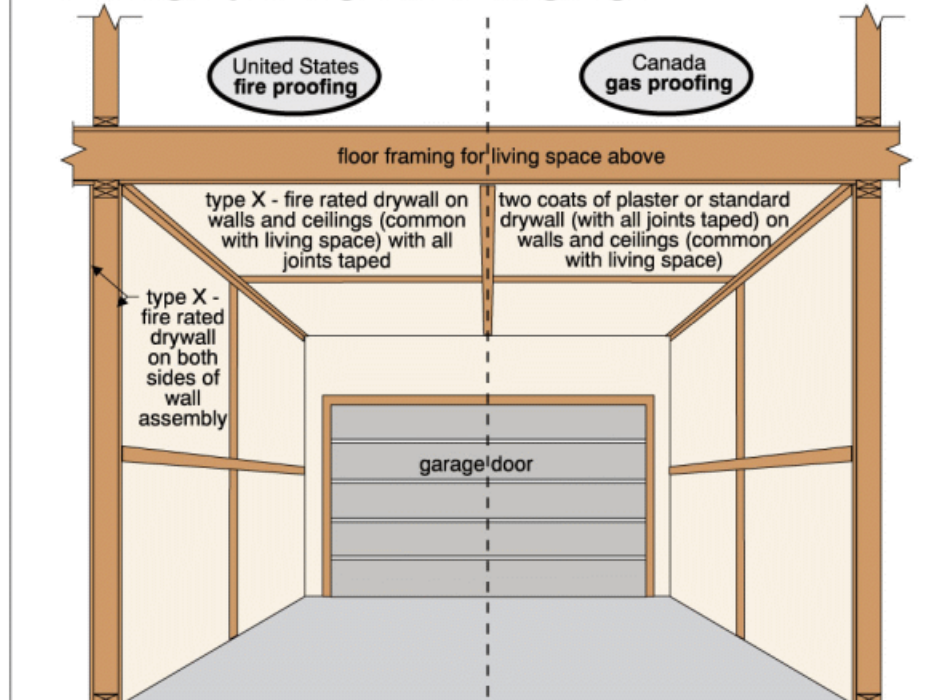
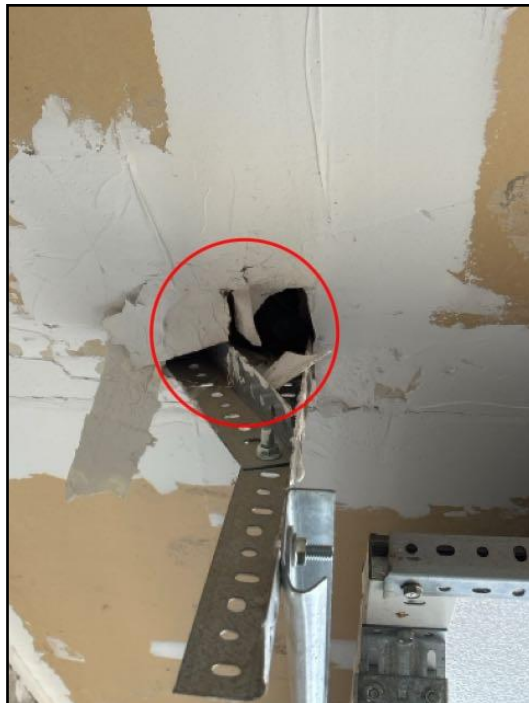
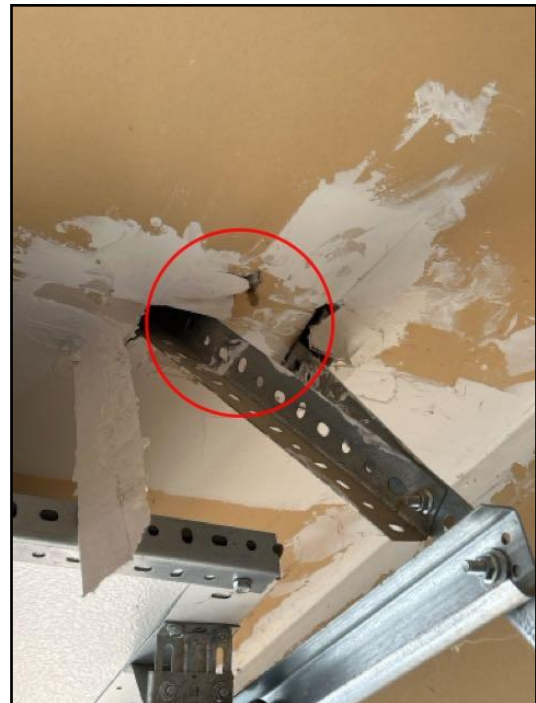
**Condition:** • Not gastight

**Implication(s):** Hazardous combustion products entering home

Not gastight

**Task:** Repair

Seller reports that holes have been filled.

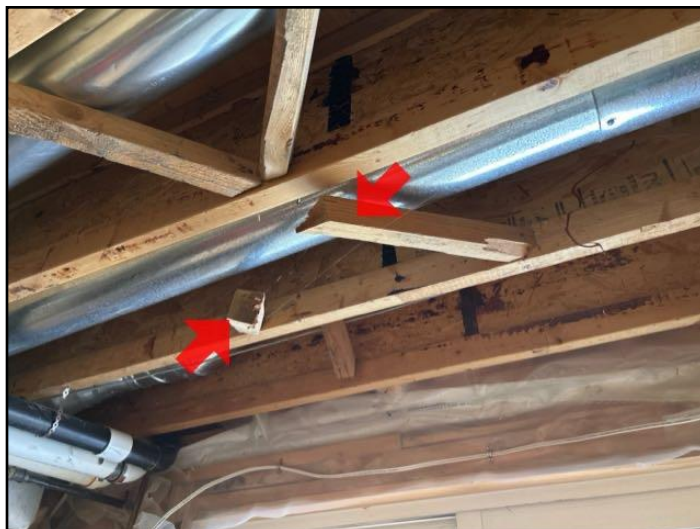
**Condition:** • Loose bracing

**Location:** Basement

*Loose bracing*

**Task:** Repair

Seller reports that this has been rectified.

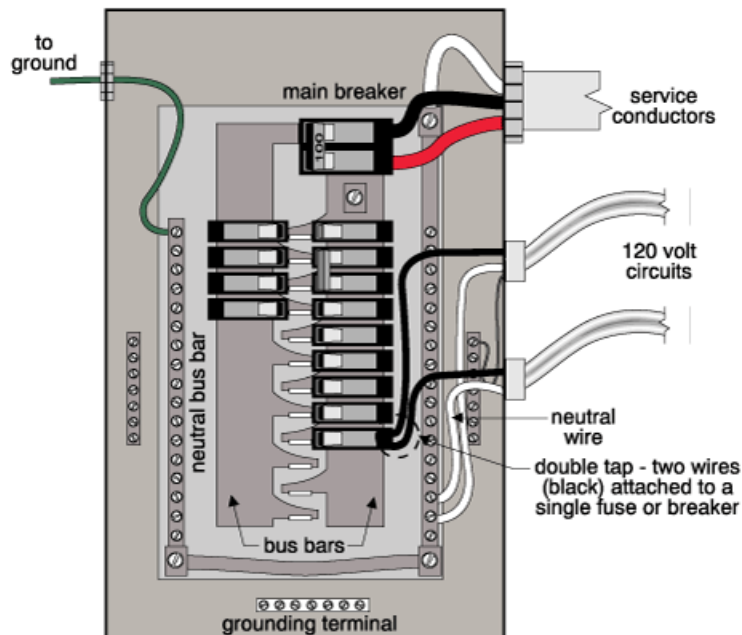
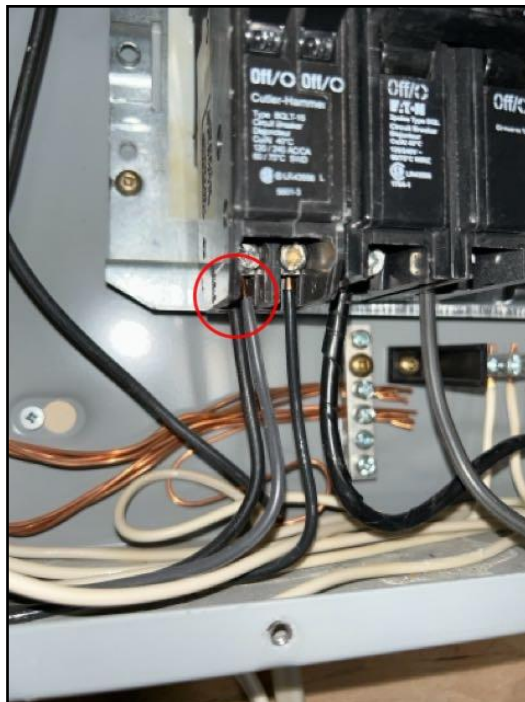
**Condition:** • [Double taps](#)

**Implication(s):** Fire hazard

*Double taps***DISTRIBUTION SYSTEM \ Wiring (wires) - installation****Condition:** • [Not well secured](#)**Implication(s):** Electric shock | Fire hazard

**Task:** Correct

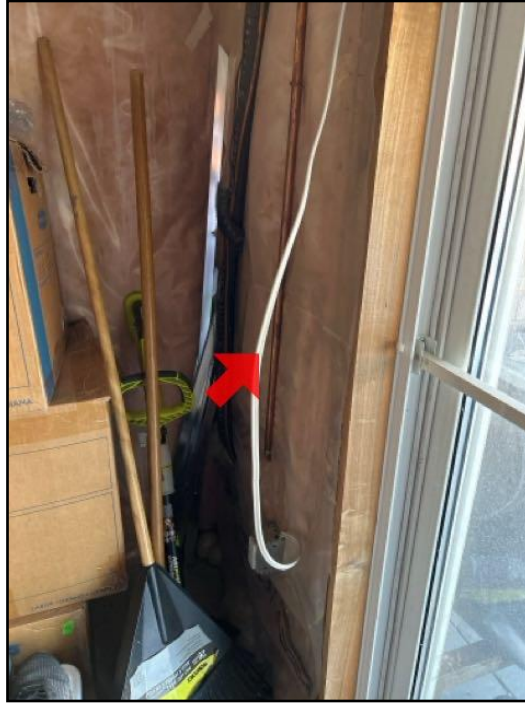
**Location:** Basement Near Exterior Door

*Not well secured*

**Task:** Repair

Seller reports that loose wire has been secured.

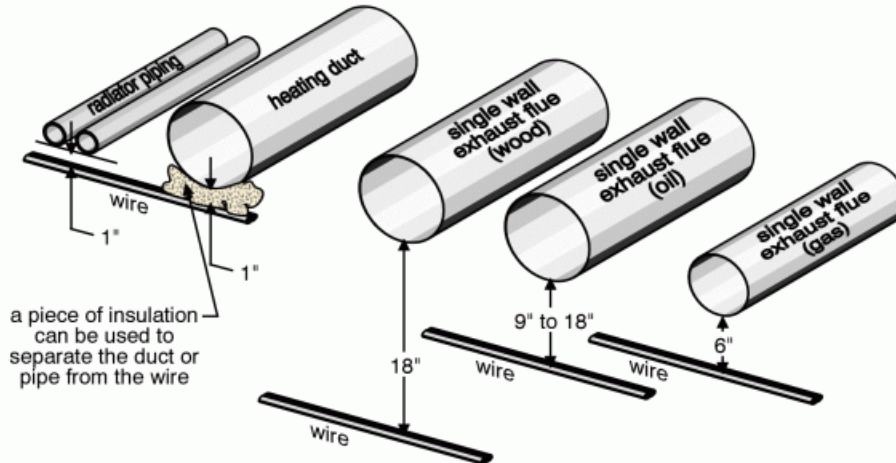
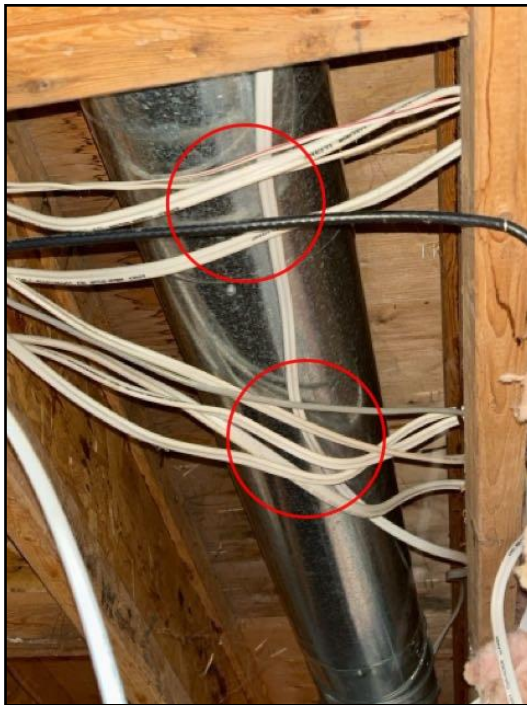
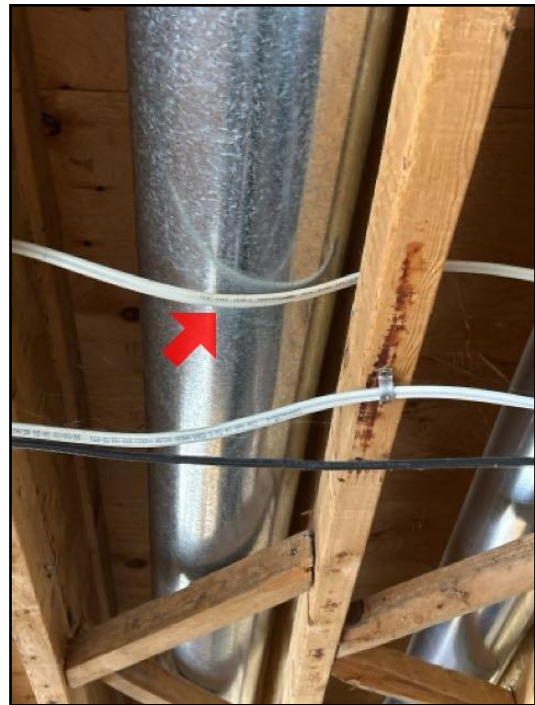
**Condition:** • [Too close to/touching duct, pipe, vent or chimney](#)

**Implication(s):** Electric shock | Fire hazard

**Location:** Basement

Too close to/touching duct, pipe, vent or...

**Task:** Improve

Seller reports that insulation has been added where needed.

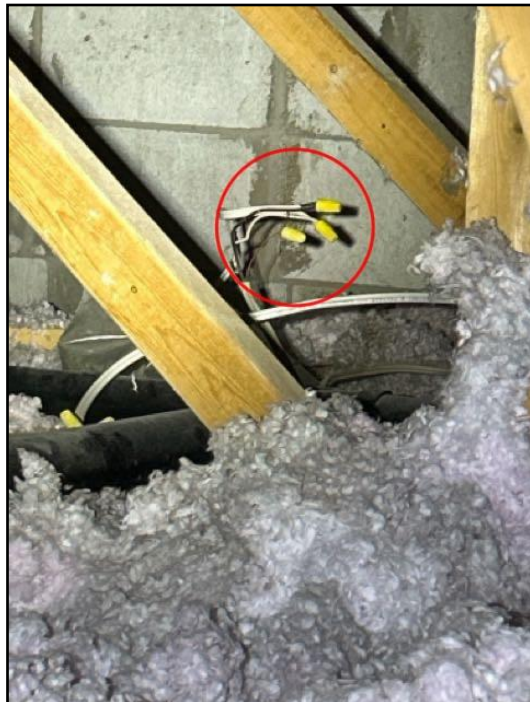
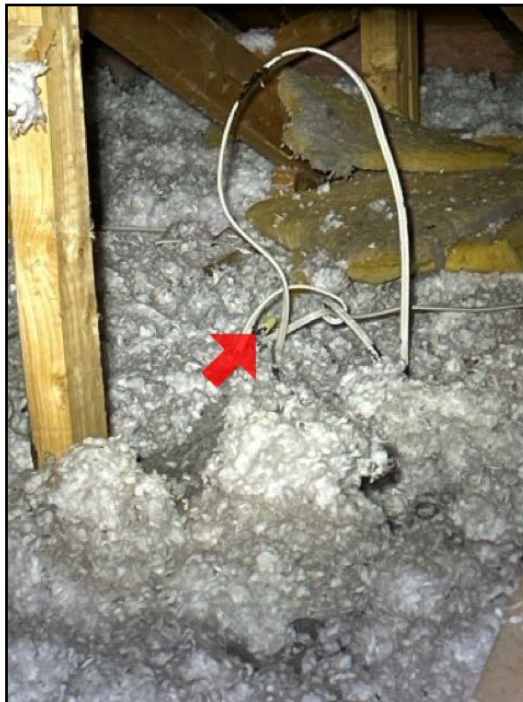
Condition: • [Missing](#)

Wire splices and terminations must be safely stowed in a junction box.

Implication(s): Electric shock | Fire hazard

**Location:** Attic

*Missing junction box*

**Task:** Provide

Seller reports that two junction boxes have been installed.

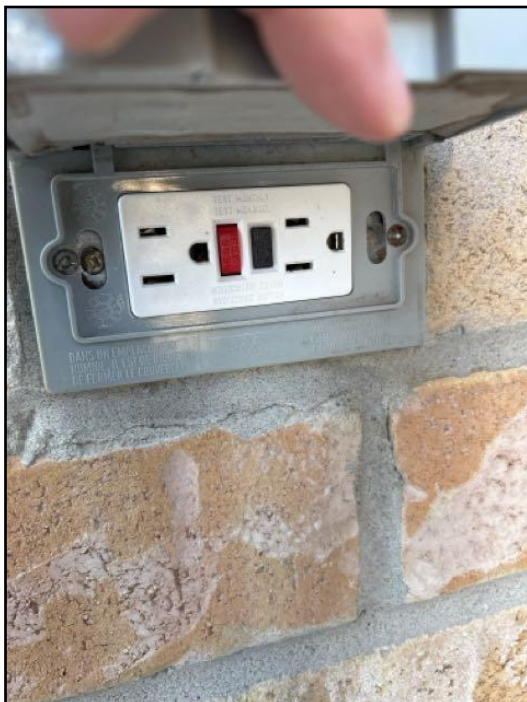
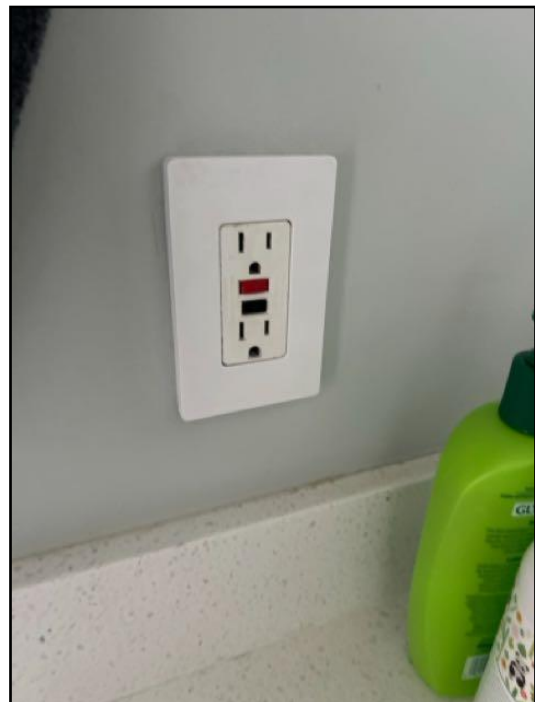
**Condition:** • [Test faulty on GFCI/GFI \(Ground Fault Circuit Interrupter\)](#)

**Implication(s):** Electric shock

**Location:** Rear First Floor Exterior, First Floor Bathroom

*Test faulty on GFCI/GFI (Ground Fault...*

**Task:** Replace

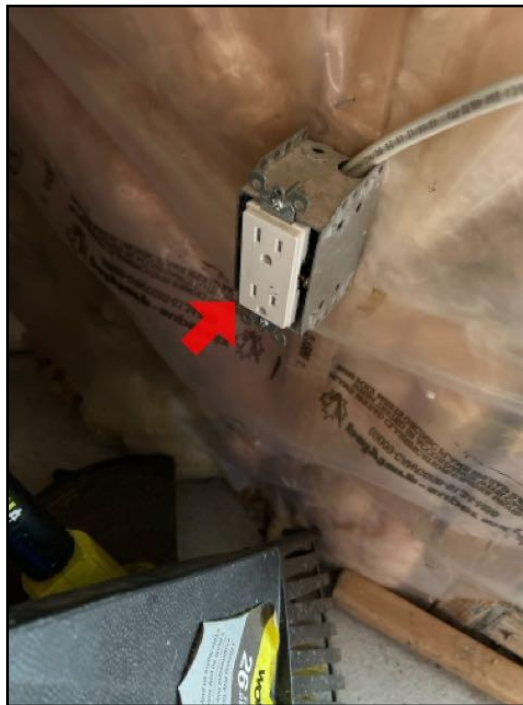
**Condition:** • [Missing](#)

**Implication(s):** Electric shock

**Location:** Basement Near Exterior Door

*Missing cover plate*

**Task:** Provide

Seller reports that cover plate has been added to outlet.

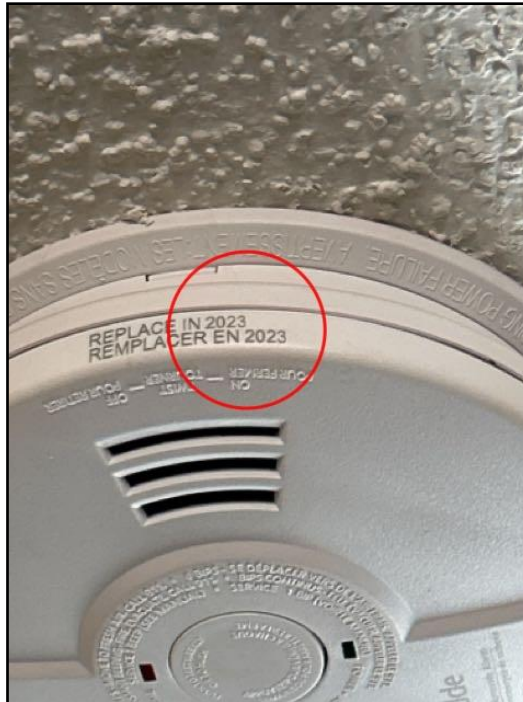
**Condition:** • Past life expectancy

**Implication(s):** Life safety hazard

**Location:** Basement, First and Second Floor

*Past life expectancy*

**Task:** Replace

Seller reports that all 3 smoke / carbon monoxide detectors have been replaced.

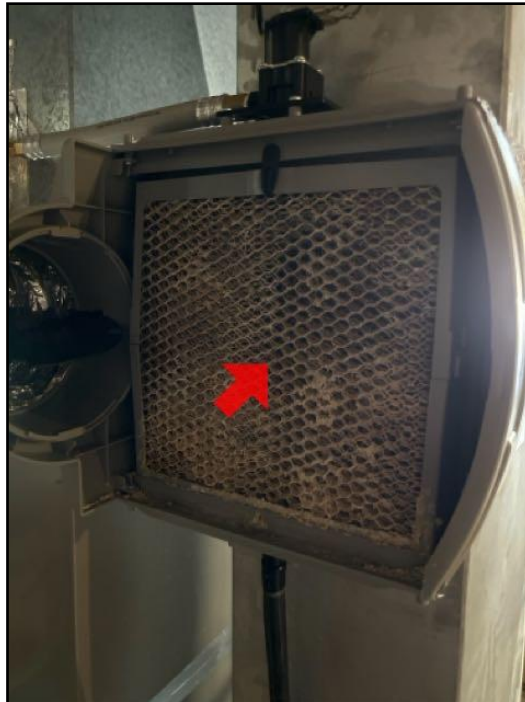
Condition: • Mesh pad dirty/clogged

*Mesh pad dirty/clogged*

Task: Replace

Seller reports that the filter has been replaced.

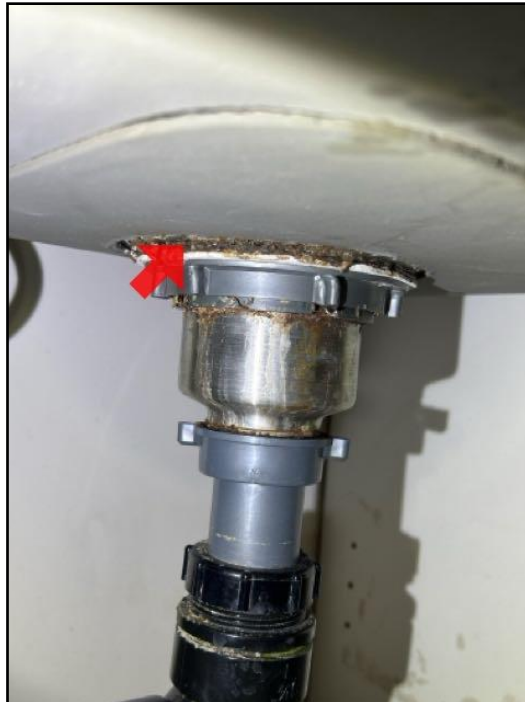
**Condition:** • [Leak](#)

**Implication(s):** Chance of water damage to structure, finishes and contents | Sewage entering the building

**Location:** Kitchen

*Leak*

**Task:** Repair

Seller reports that this  
has been rectified.

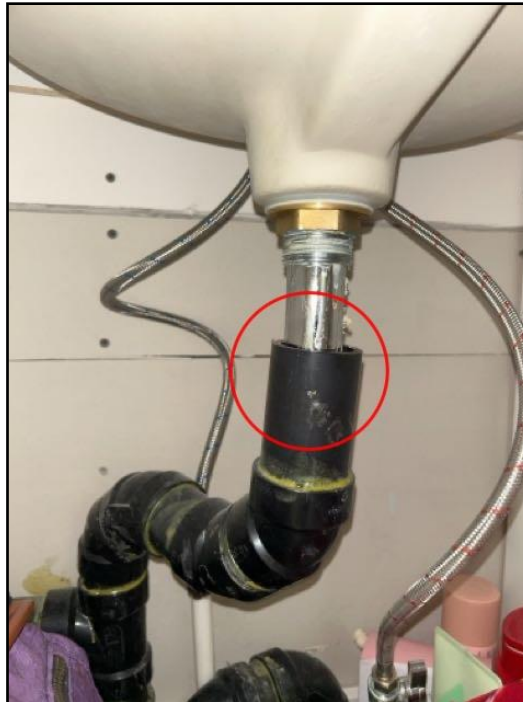
**Condition:** • Drain assembly not properly installed

**Implication(s):** Risk of leaks, water damage

**Location:** Principal Ensuite Bathroom

*Drain assembly not properly installed*

**Task:** Repair

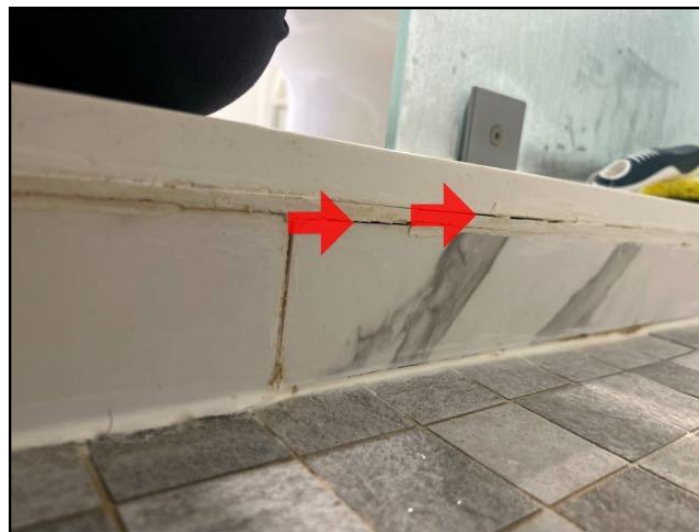
**Condition:** • [Grout loose, missing or deteriorated](#)

**Implication(s):** Chance of water damage to structure, finishes and contents

**Location:** Principal Ensuite Bathroom

*Grout loose, missing or deteriorated*

**Task:** Repair

Seller reports that  
caulking has all been  
replaced.

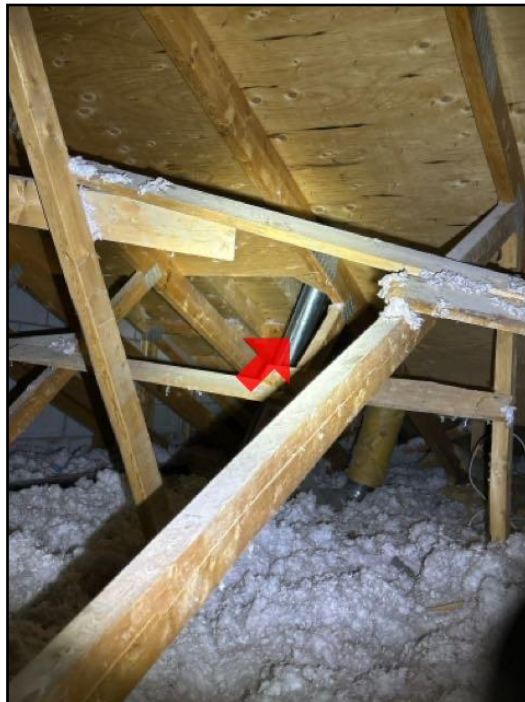
**Condition:** • [Not insulated in unconditioned space](#)

**Implication(s):** Chance of condensation damage to finishes and/or structure

**Location:** Attic

*Not insulated in unconditioned space*

**Task:** Improve

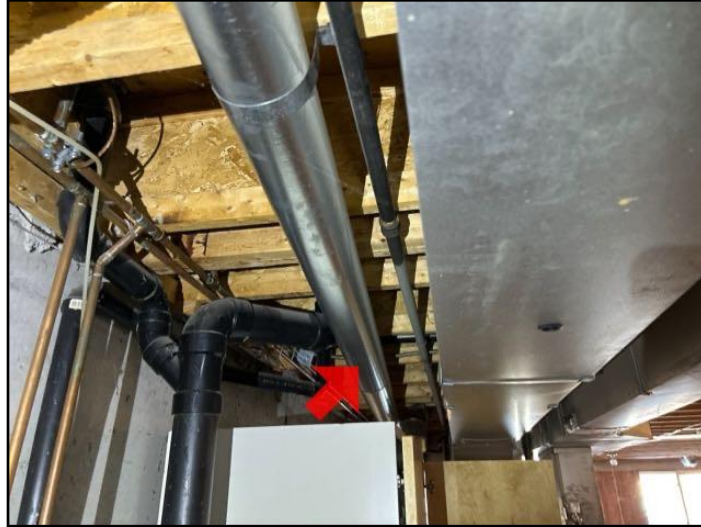
**Condition:** • Dryer duct poorly supported

**Location:** Basement

*Not properly supported*

**Task:** Improve
