Your Inspection Report

6 Basildon Crescent
Toronto, ON M1M 3E2

INSPECTION DATE:
Monday, July 24, 2023

Report No. 3929

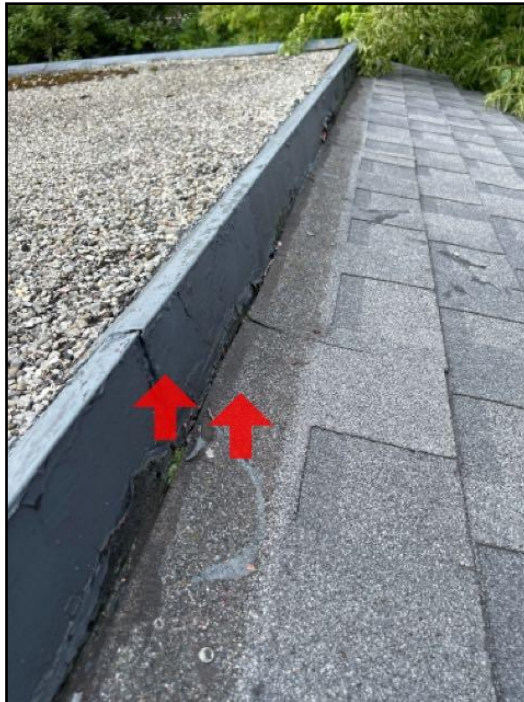
Condition: • [Missing](#)

Implication(s): Chance of water damage to structure, finishes and contents

Location: North Garage

Missing flashing

Task: Provide

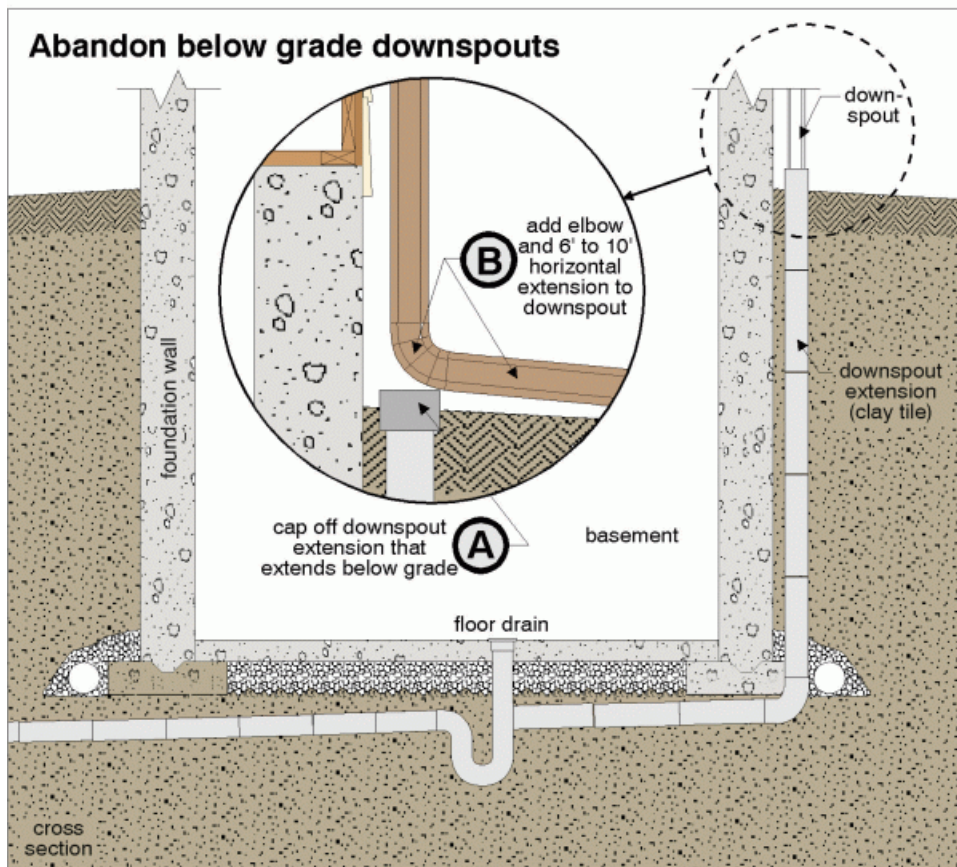
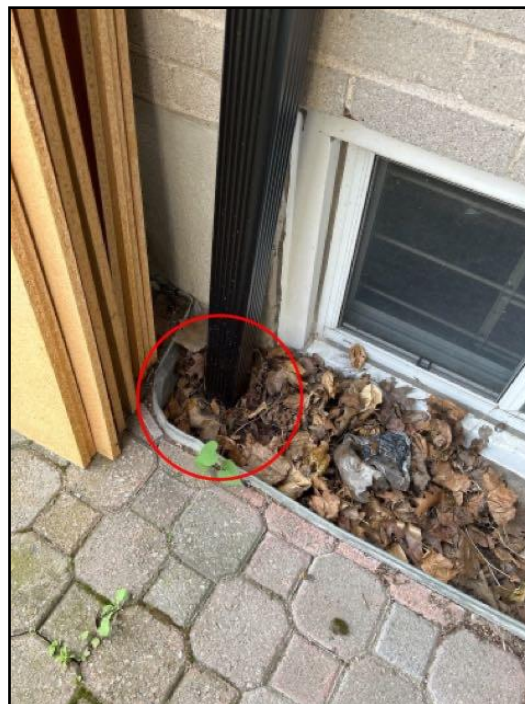
Condition: • [Discharge below grade](#)

Implication(s): Chance of water damage to structure, finishes and contents

Location: North

Task: Correct

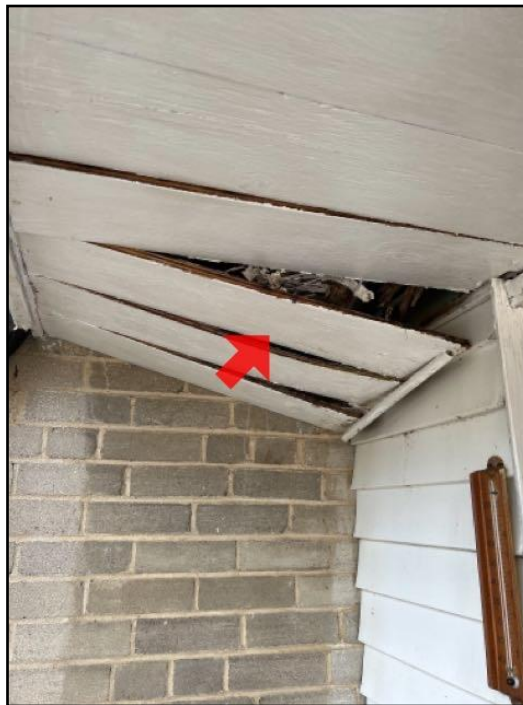
Condition: • [Damage](#)

Implication(s): Chance of water damage to structure, finishes and contents

Location: Garage

Damage

Task: Repair

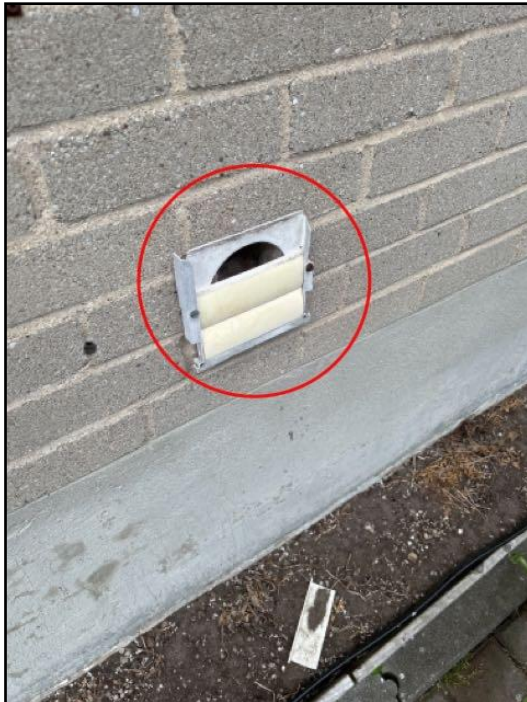
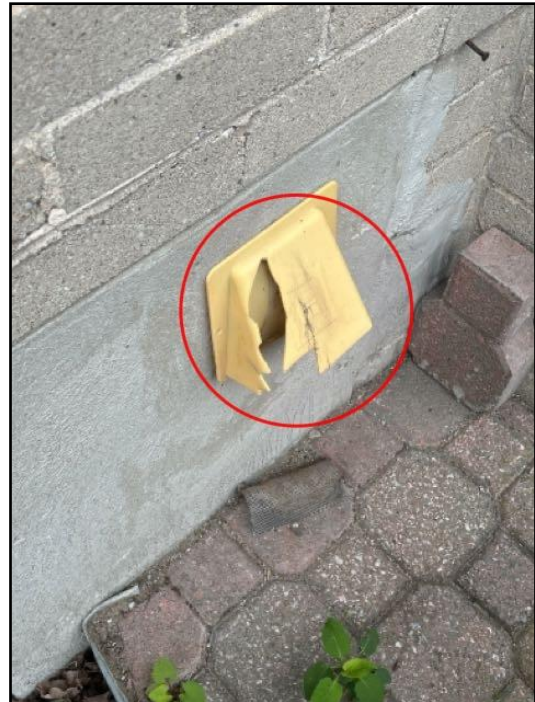
Condition: • Cover damaged

Implication(s): Increased operating costs

Cover damaged

Apply caulking around replacement vent covers.

Task: Replace

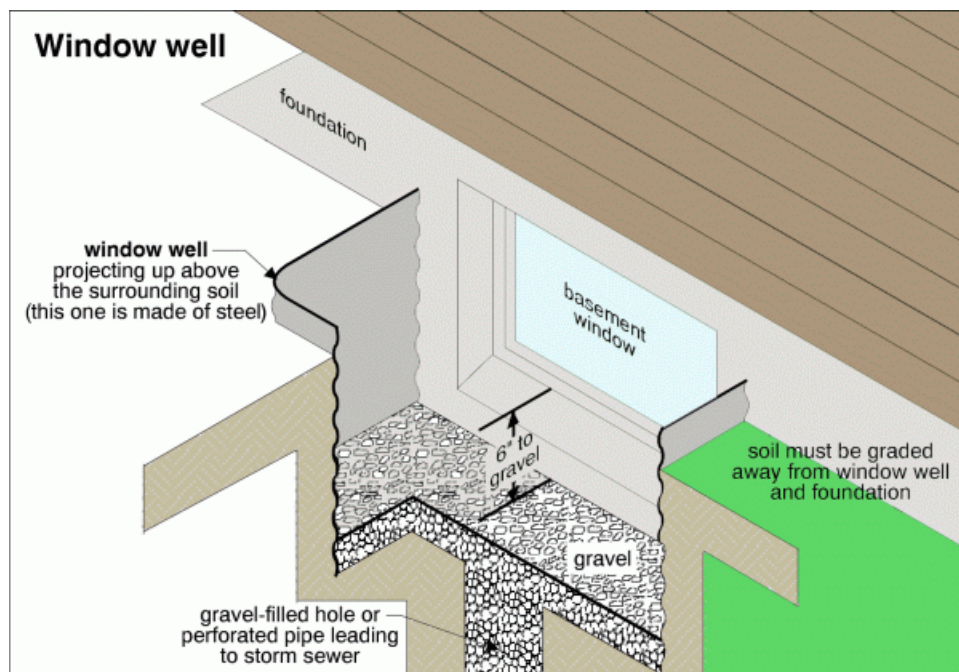
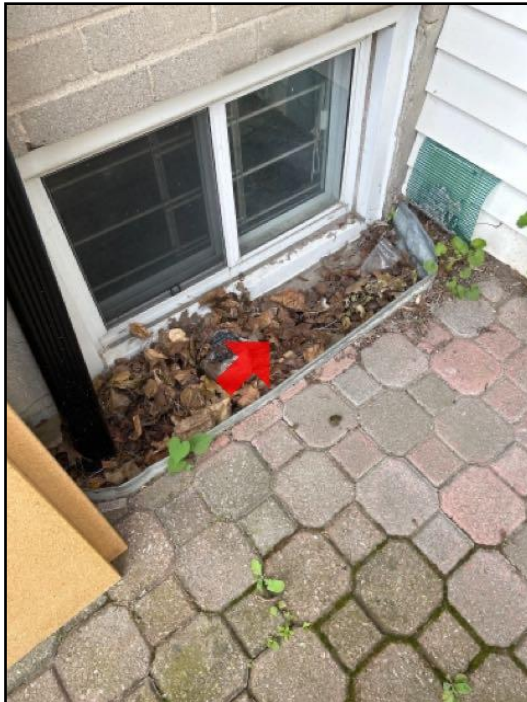
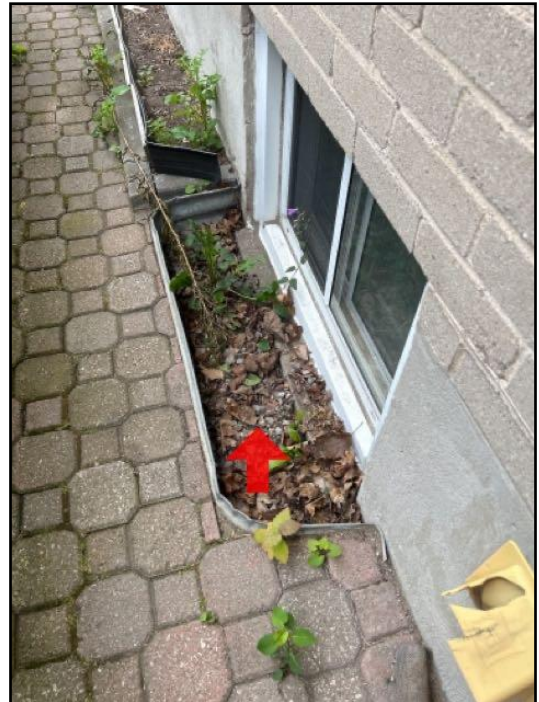
Condition: • [Less than 6 inches below window](#)

Implication(s): Chance of water entering building

Less than 6 inches below window

Task: Improve

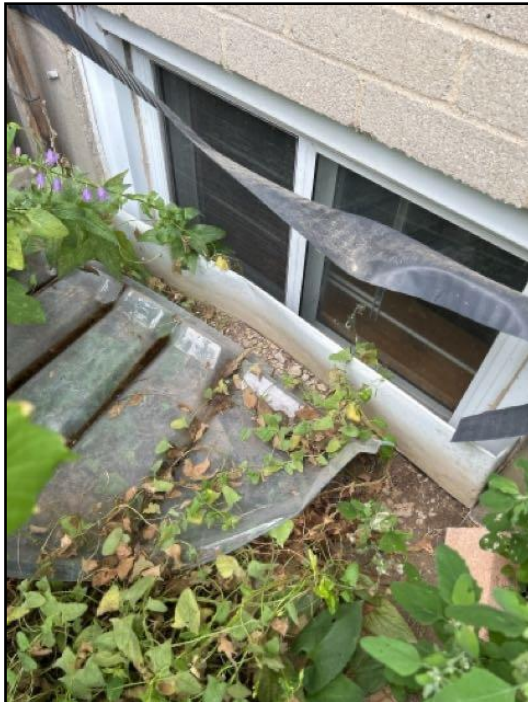
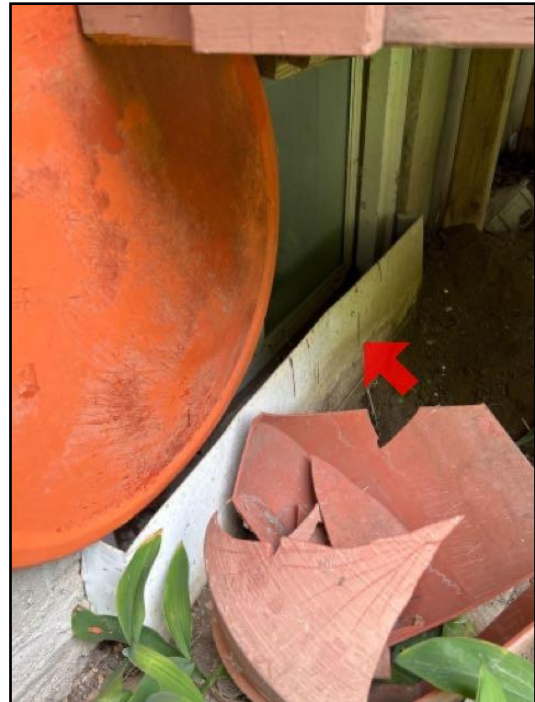
Condition: • [Missing](#)

Implication(s): Chance of water damage to structure, finishes and contents | Material deterioration

Missing window well

Missing/inadequate window well

Task: Provide

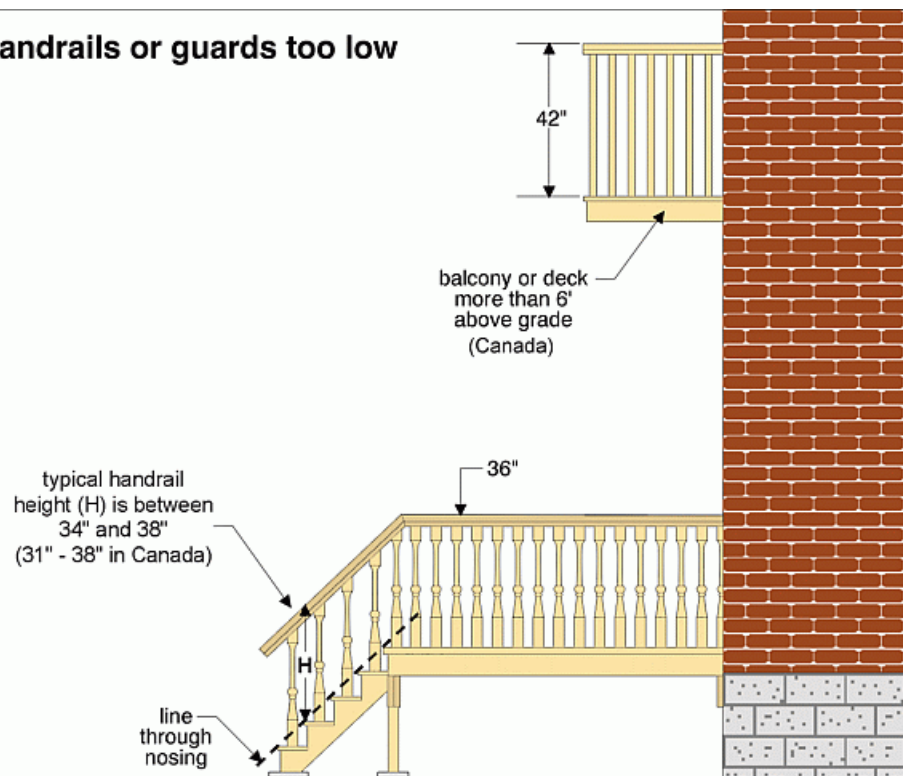
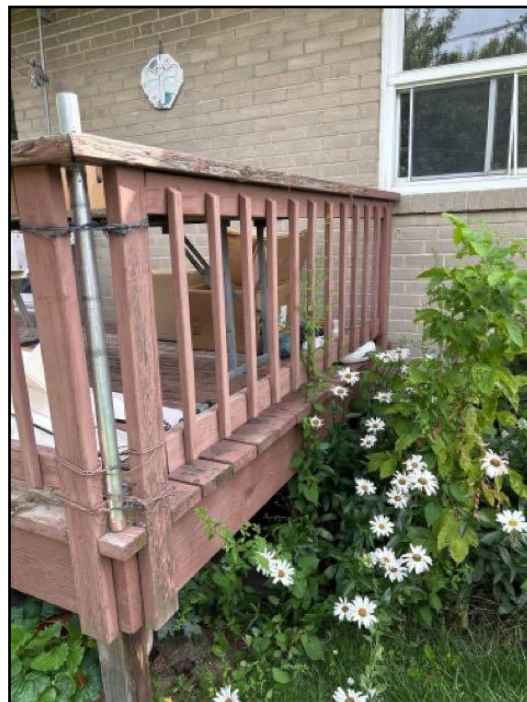
Condition: • [Too low](#)

Implication(s): Fall hazard

Handrails or guards too low

Too low

Task: Correct

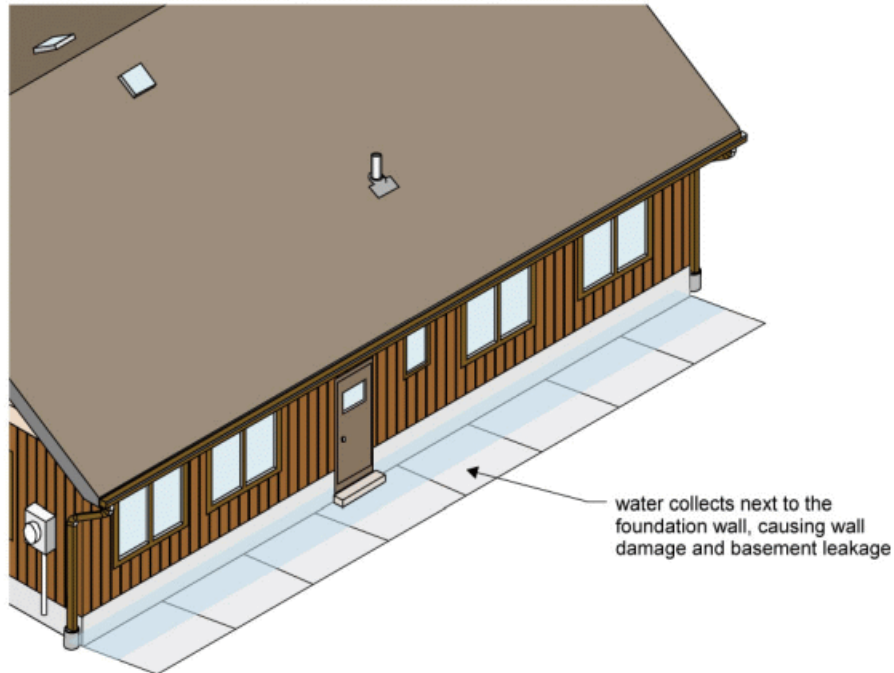
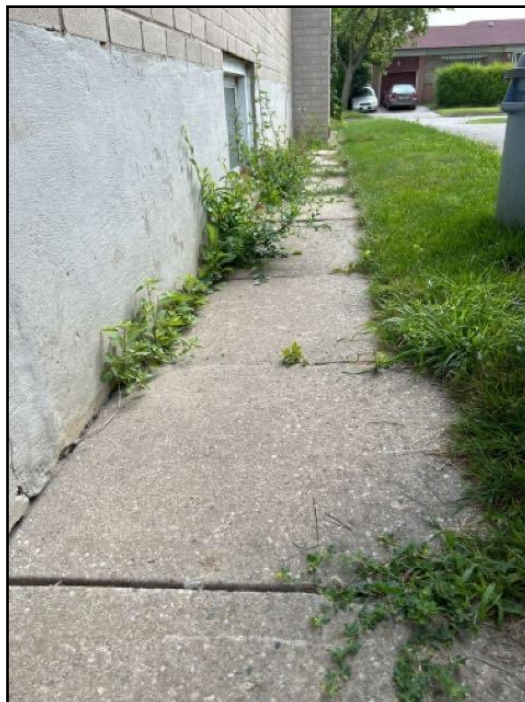
Condition: • [Improper slope or drainage](#)

No current interior water issues were noted.

Implication(s): Chance of water damage to structure, finishes and contents

Walk/patio sloping towards house

Improper slope or drainage

Task: Improve

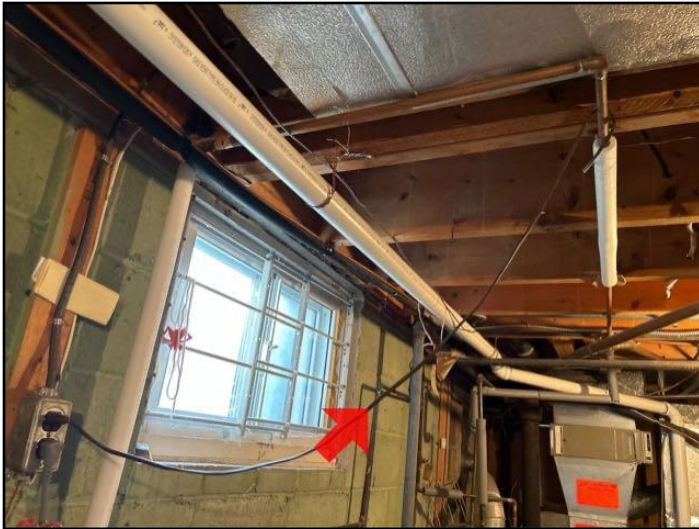
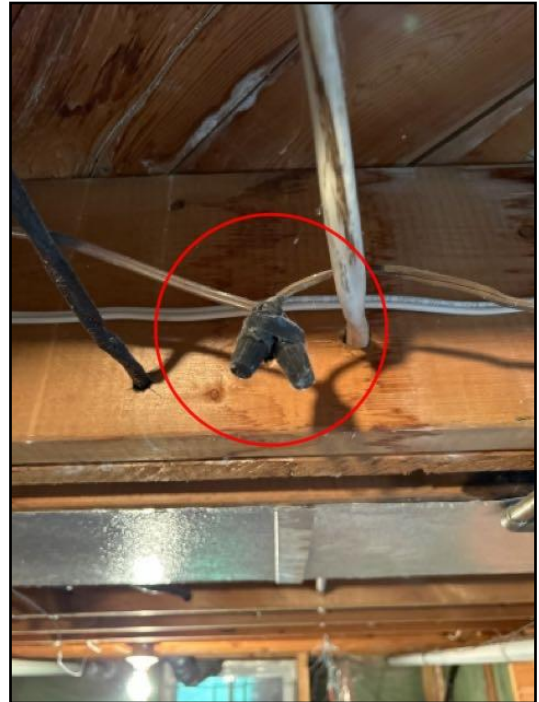
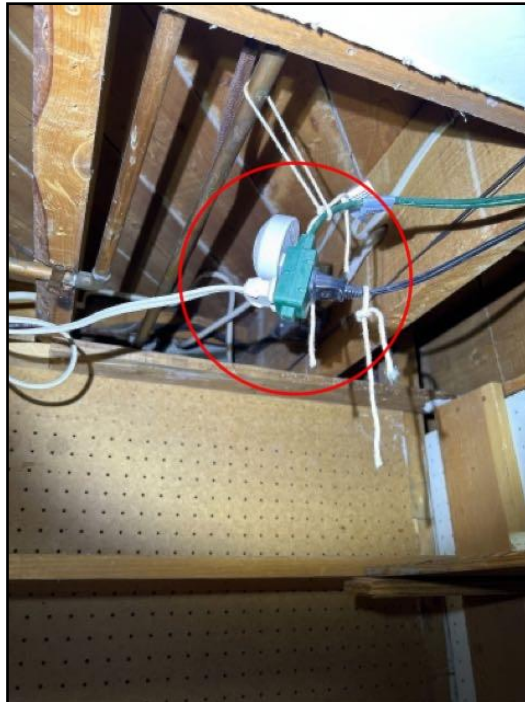
Condition: • [Extension cord used as permanent wiring](#)

Implication(s): Electric shock | Fire hazard

Extension cord used as permanent wiring

Splice should be in a junction box

Task: Correct

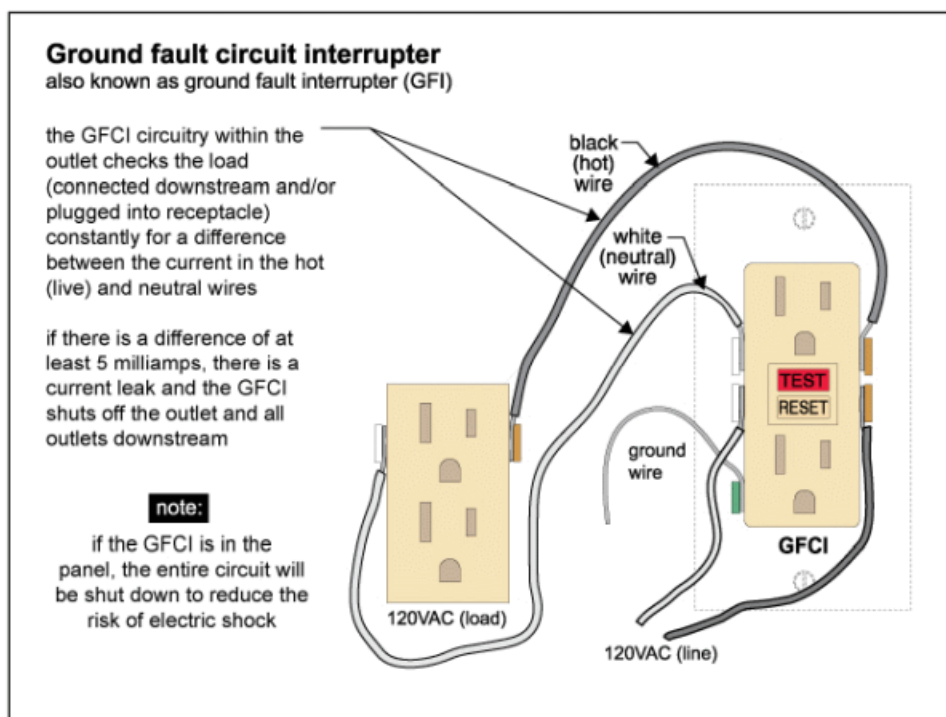
Condition: • [No GFCI/GFI \(Ground Fault Circuit Interrupter\)](#)

Implication(s): Electric shock

Location: Bathroom, Kitchen

Task: Provide

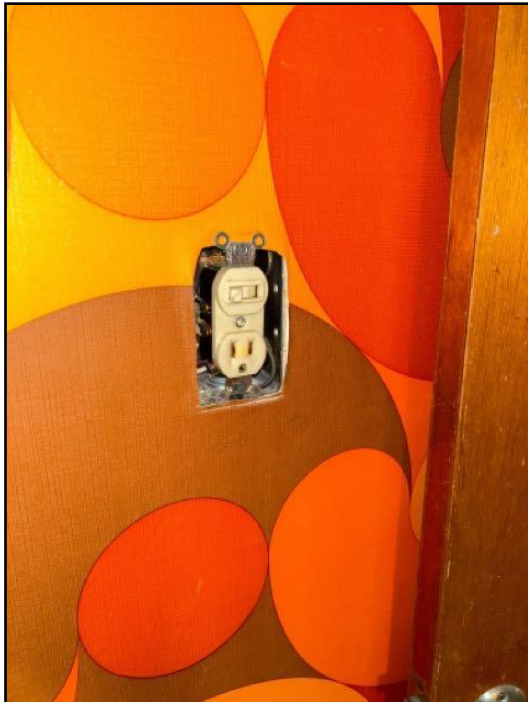
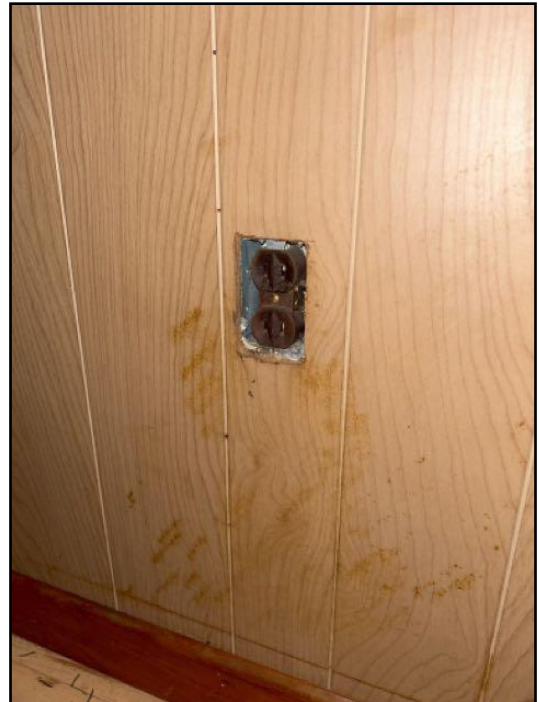
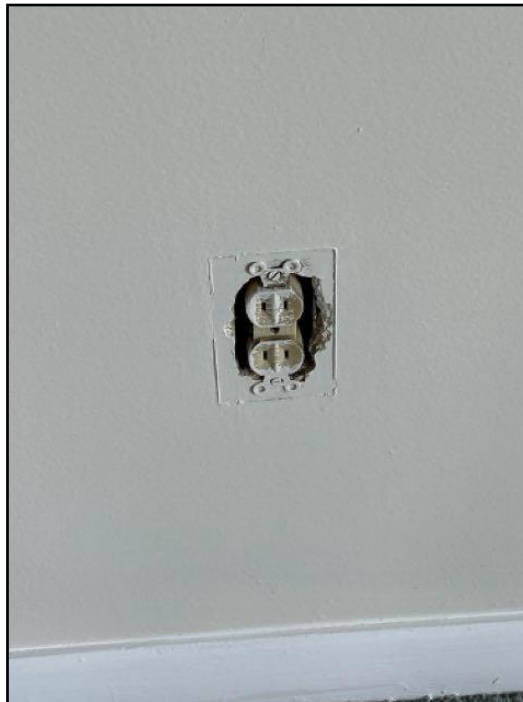
**DISTRIBUTION SYSTEM \ Cover plates****Condition:** • [Missing](#)**Implication(s):** Electric shock**Location:** Various**Task:** Provide**Time:** Immediate**Cost:** Minor

Missing cover plate

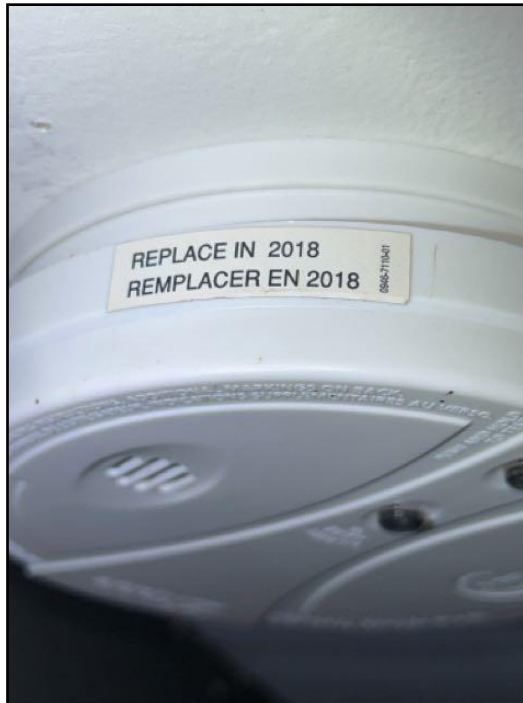
Condition: • Old

Implication(s): Life safety hazard

Old

Task: Replace

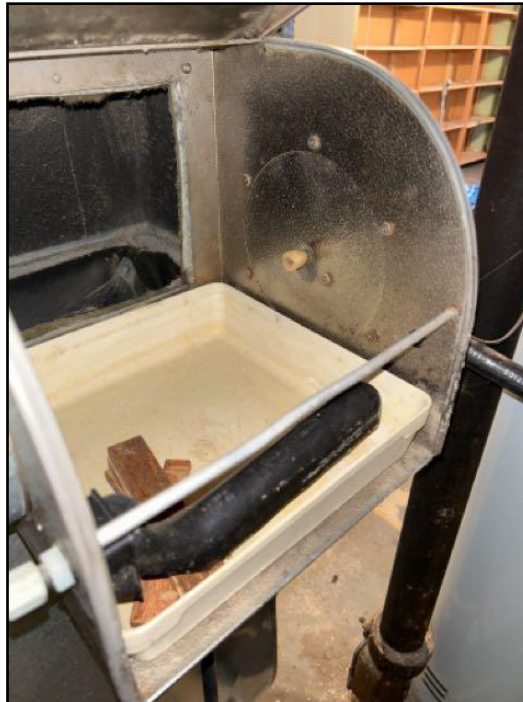
Condition: • Drum missing, motor inoperative

Drum missing/inoperative

Task: Replace

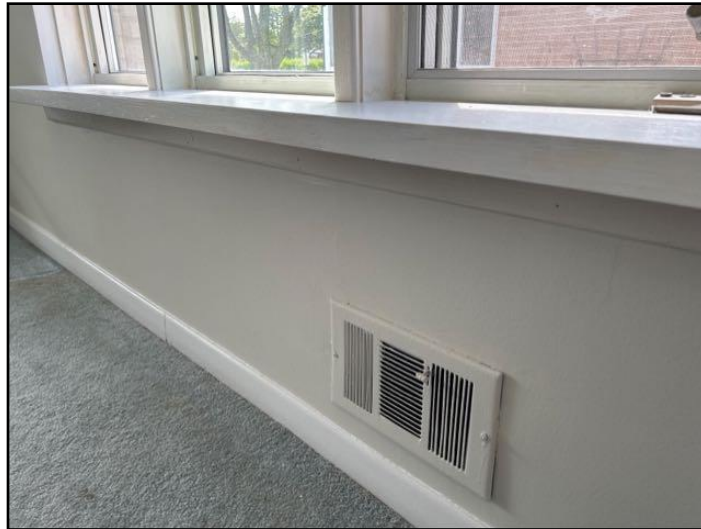
Condition: • [Weak airflow](#)

Implication(s): Increased heating costs | Reduced comfort

Weak airflow

Task: Further evaluation/repair

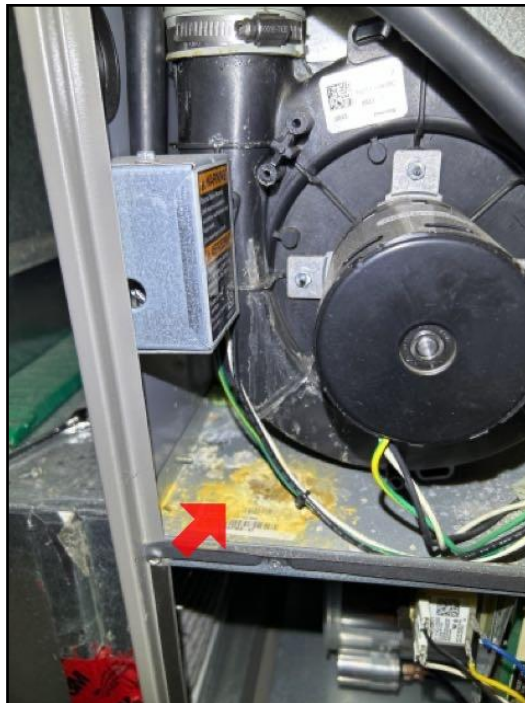
Condition: • [Condensate leak](#)

This could be an old issue that has already been repaired. Have it checked by an HVAC professional.

Condensate leak

Task: Further evaluation/Repair

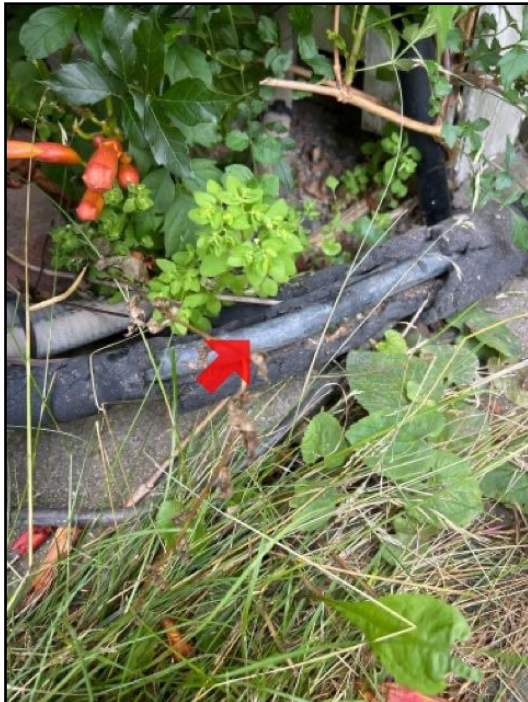
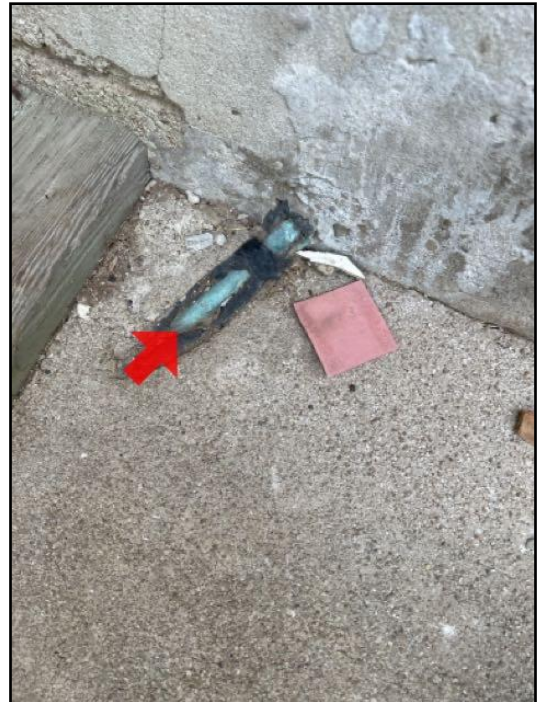
Condition: • Insulation damaged/missing

Location: Northwest Exterior

Insulation damaged/missing

Task: Repair

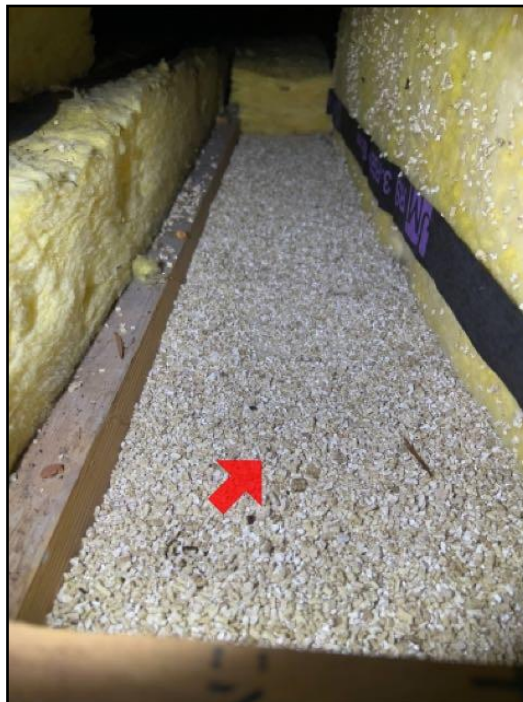
Condition: • Vermiculite insulation was found in the attic. Some vermiculite comes from a mine in Libby, Montana and may contain asbestos. Laboratory testing of the material is required to determine its contents. Left undisturbed it poses little risk.

Agent's Note - Vermiculite was tested - lab results available upon request. The attic insulation does NOT contain asbestos.

Vermiculite insulation

Task: Further evaluation

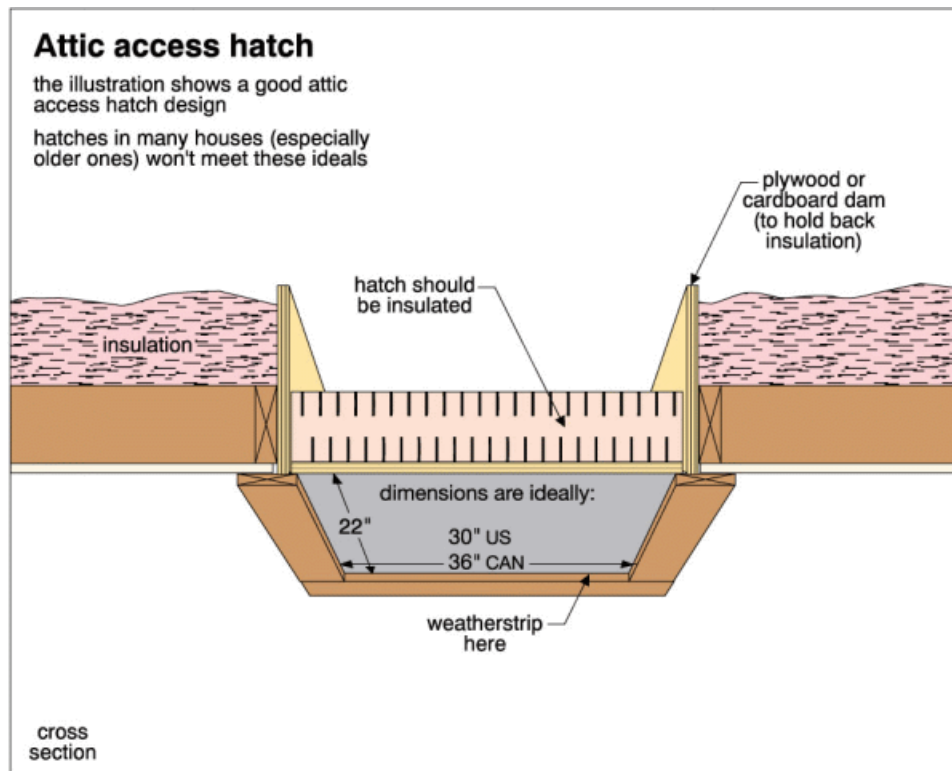
Condition: • [Not insulated and not weatherstripped](#)

Implication(s): Chance of condensation damage to finishes and/or structure | Increased heating and cooling costs | Reduced comfort

Task: Improve

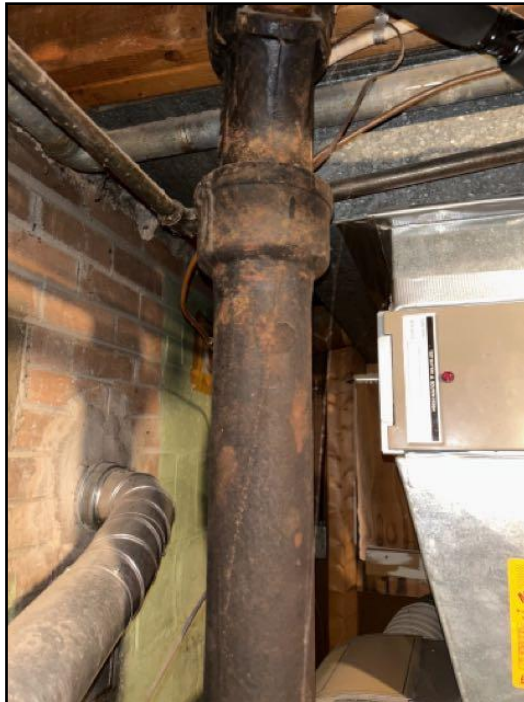
Condition: • Cast iron: A few insurance companies (not all) are requesting to know the amount of cast iron waste plumbing and requiring that it be replaced with ABS plastic. The cost for this is approximately \$1,000 per floor, exclusive of cosmetic repairs. The inspection did not reveal current issues with the pipe.

A cast iron waste pipe appears to run from the basement to the first floor.

Cast iron

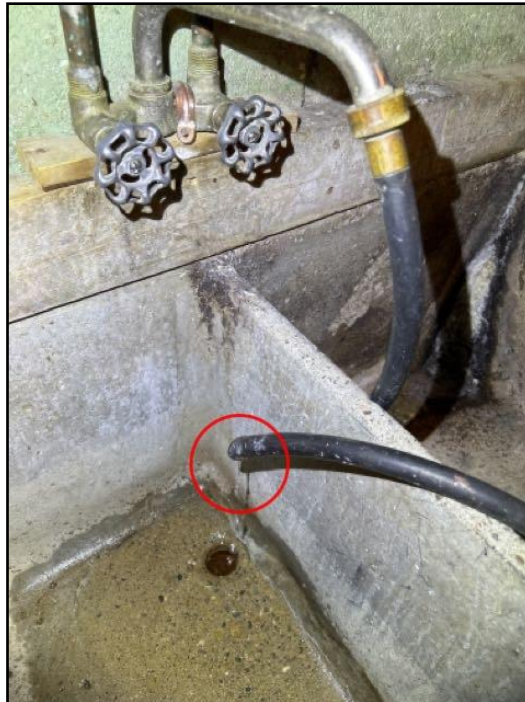
Condition: • [Drip, leak](#)

Location: Laundry Area

Drip, leak

Task: Repair or replace

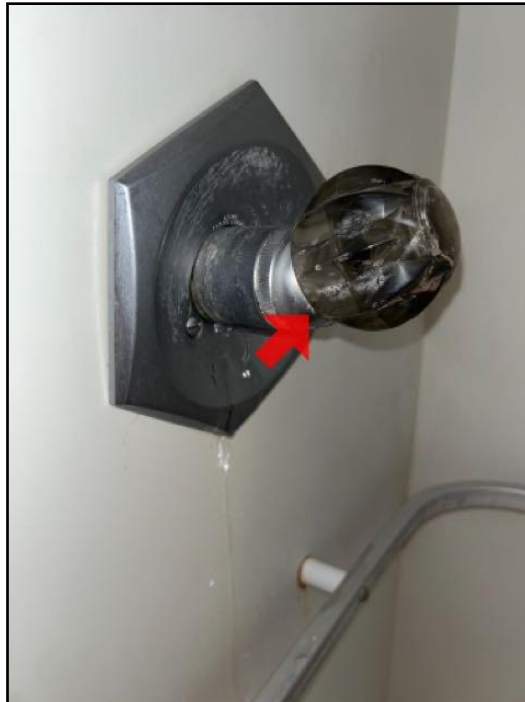
Condition: • [Drip, leak](#)

Location: Basement Bathroom

Drip, leak

Task: Repair or replace

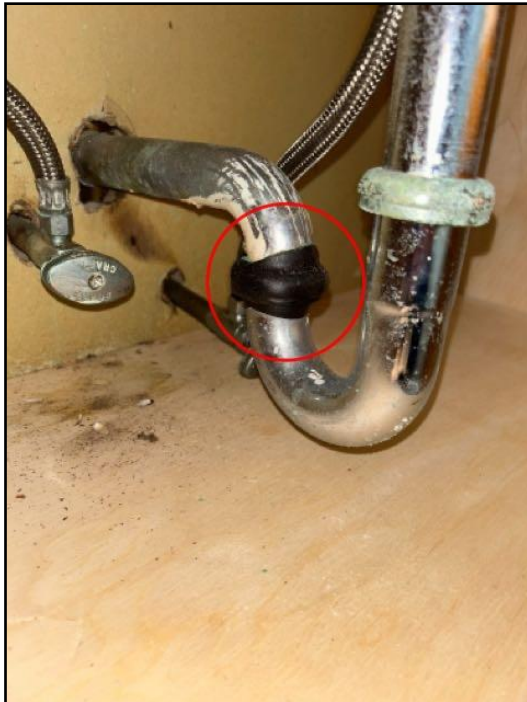
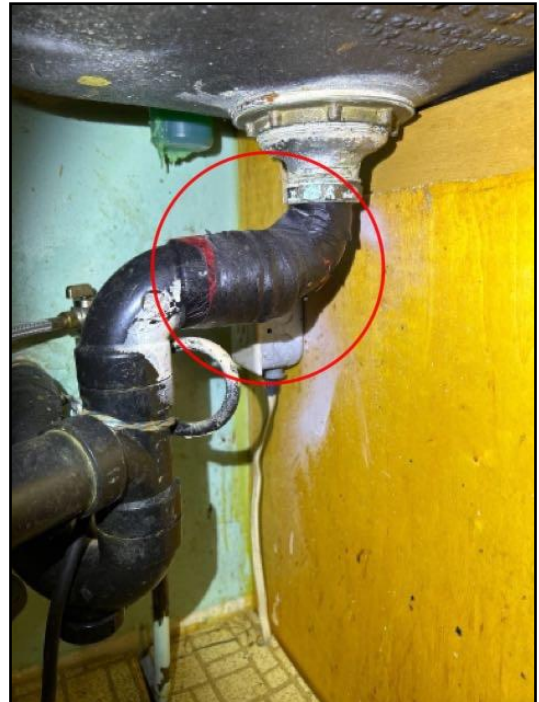
Condition: • Taped connection may indicate a poor seal/leak

Location: Basement Bathroom, Kitchen

Possible poor seal/leak

Task: Further evaluation

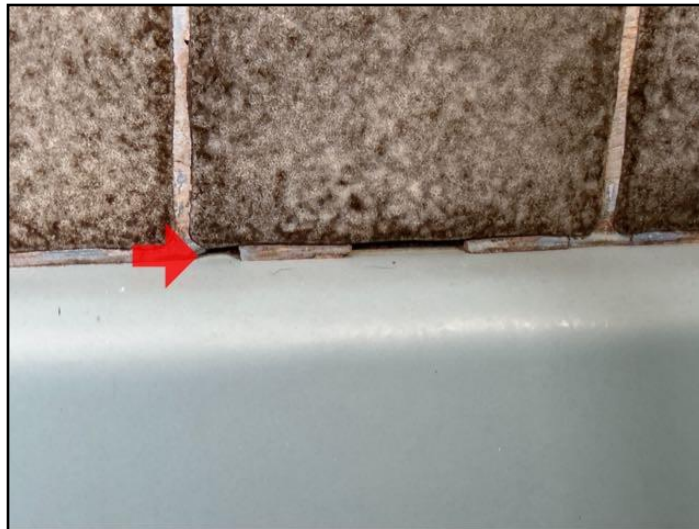
Condition: • [Caulking loose, missing or deteriorated](#)

Location: First Floor Bathroom

Caulking loose, missing or deteriorated

Task: Repair/Provide

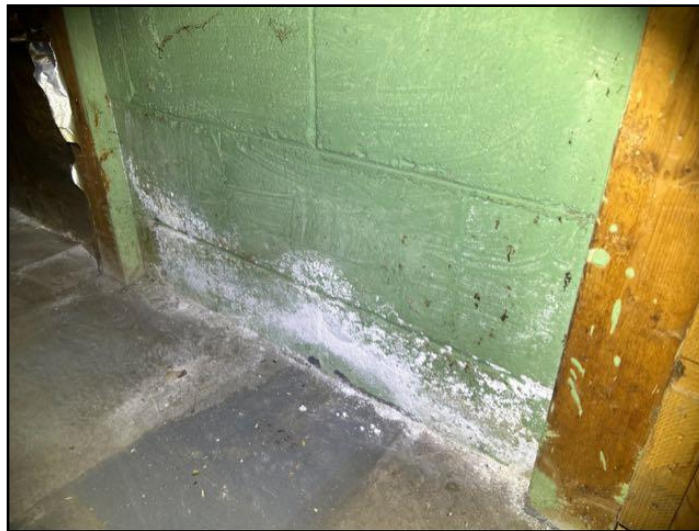
Condition: • [Efflorescence](#)

Some efflorescence is common on foundation walls in old houses. No water leakage/dampness was noted where efflorescence is present.

Efflorescence

Task: Monitor

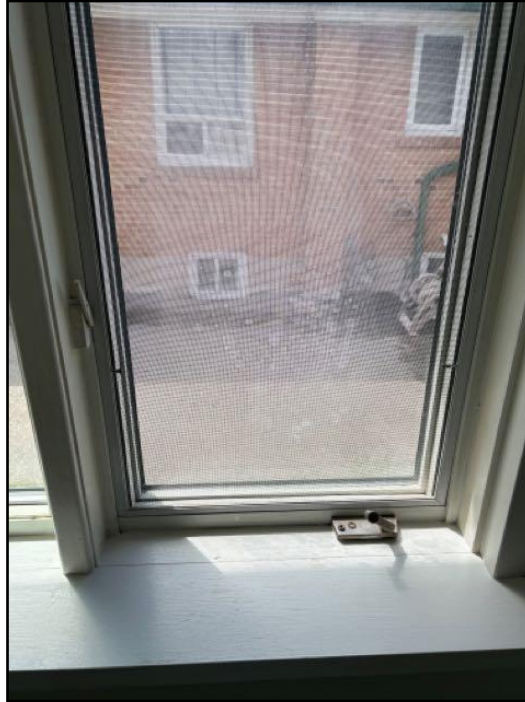
Condition: • [Lost seal on double or triple glazing](#)

Lost seal on double or triple glazing

Task: Repair or replace

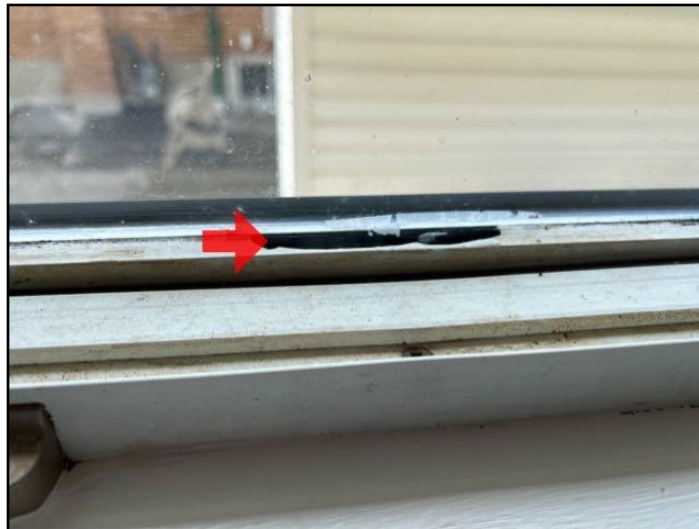
Condition: • Damage

Task: Repair or replace

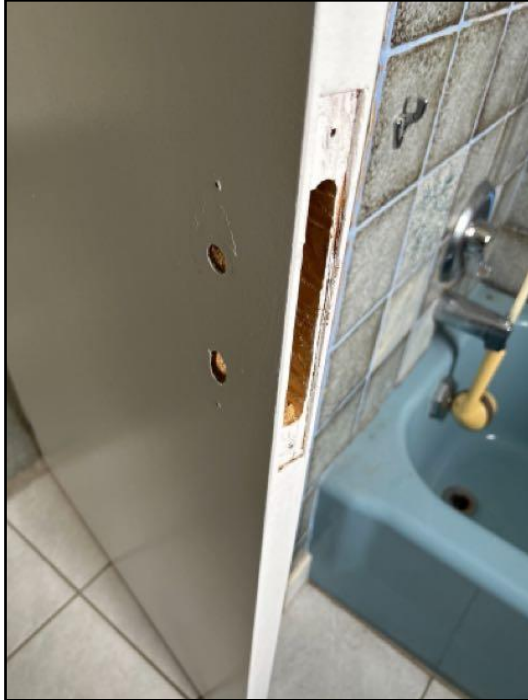
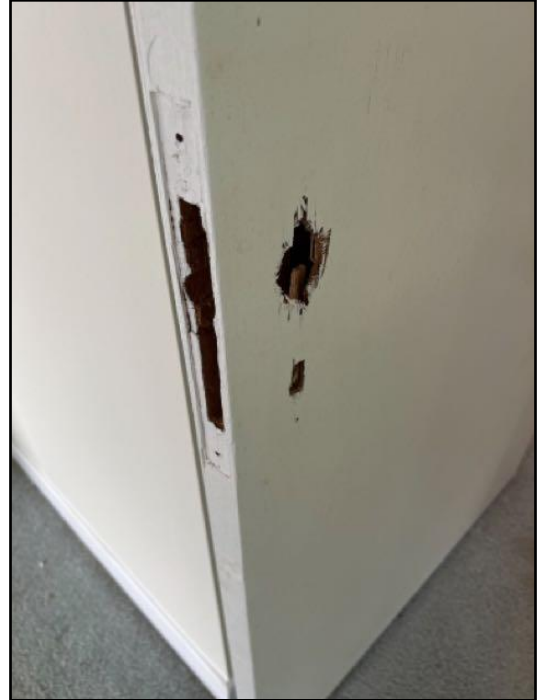
Condition: • [Missing](#)

Missing hardware

Task: Repair or replace

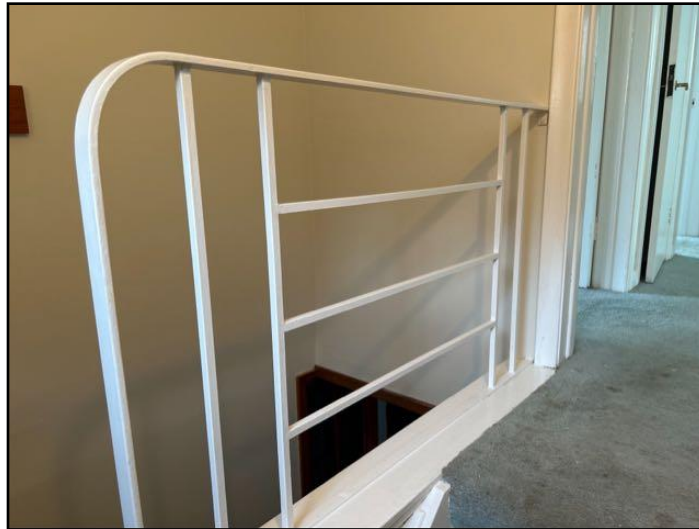
Condition: • [Easy to climb](#)

Implication(s): Fall hazard

Easy to climb

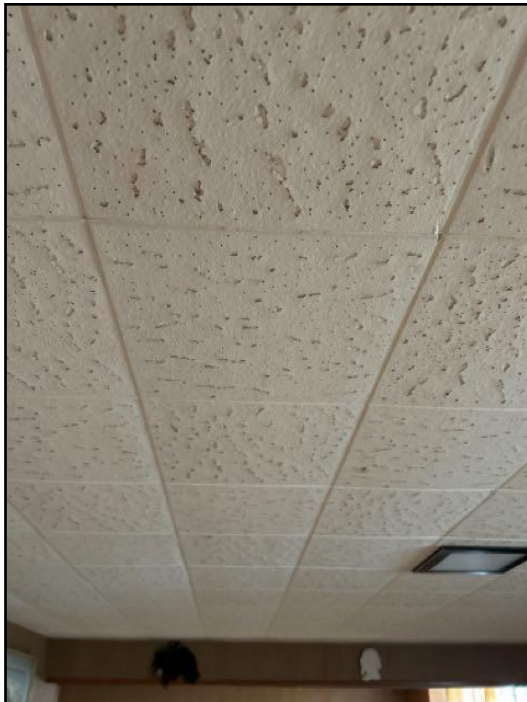
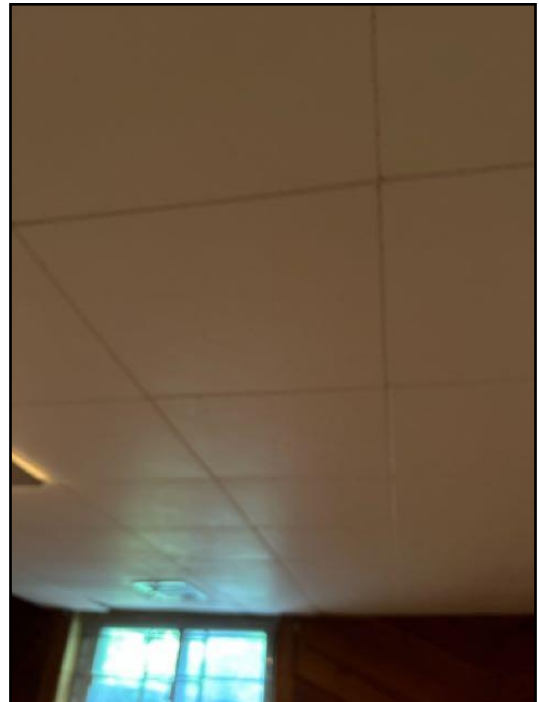
Condition: • Possible asbestos containing materials

Implication(s): Health hazard

Possible asbestos containing materials
