# Your Inspection Report

7 Redstone Path  
Toronto, ON M9C 1Y7

**INSPECTION DATE:**  
Wednesday, March 6, 2024

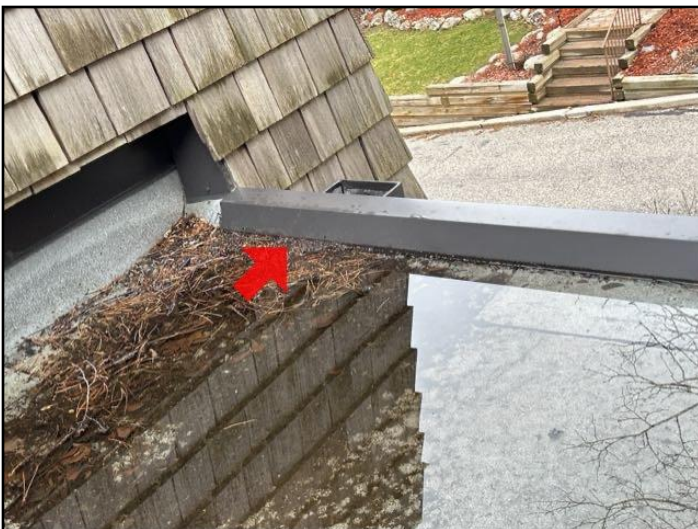
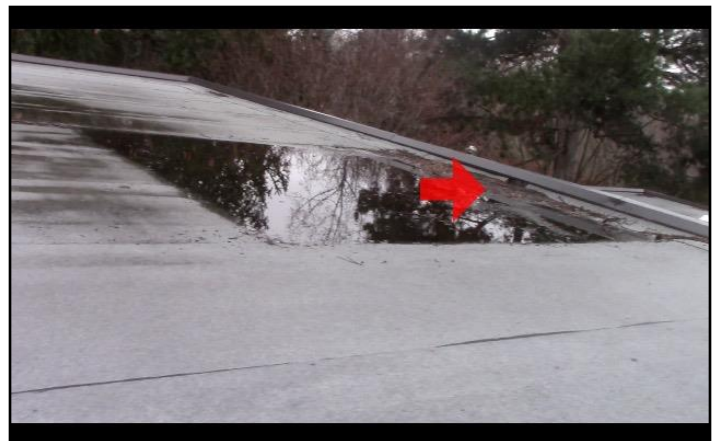
Condition: • [Clogged](#)

Roof debris is blocking the scupper drains, causing ponding on the roof.

Implication(s): Chance of water damage to structure, finishes and contents

*Clogged*

Task: Clean

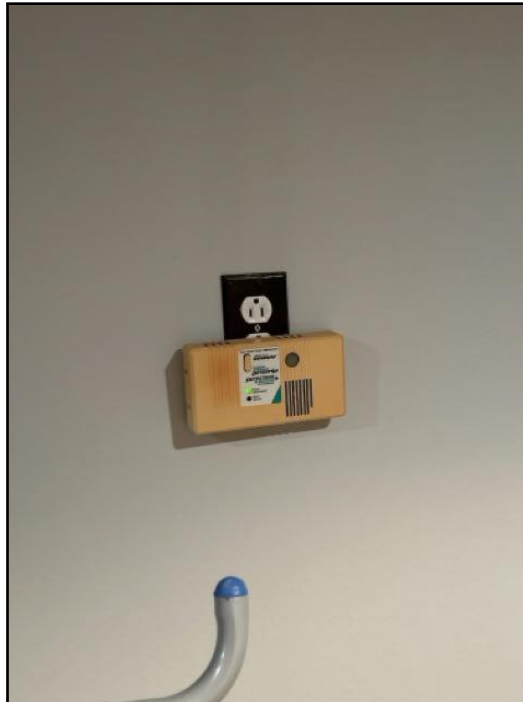
**Condition:** • Ungrounded

The seller has contracted to have this issue remedied prior to listing.

**Implication(s):** Electric shock

*Ungrounded*

**Task:** Repair

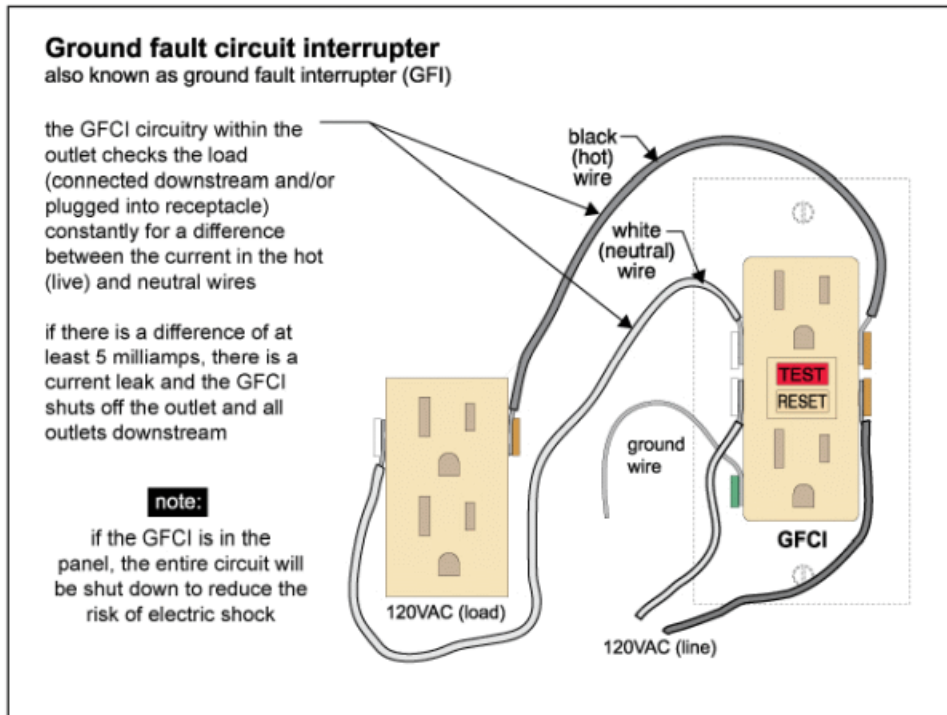
**Condition:** • [No GFCI/GFI \(Ground Fault Circuit Interrupter\)](#)

The seller has contracted to have this issue remedied prior to listing.

**Implication(s):** Electric shock

**Task:** Provide

**Realtor's Note - Electrical repairs have been made.  
Invoice with work description can be provided.**

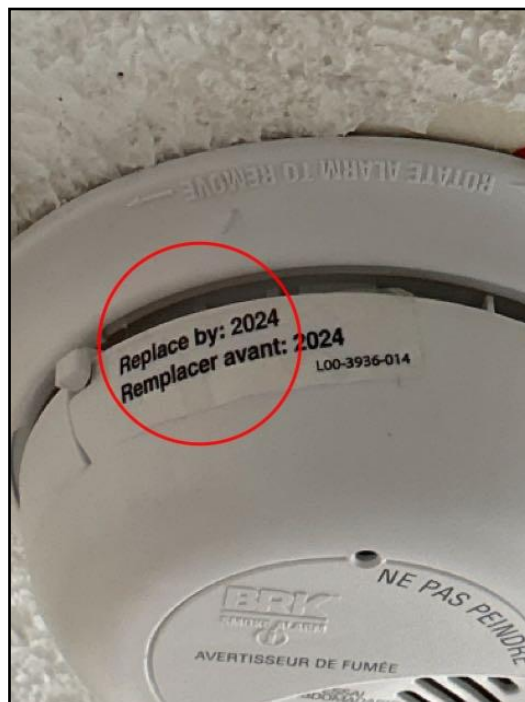
**Condition:** • End of life expectancy

*End of life expectancy*

**Task:** Replace

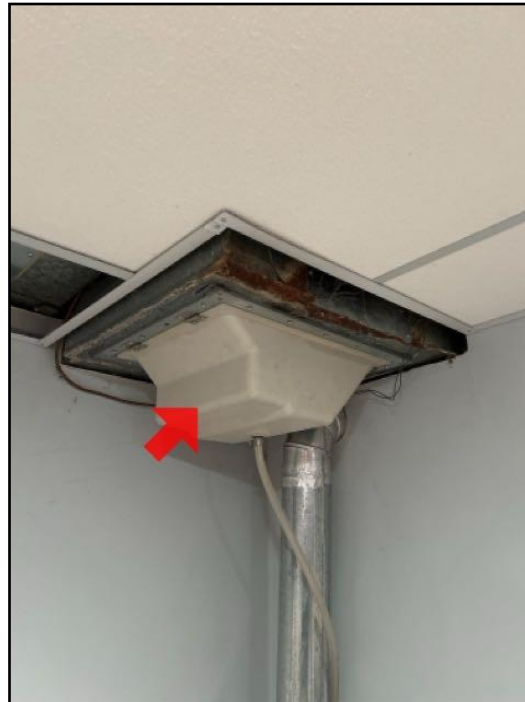
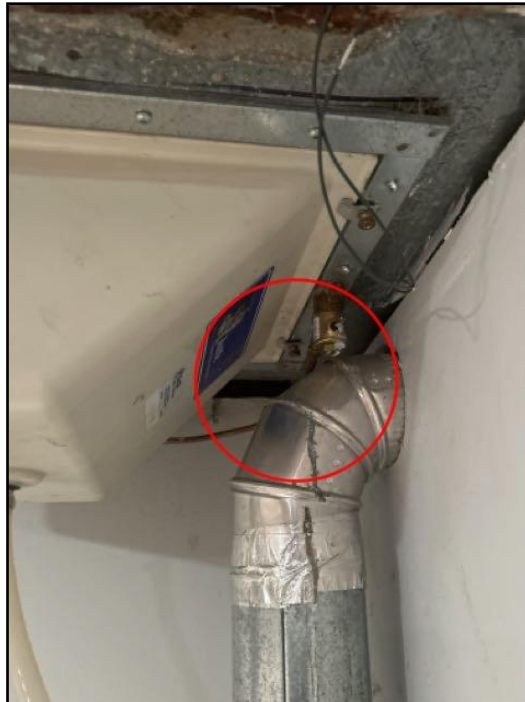
**Condition:** • Service access blocked by dryer exhaust vent. Humidifier contains a mesh pad that should be replaced annually.

*Access blocked by duct*

**Task:** Improve

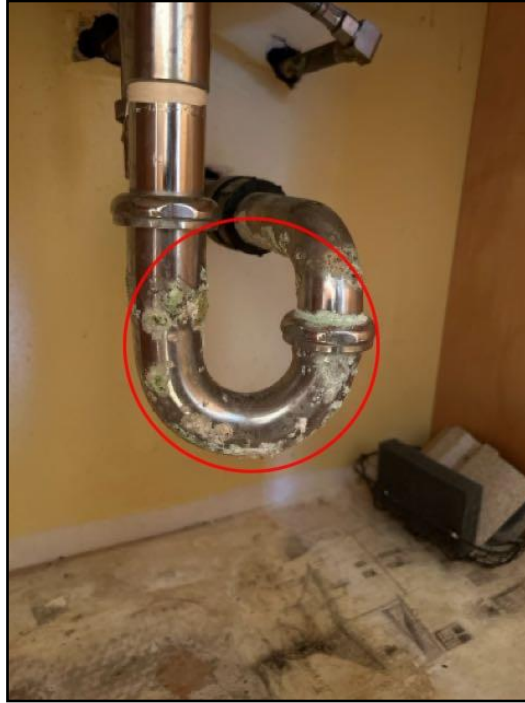
- WATER HEATER \ Life expectancy**
- Condition: • Past life expectancy
- Implication(s): Chance of water damage to structure, finishes and contents | No hot water
- Task: Replace
- Time: Less than 1 year
- Cost: Depends on approach
- WASTE PLUMBING \ Traps - performance**
- Condition: • Corrosion

*Corrosion*

**Task:** Replace

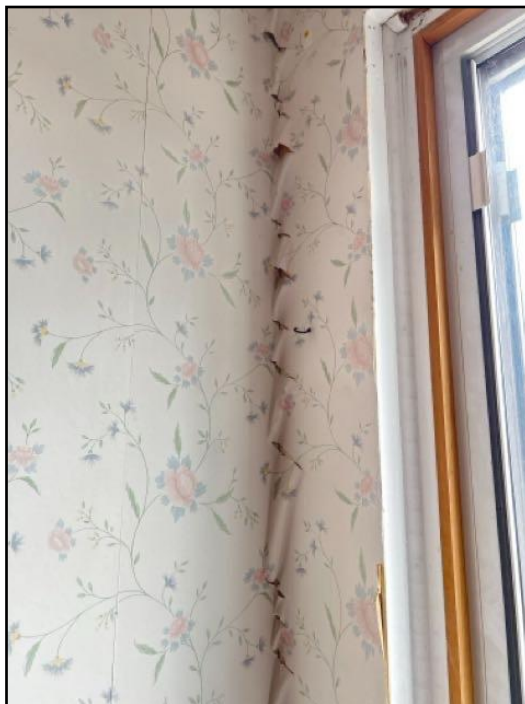
**Condition:** • Buckled/torn wallpaper - the corner tests dry with a moisture meter. This may due to some old, minor settling/movement.

*Buckled/torn wallpaper*

**Task:** Repair

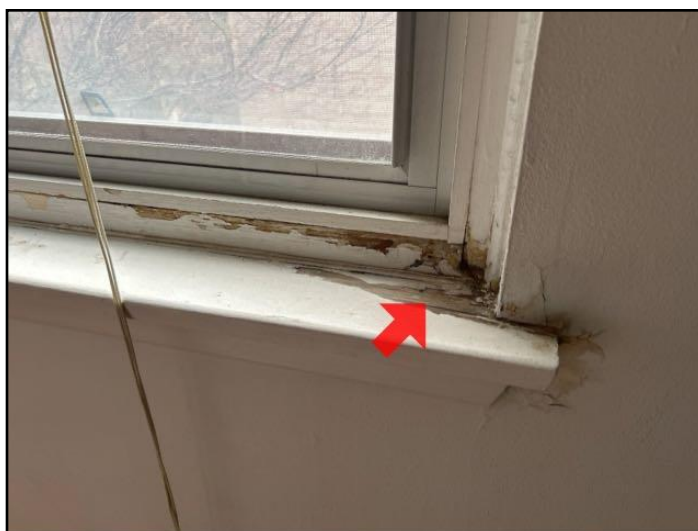
**Condition:** • Water damage - likely caused by window being left open during rain.

*Water damage*

**Task:** Repair

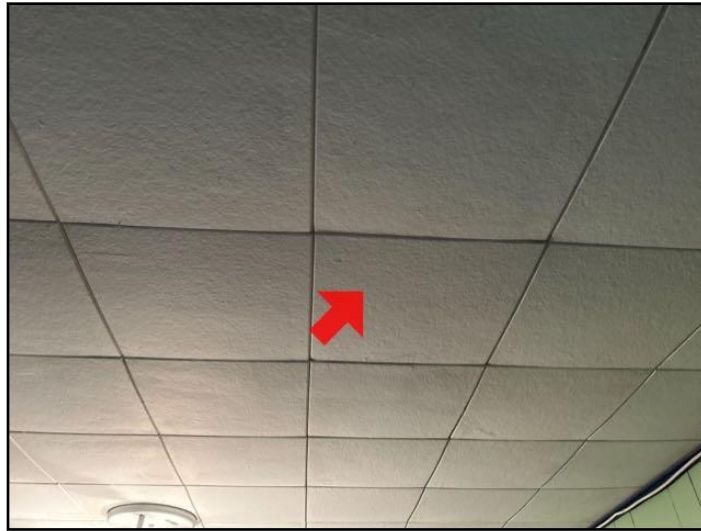
**Condition:** • Possible asbestos containing materials

**Implication(s):** Health hazard

**Realtor's Note - Tiles tested negative for asbestos.  
Lab certificate can be provided.**

*Possible asbestos containing materials*

**Task:** Further evaluation/remove if necessary
