Your Inspection Report

8-1 Bradbrook Road
Toronto, ON M8Z 5V3

INSPECTION DATE:
Wednesday, March 6, 2024

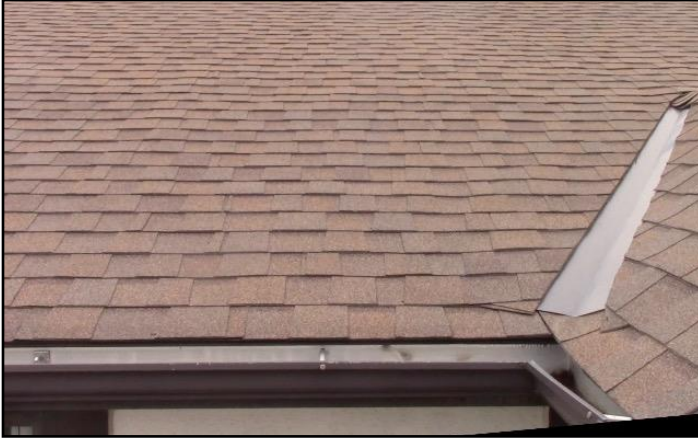
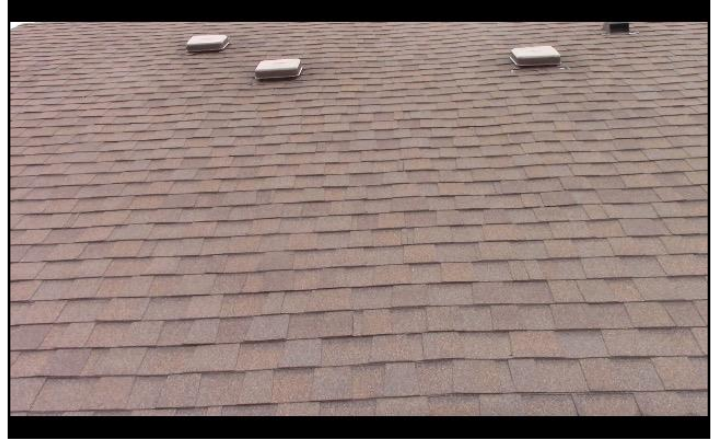
Asphalt shingles

Condition: • No roofing recommendations are offered as a result of this inspection. Roofing material appears to be in good condition.

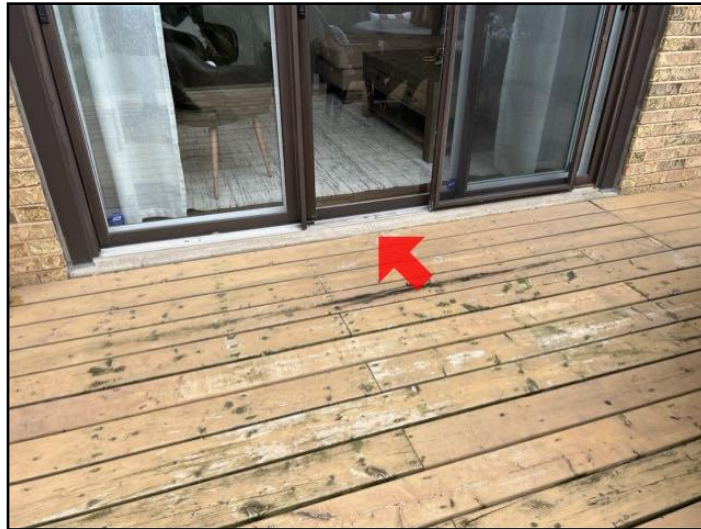
Condition: • [No step up into building](#)

Implication(s): Material deterioration | Chance of water damage to structure, finishes and contents

Location: Rear

No step up into building

Task: Keep a door area cleared of snow in winter

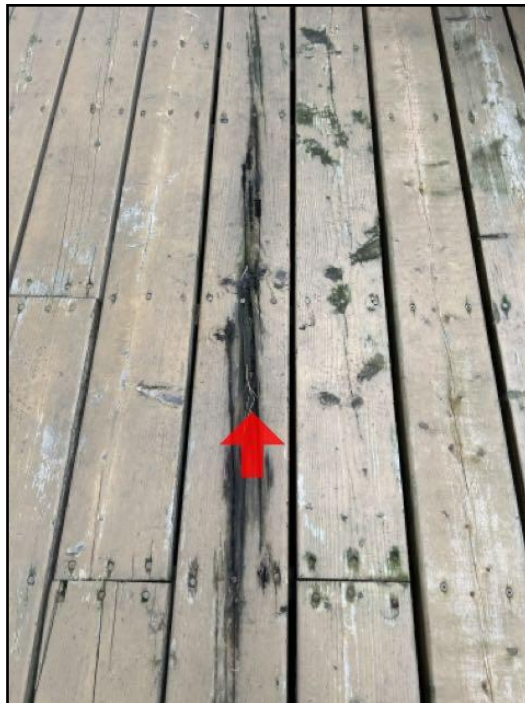
Condition: • [Rot](#)

Implication(s): Material deterioration | Chance of movement | Weakened structure

Location: Rear

Rot

Task: Repair

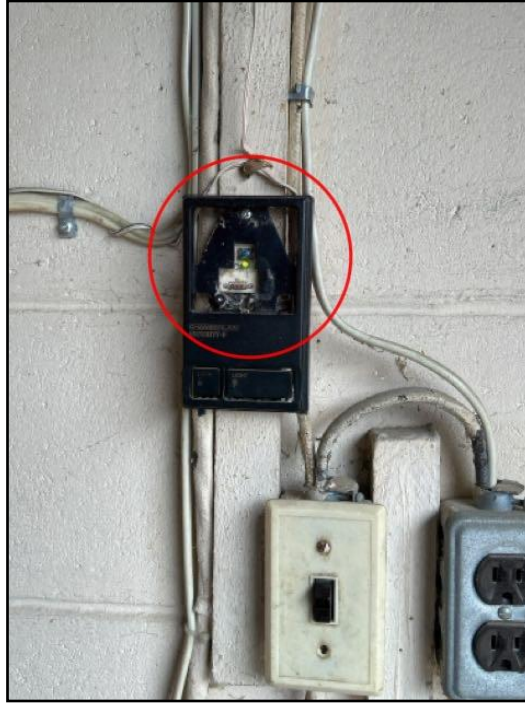
Condition: • Garage wall switch damaged

Switch damaged

Location: Garage
Task: Replace
Time: Less than 1 year
Cost: Minor

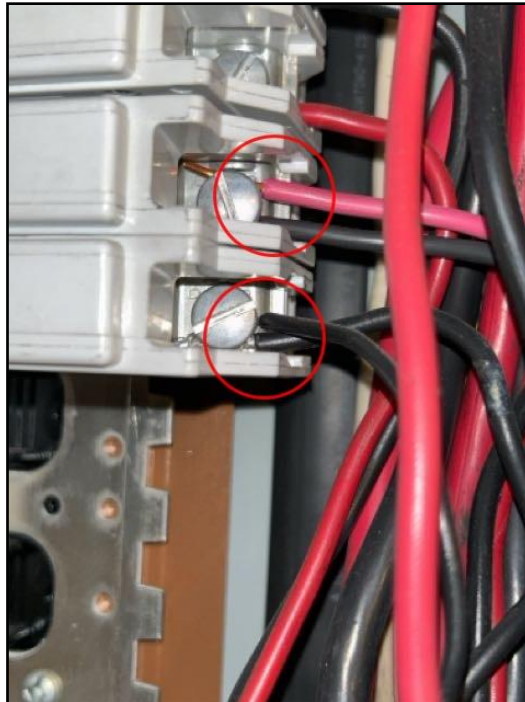
Condition: • [Double taps](#)

Implication(s): Fire hazard

Double taps

Task: Correct

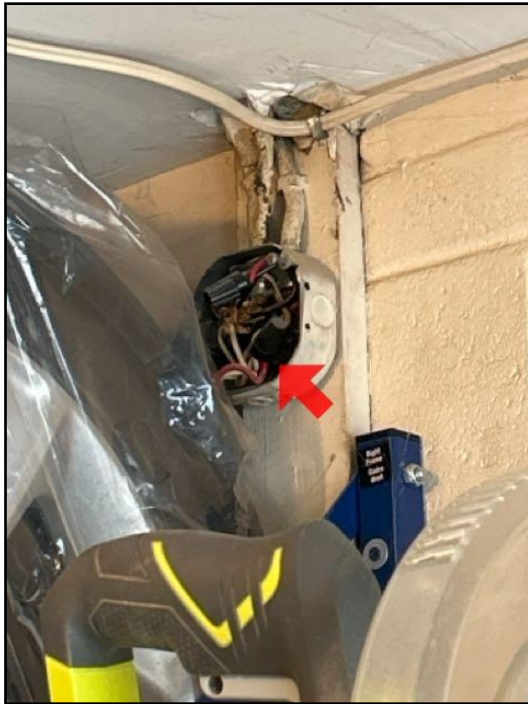
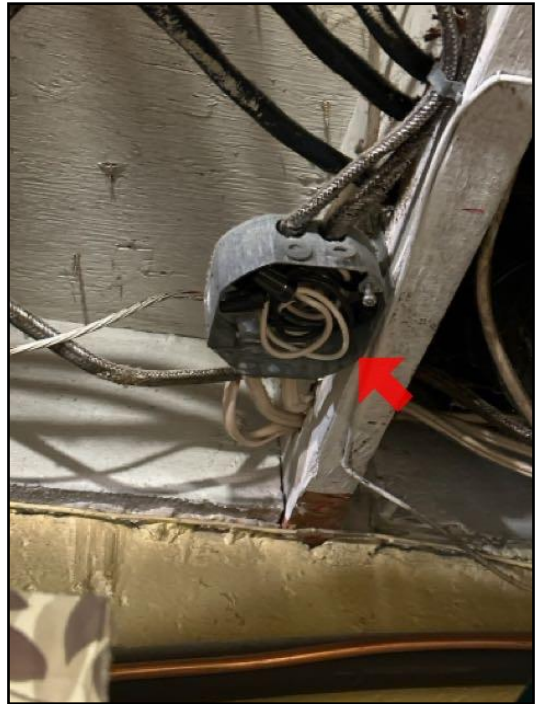
Condition: • [Missing](#)

Implication(s): Electric shock

Location: Garage, Utility Room

Missing cover plate

Task: Provide

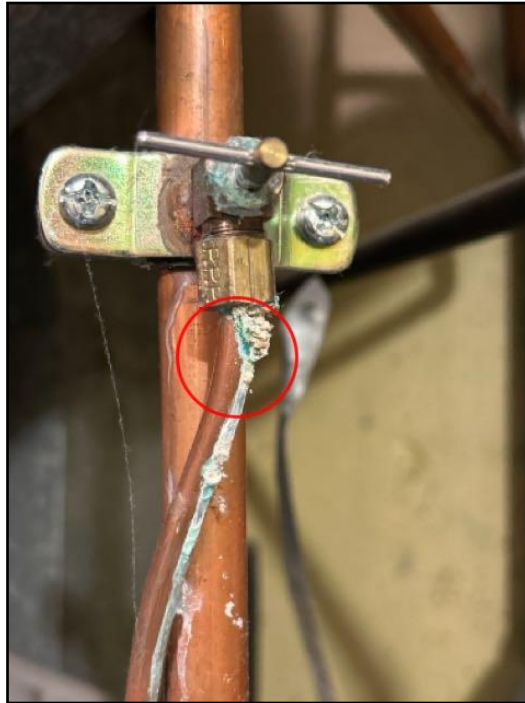
Condition: • Corrosion on water supply line for humidifier

Location: Utility Room

Corrosion

Task: Repair

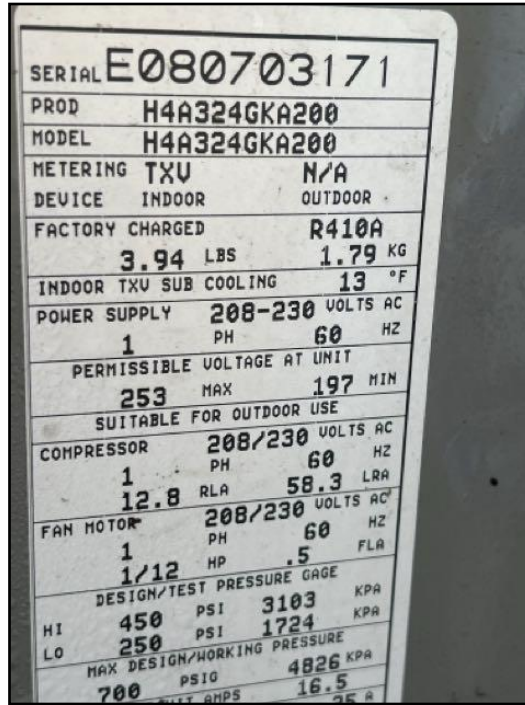
Air Conditioner data plate

Compressor approximate age: • 15 years

Typical life expectancy: • 12 to 15 years

Condition: • [Near end of life expectancy](#)

Implication(s): Equipment failure | Reduced comfort

Task: Replace

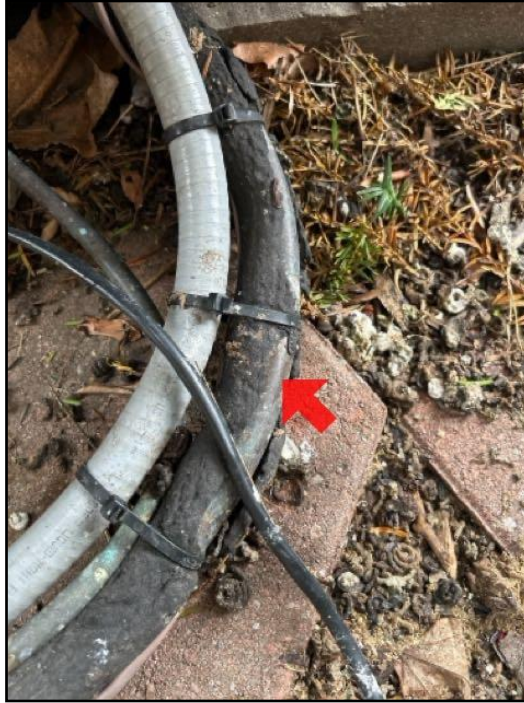
Condition: • Insulation damaged/missing

Location: Front Exterior

Insulation damaged/missing

Task: Repair

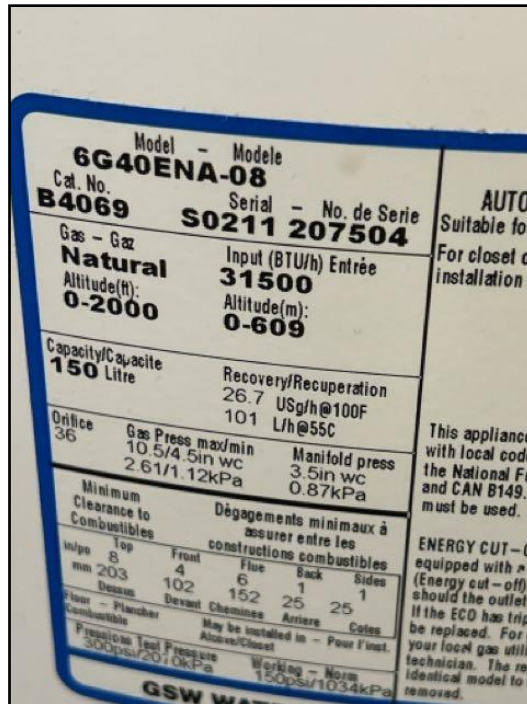
Water heater data plate

- Water heater tank capacity: • [40 gallons](#)
- Water heater approximate age: • 22 years
- Water heater typical life expectancy: • 10 to 15 years
- Waste and vent piping in building: • [ABS plastic](#) • [Not visible](#)
- Floor drain location: • Near laundry area
- Backwater valve: • None noted

Condition: • [Old](#)

Implication(s): No hot water

Task: Replace

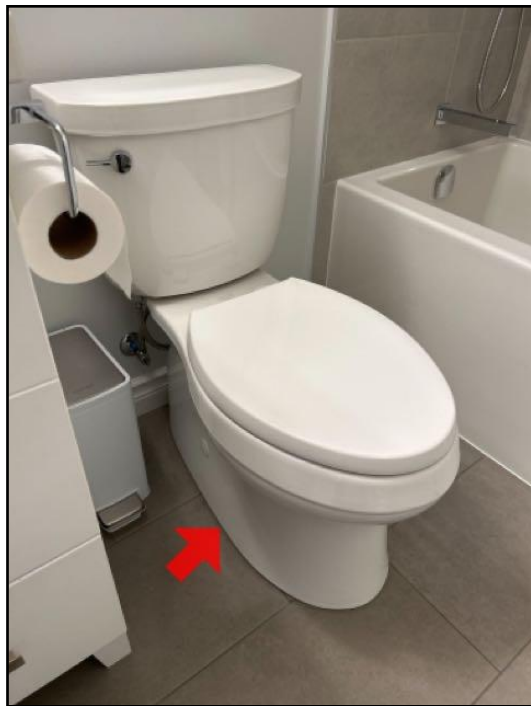
Condition: • [Loose](#)

Implication(s): Chance of water damage to structure, finishes and contents | Sewage entering the building | Possible hidden damage

Location: Second Floor Bathroom

Loose

Task: Repair
